Geotechnical Report and Stability Assessment

Albert Town Landslides

Otago Regional Council

9 December 2014

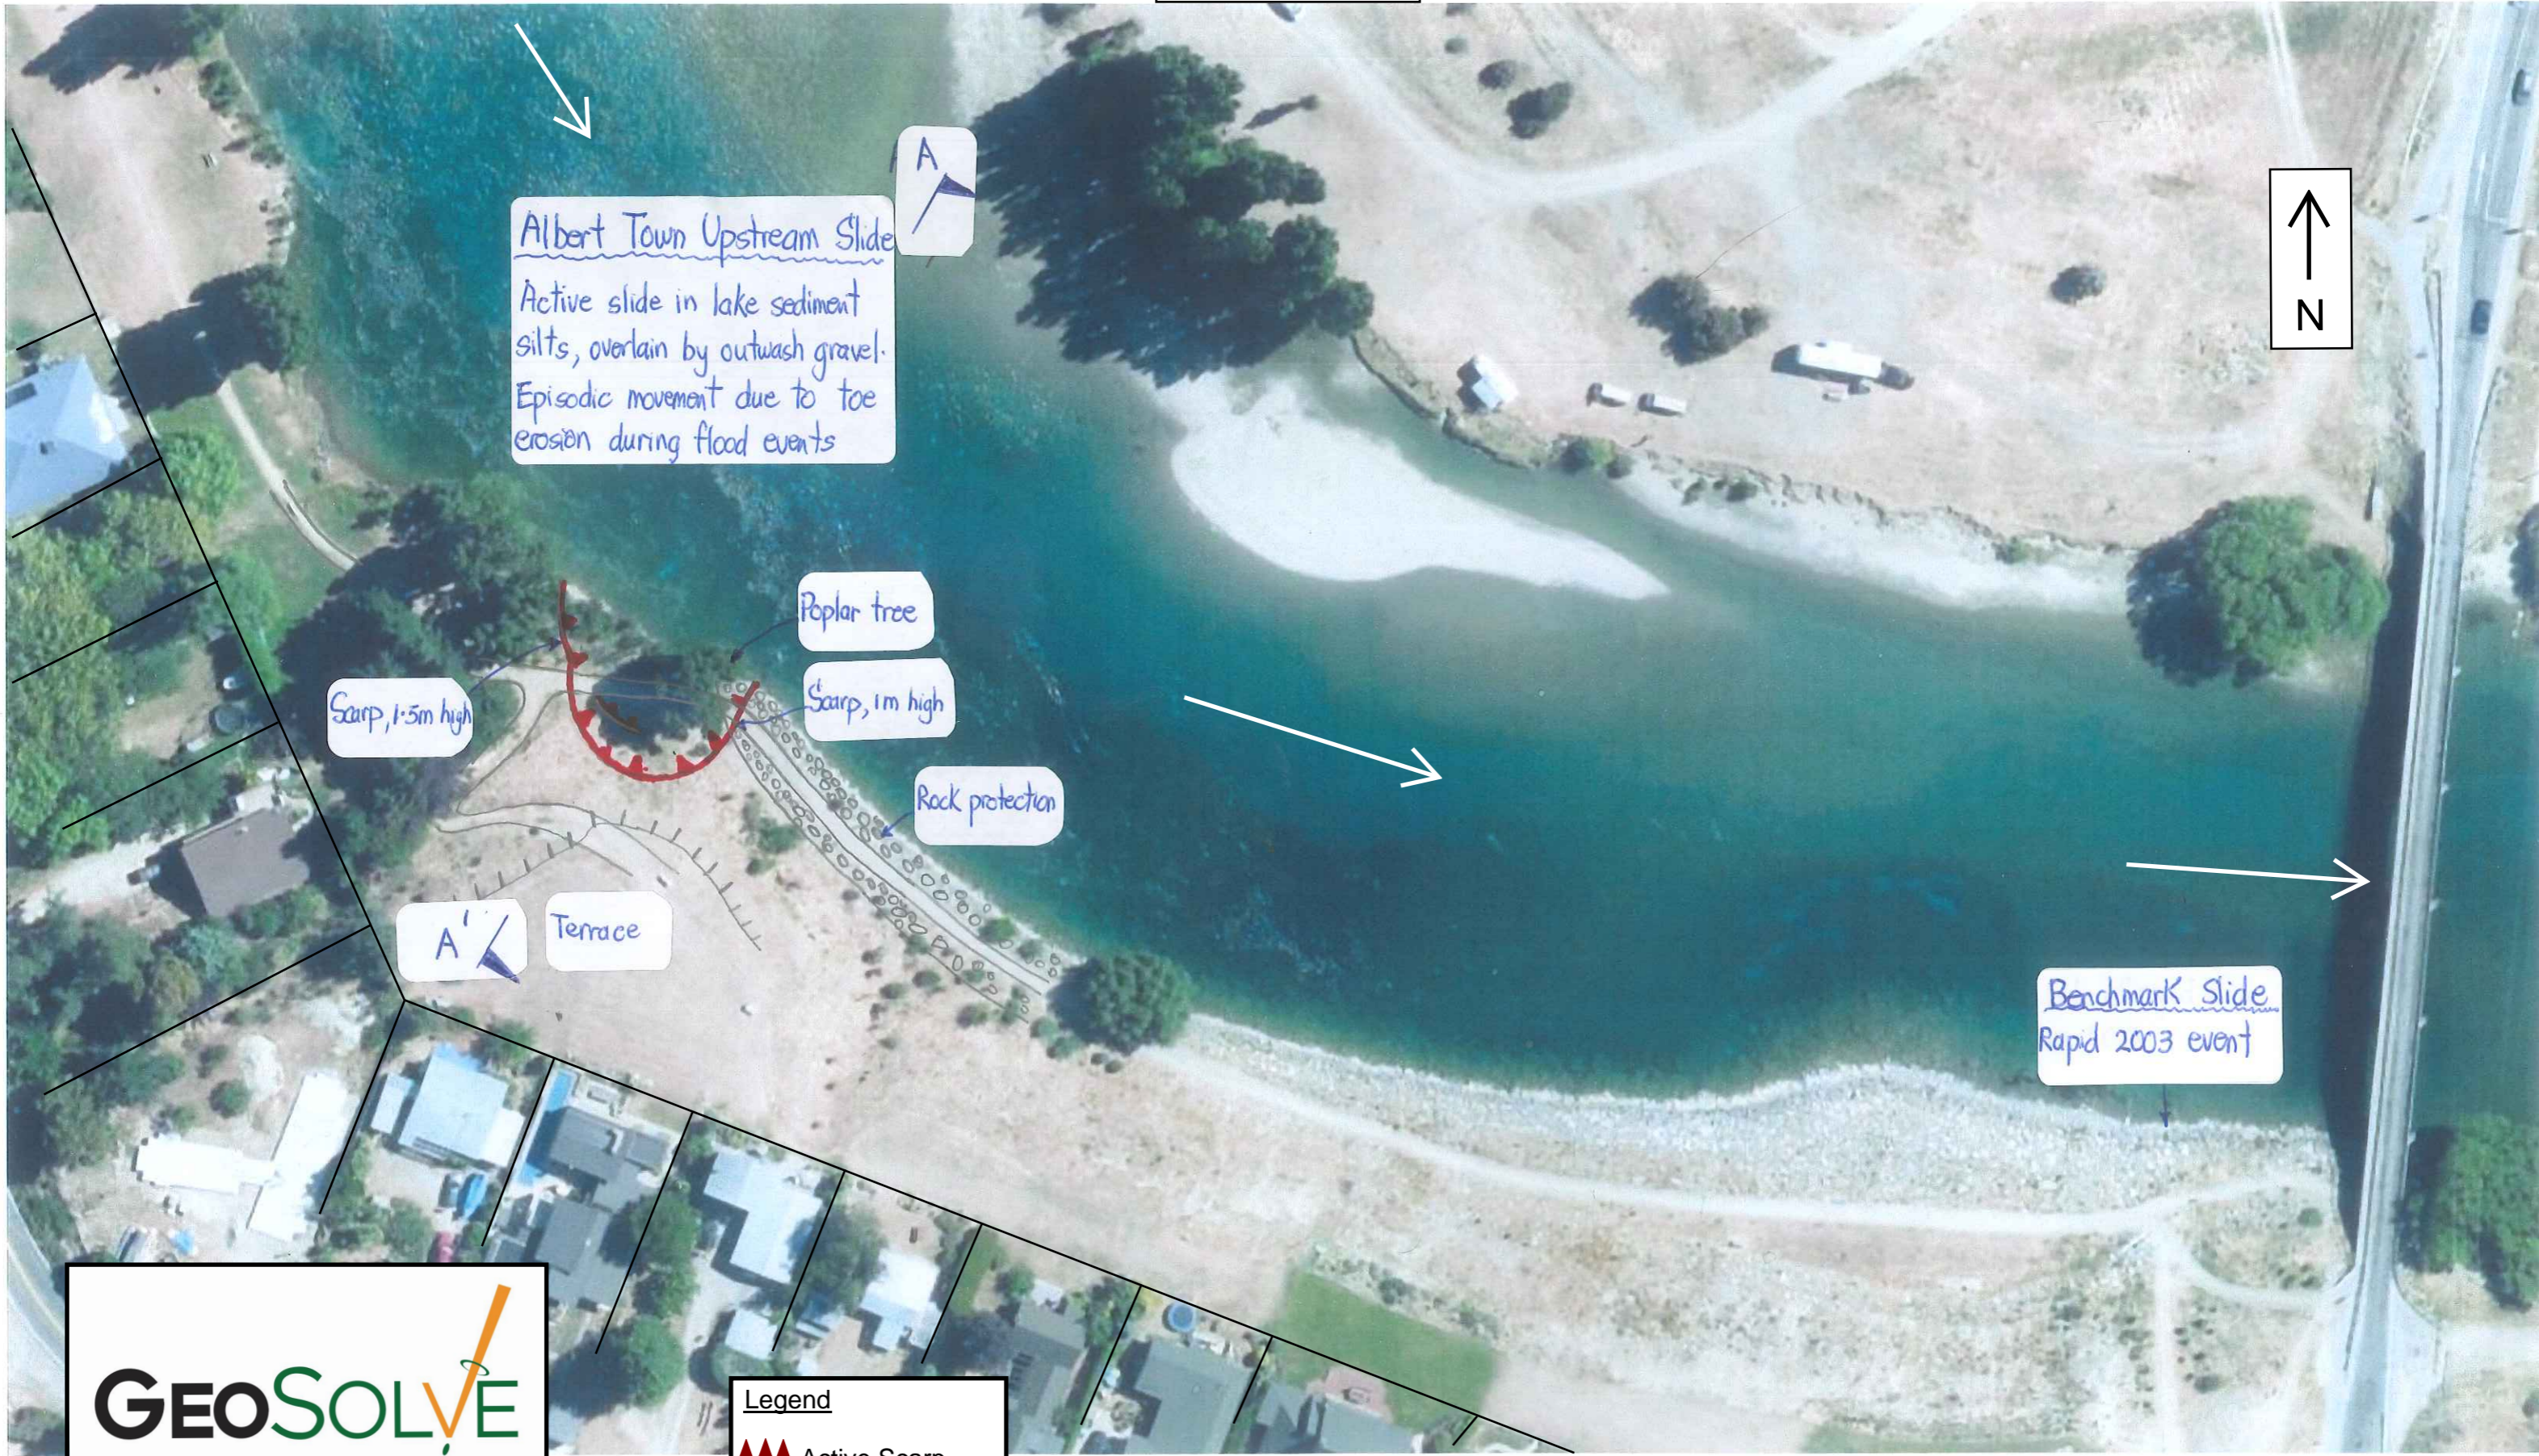
Figure 3

This is a small landslide about 30m wide in a steep terrace face that affects a section of the cycle track along the bank of the Clutha River, about 250m upstream of the Albert Town Bridge (see Appendix A, Fig. 3; and Appendix B, Fig. 5). It has undergone intermittent minor movements in recent years in response to flood events, including the development of a perimeter scarp up to 1.5 m high at the western margin, which produces an abrupt step in the cycle track.

There are several scarps within the landslide which is showing signs of retrogressing back up the slope. The toe is inferred to exit below river level in the deeply eroded thalweg of the river on the outside of the adjacent bend (Appendix B, Fig. 5). The rock revetment along the river bank terminates a few metres onto the landslide, and may be contributing to scouring of the river channel and bank in the landslide toe area immediately upstream owing to possible eddying action (see 3.2.1.1 below).

The landslide is developed largely in laminated lake silts, with outwash gravels lying above an old erosion surface in the upper landslide. A bedding plane-parallel translational sliding mechanism is inferred, due to the presence of weak clayey silt layers along the sub-horizontal bedding. The water table is inferred to generally rise away from the river with moderate gradient.

With further flood induced toe erosion, this landslide is likely to continue to undergo minor movement manifested as intermittent creep, and retrogress further up the slope.

It is possible that a major retrogression towards the top of the steep terrace could be triggered by a major flood scour. The loss of support could possibly result in a relatively rapid movement event. However, owing to substantial side friction associated with the narrow width of the landslide, it is considered that velocities would likely be of the order of 1 metre/minute rather than the 1 metre/second inferred for the rapid 2003 event.

Albert Town Upstream Slide
Active slide in lake sediment
silts, overlain by outwash gravel.
Episodic movement due to toe
erosion during flood events

Scarp, 1.5m high

Scarp, 1m high

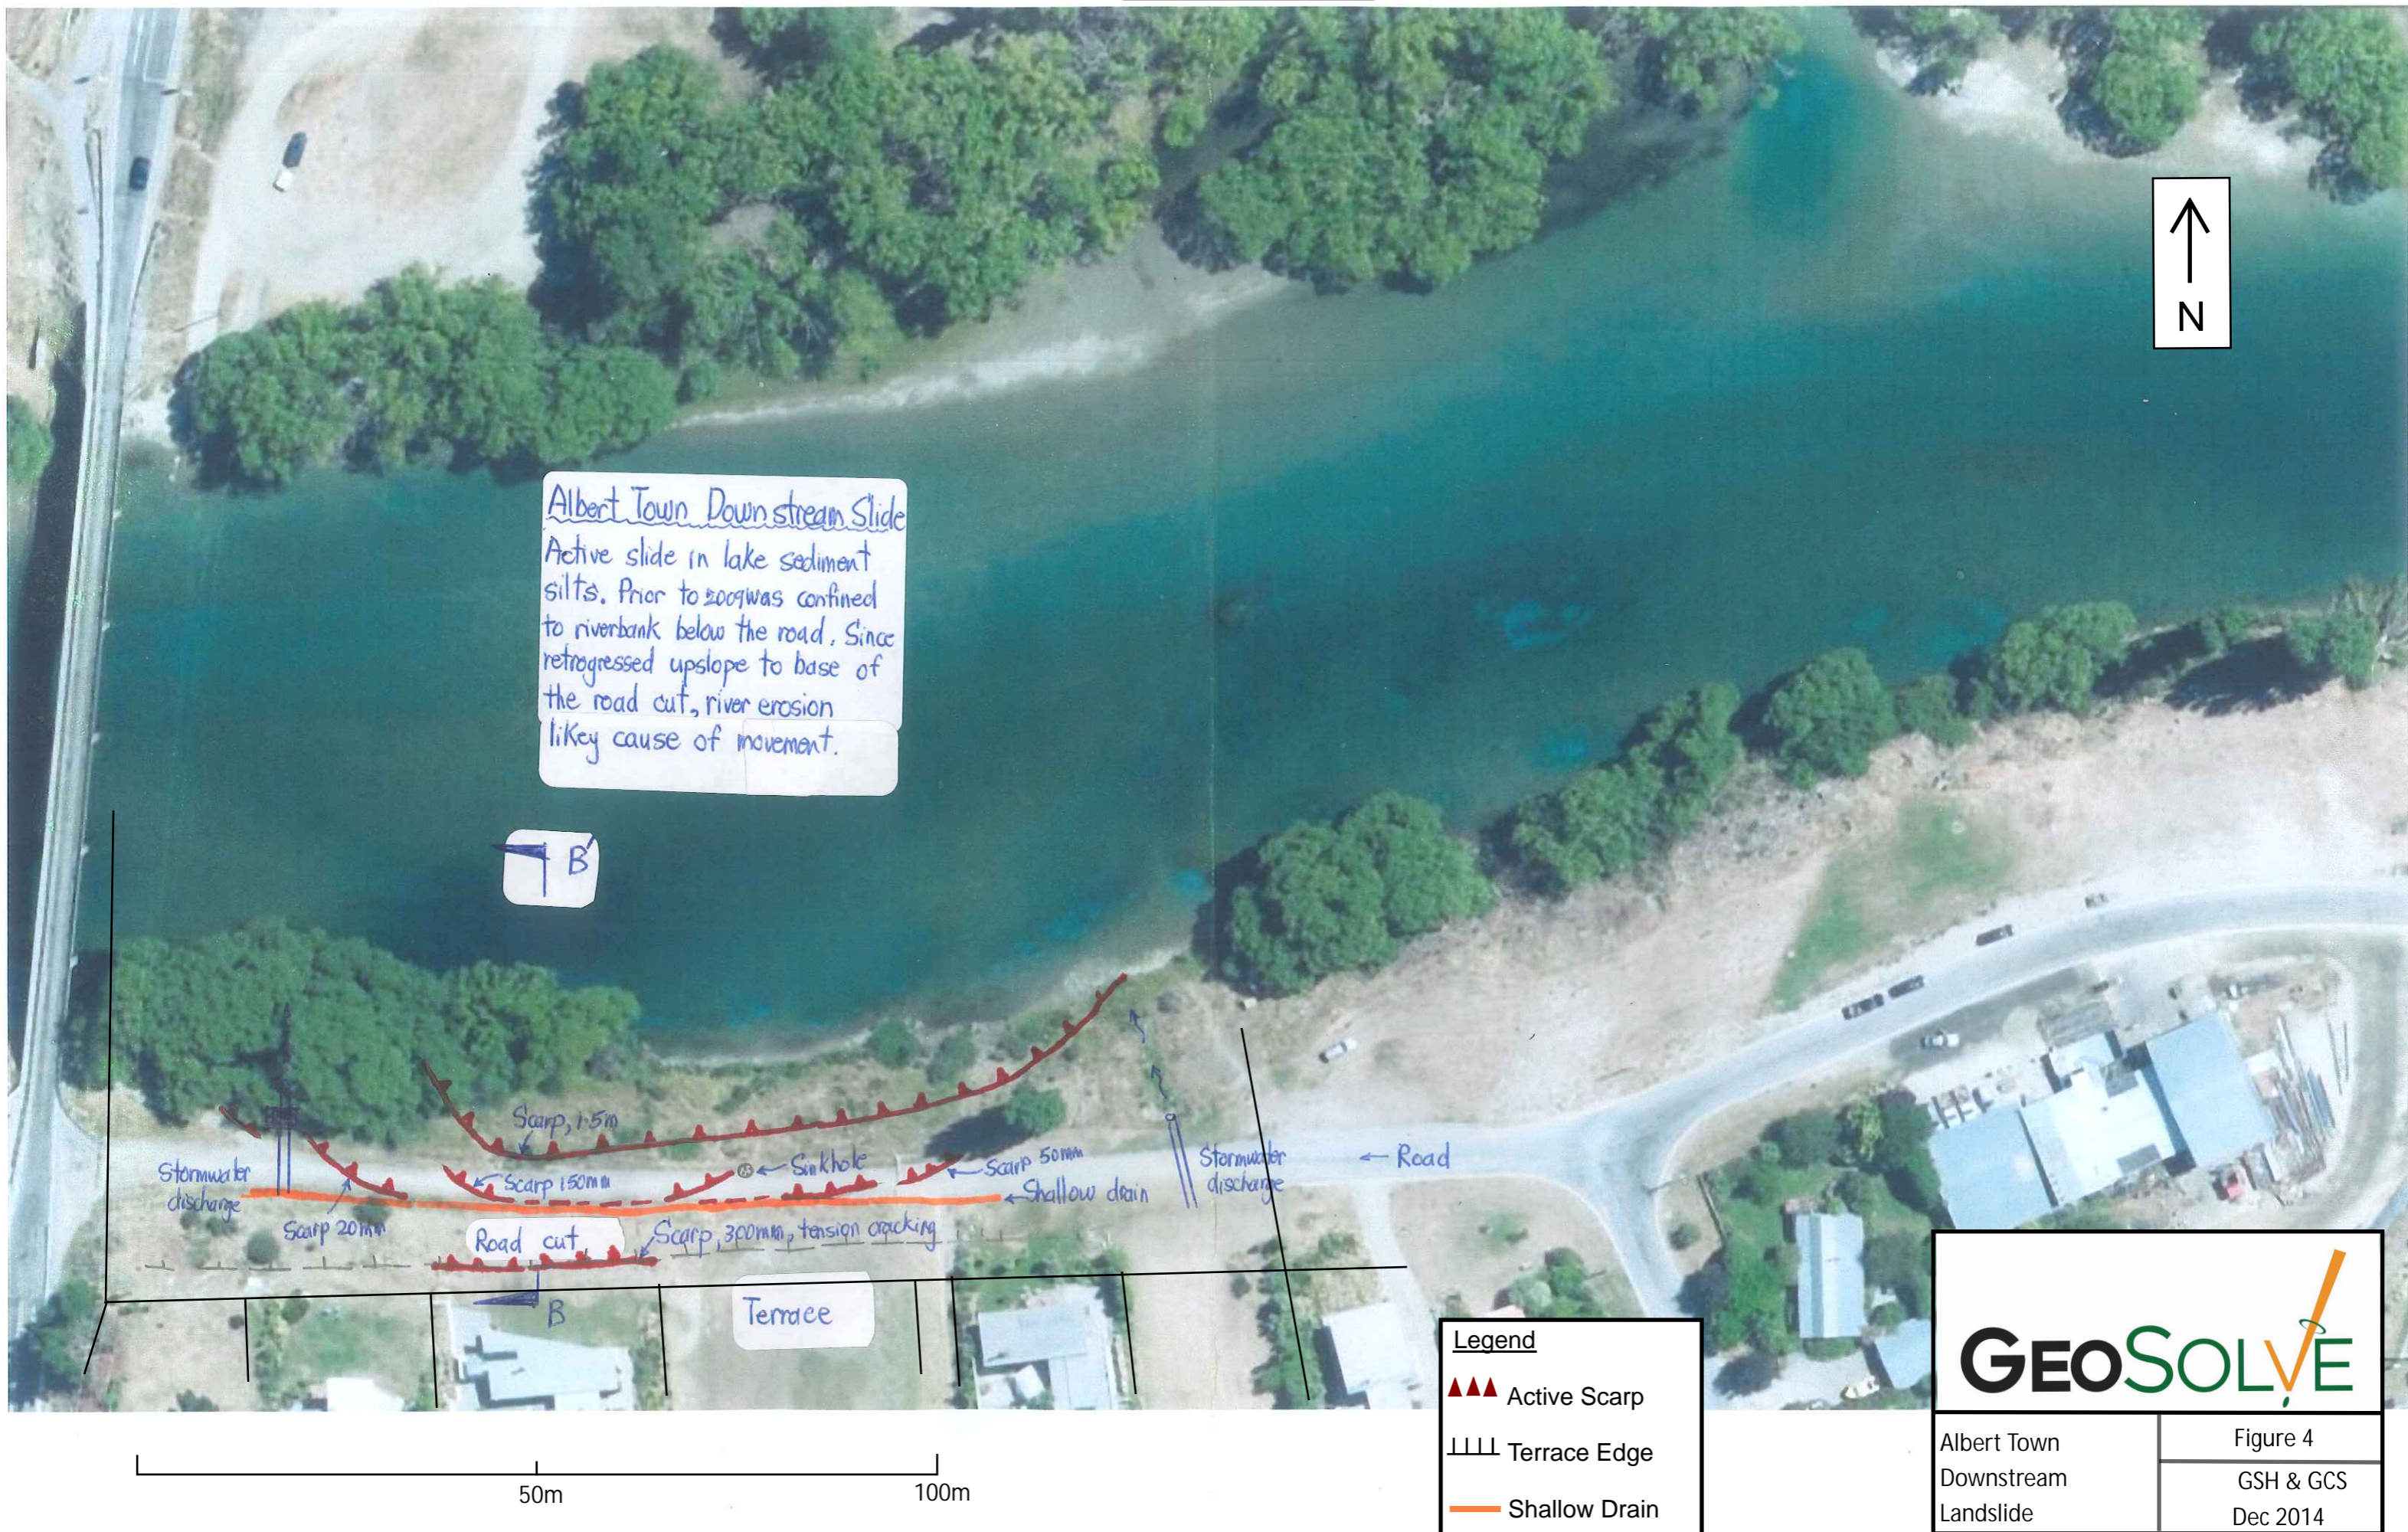
Albert Town Downstream Landslide

The feature (located as shown in Appendix A, Figure 4) is a long riverbank landslide that was studied in detail in an April 2009 University of Canterbury project by A. Klahn, guided by current GeoSolve staff. At that stage it was located entirely below the riverbank road, but in recent times it has retrogressed back to the road cut on the uphill side (Appendix B, Fig. 6). The displacements evident

on the road surface are minor, ranging from about 20-150 mm. A small sinkhole about 100 mm diameter is present on one of the scarps.

The upper scarp feature at the top of the road-cut near the axis of the slide (see Appendix A, Figure 4) is about 300 mm high, exhibits local tension cracking, and extends about 25 m across the width of the 9 Bridgewater Road property. It cannot be visually traced further upstream or downstream.

The owner of the property advises that the scarp first formed about 2-3 years ago, but has not noticed significant movement since. Local tension cracking indicates minor current movement.

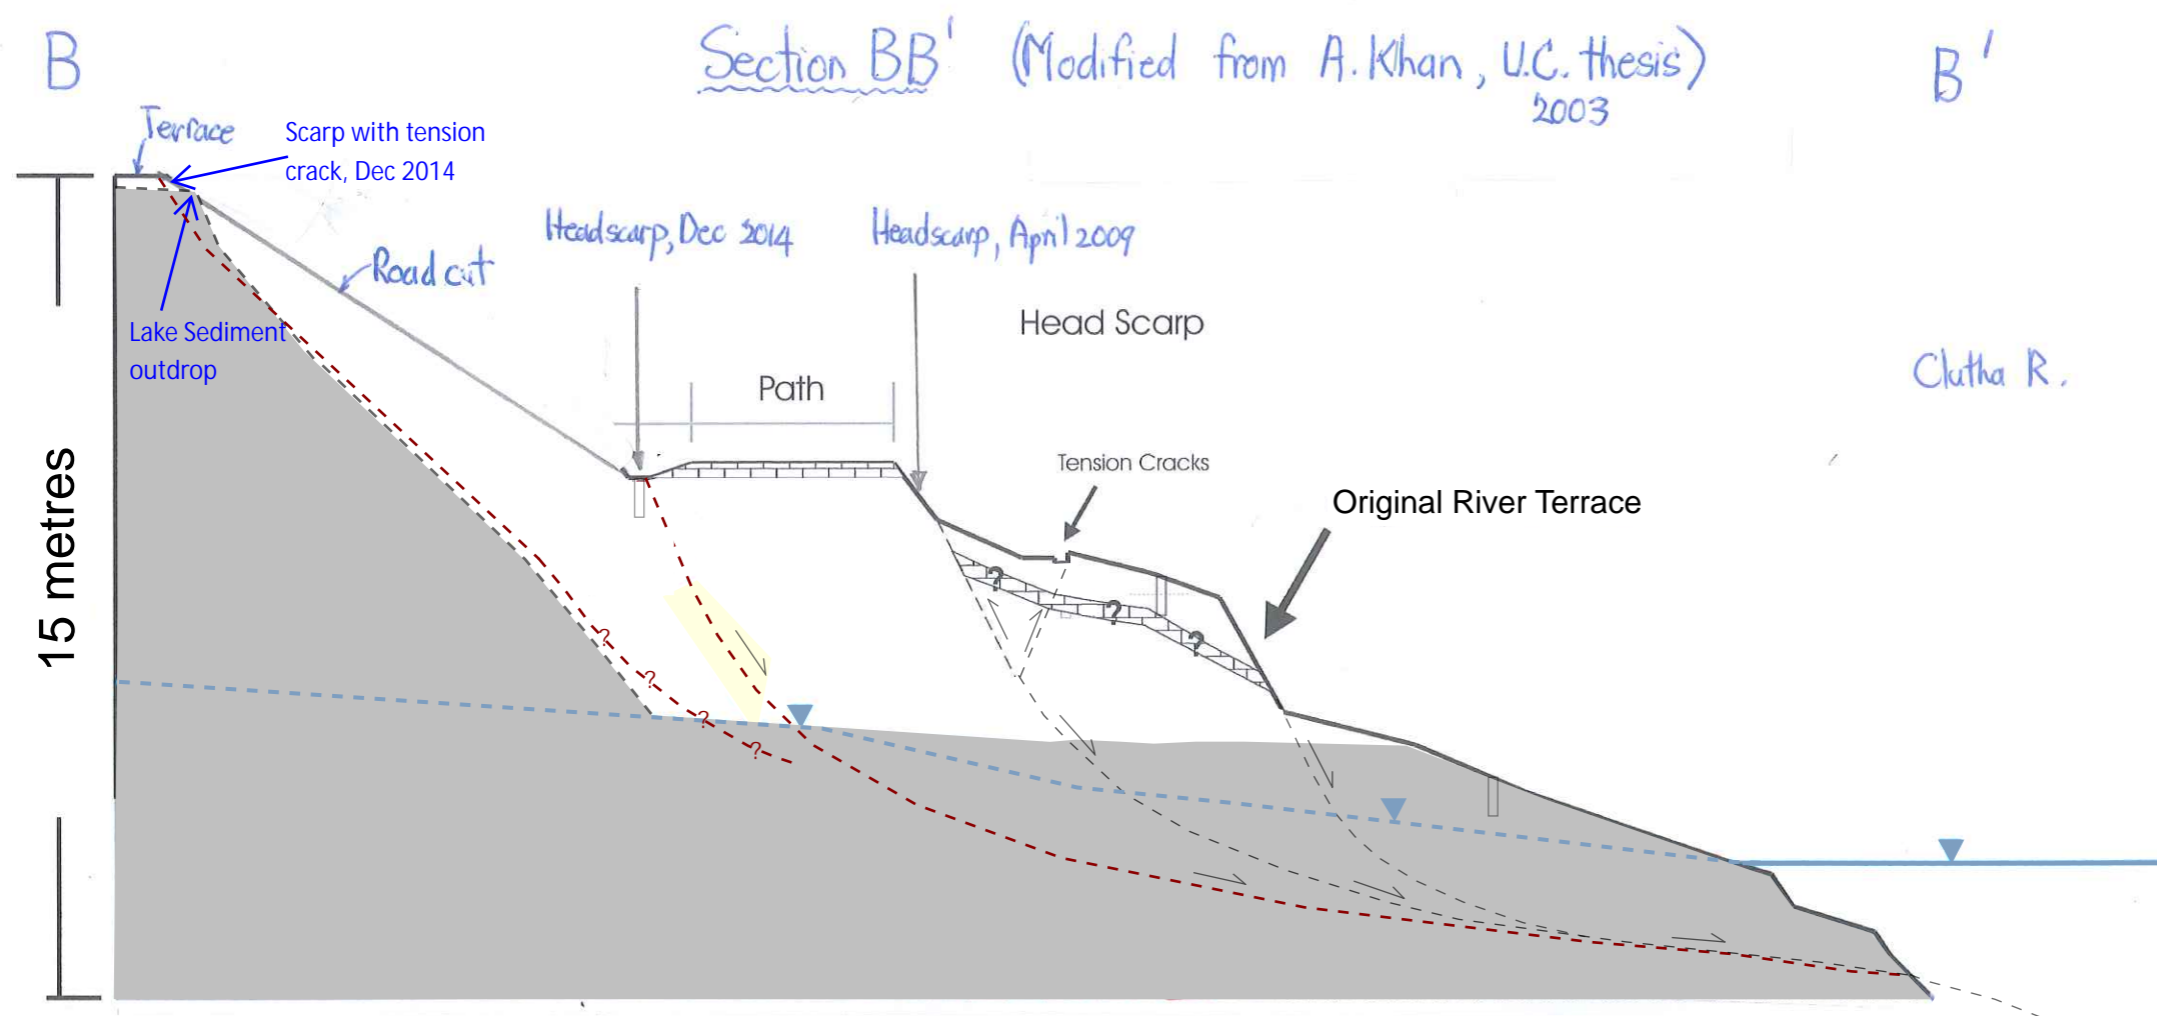
Albert Town
Downstream Landslide
Cross Section B - B'

This landslide is developed largely in laminated lake silts, with outwash gravels lying above (Appendix B Fig. 6). A translational mechanism similar to the upstream landslide is inferred. The water table is inferred to rise at a moderate gradient away from the river.

The upper scarp exposes silty gravels (inferred to be colluvium), with lake sediment silts visible at one location (see Appendix B, Figure 6). The face of the cut below the scarp is silty gravel colluvium.

It is unclear whether the scarp is due to deep seated retrogression of the slide (as shown on the left-most retrogressed failure surface in Appendix B, Figure 6), or to shallow slumping on the 30 degree cut slope caused by local withdrawal of support at the toe.

- If the failure surface is shallow, future movement on the 30 degree slope is unlikely to be rapid, and risk to track users and adjacent properties is considered low.
- If the failure surface is deep-seated, future movement rates could be significant because the slide is wide in relation to its length in the direction of movement (minimal lateral restraint or "3D effect"). There are some more favourable aspects, mainly the low average inclination of the landslide and the residual strength condition that is likely to now be developed on most of the potential failure surface (see Appendix B, Fig. 6).
