Davis Consulting Group: Preliminary Site Investigation (PSI) Report
and Addendum

Proposed Rezoning of Lakeview Queenstown Preliminary Site Investigation

Queenstown Lakes District Council

July 2014

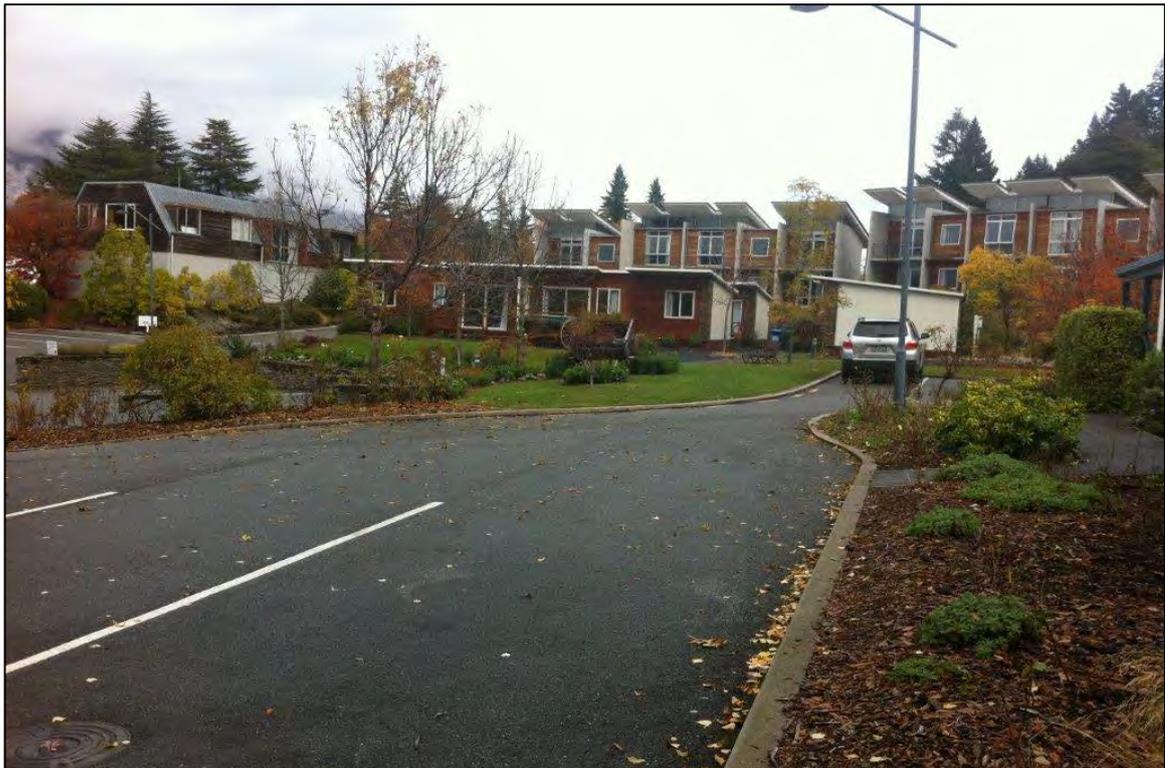
Plate 1: Holiday park facilities

The existing holiday park is shown in the 2013 aerial photograph (see Figure 5). Current facilities include a public waste water dump station, ablution block, motel units and holiday park reception (Plate 1). A plan of the holiday park is included in Appendix B. Waste water from the ablutions and waste water dump stations is reticulated to the main town waste water system, as

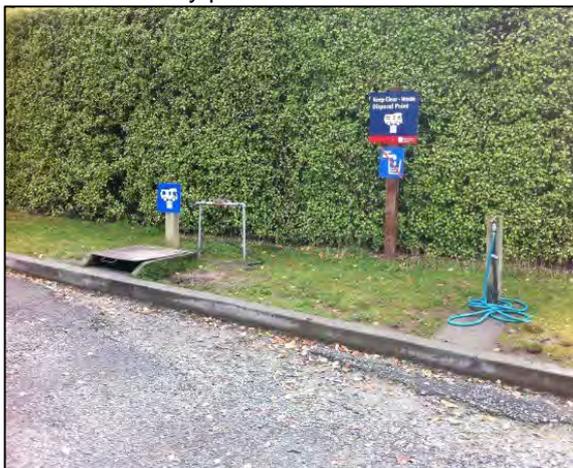
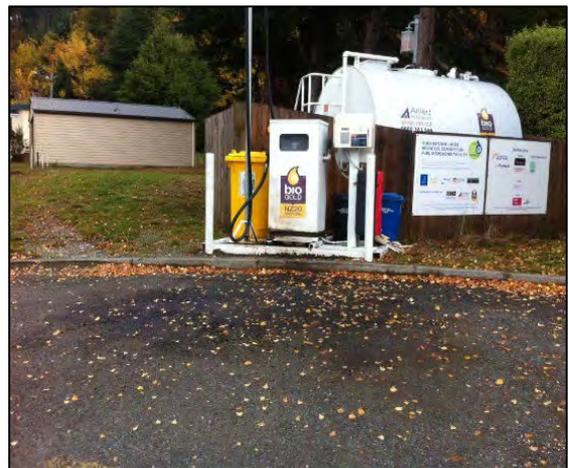
Plate 2: Public waste water dump station and diesel tank and fuel pump on cemetery road

A public waste water dump station and allied petroleum diesel tank and fuel pump bowser are located to the north of the project boundary on Cemetery Road (Plate 2). There is no evidence of onsite septic or effluent disposal fields on the site. Power is distributed by underground electrical utilities and a transformer is located to the west of the carpark area.

On the north east corner of the Lakeview Site, along Cemetery Road there is a diesel tank and fuel pump bowser. The HAIL lists the bulk storage of fuel as a hazardous activity with the potential to cause ground contamination. The diesel tank was in good structural condition however it does not appear to be bunded. The associated fuelling pump/bowser was also not bunded and spilt diesel has stained the ground over 4 square meters of roadway beside the fuelling area (Plate 2).

On the north east boundary of the Lakeview Site, along Cemetery Road, there is diesel tank and fuel pump bowser owned by Allied Petroleum. The tank was in good structural condition, but does not have a bund, and therefore could not have contained any spillage that may have occurred. The fuelling area was not banded to contain spillage during fuelling and consequently, diesel was observed in a layer over 4 square meters of roadway beside the fuelling area (Plate 2).

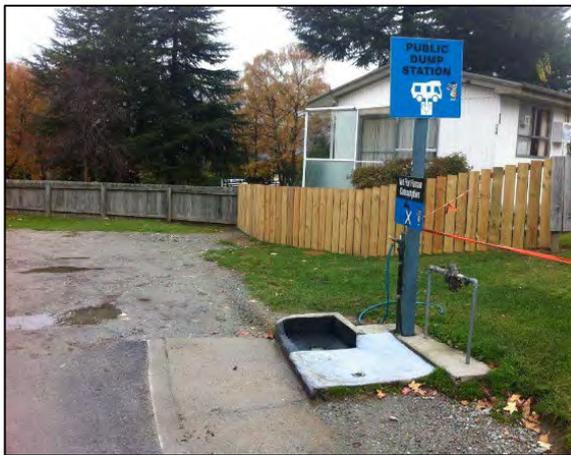
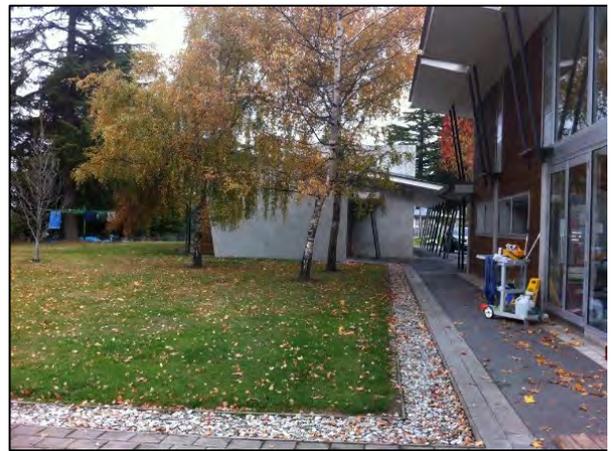
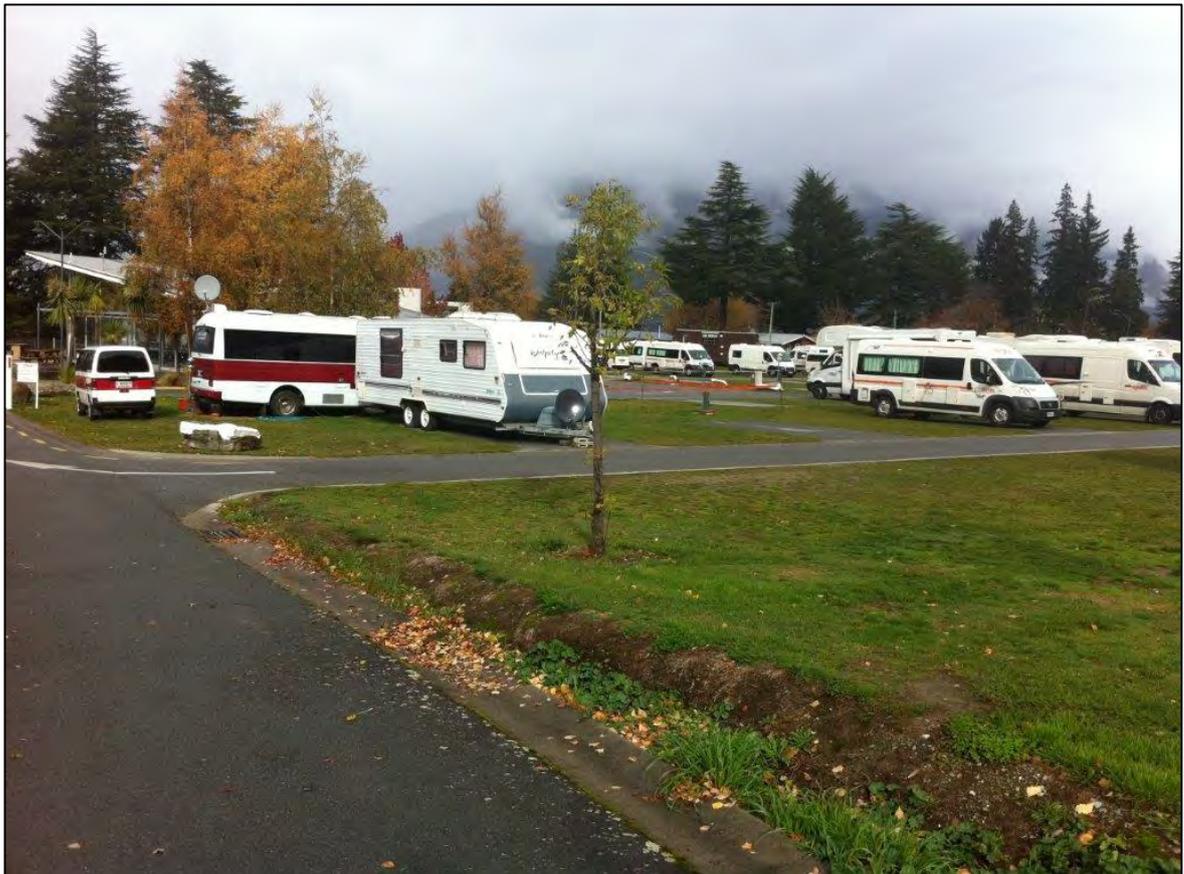
Plate 3: Operational Facilities on Reserve Block. Waste water dump station, abluion block and campervan parking

and cribs (Plate 3). Waste water from the ablutions and waste water dump stations is reticulated to the main town waste water system, as shown in the QLDC sewage plan included in Appendix B. Waste water from the demolished abluion blocks was reticulated to the main town waste water system, as shown in the QLDC sewers plan in Appendix B. There is no evidence of onsite septics or effluent disposal fields on the Reserve Block. Powerlines and associated electrical transformers are shown in electrical plans are included Appendix B.

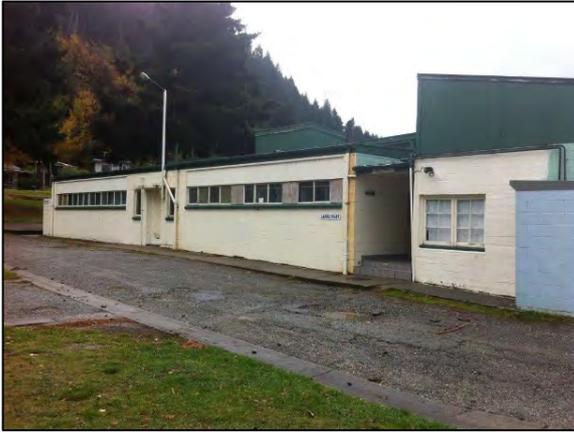
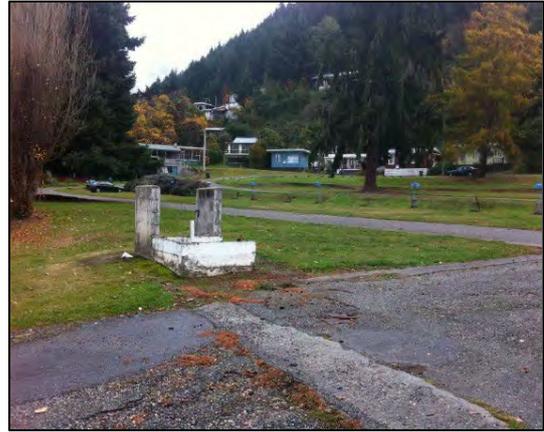
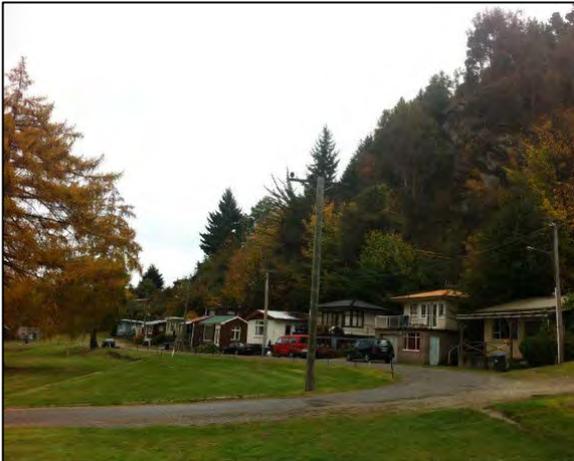
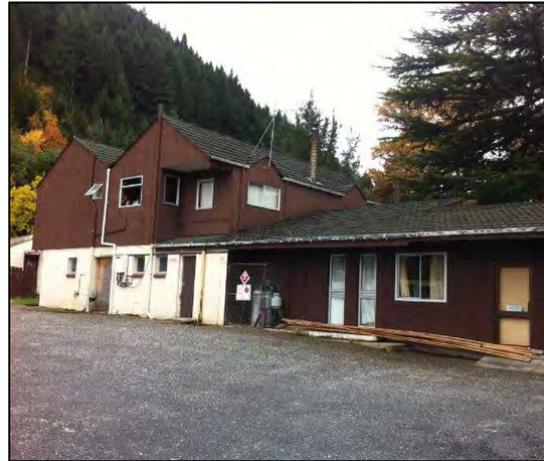
Plate 4: Closed holiday park facilities within Freehold Block. Ablutions block, waste water dump station, power lines, park administration and store (left to right).

Closed holiday park facilities remaining on site include two waste water dump stations, ablution block, motel units, power lines, original holiday park reception and caretaker residence (Plate 4). Many of these buildings were constructed prior to 1980 and consequently may contain asbestos in building materials and/or insulation. These buildings appeared to be in good structural condition.

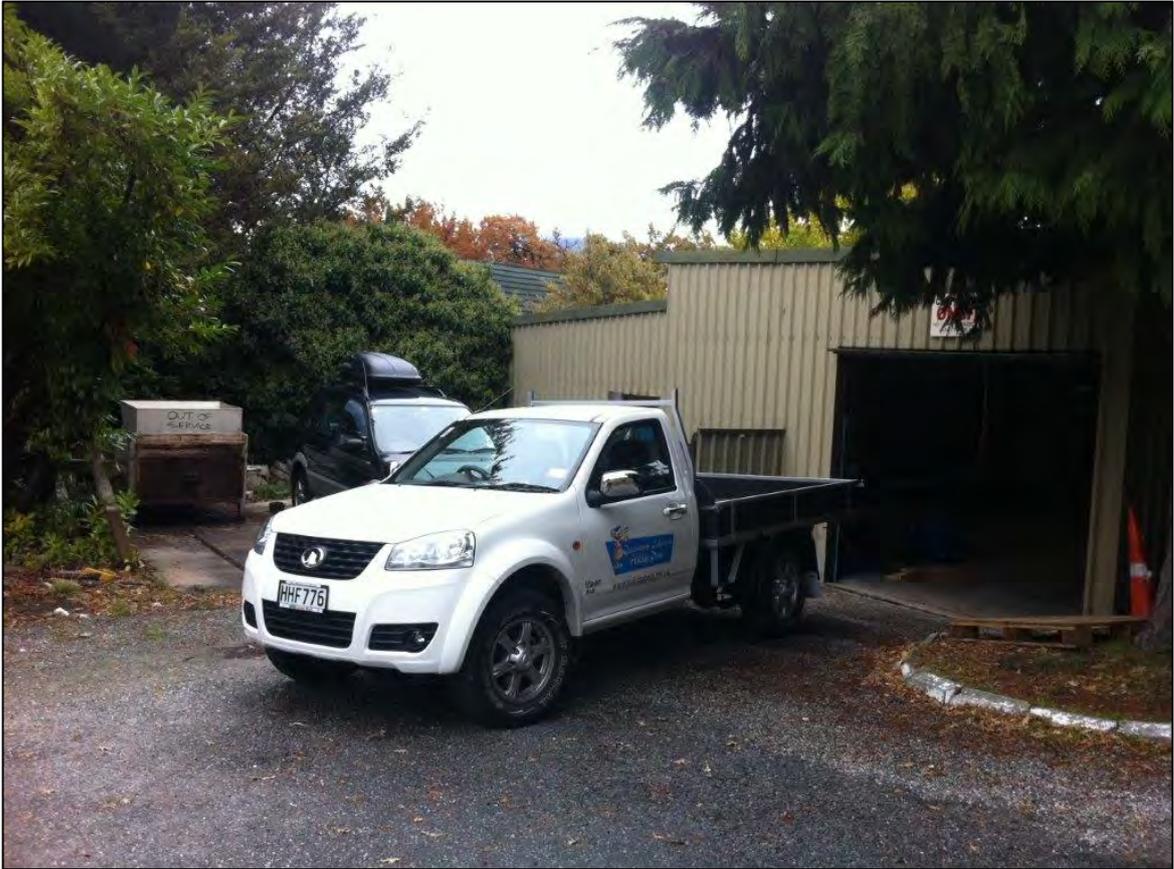
Plate 5: Freehold Block motor vehicle workshop (active)

The original holiday park workshop is still in use (Plate 5), located adjacent to the original park reception on the eastern boarder of Freehold Block. The workshop building has a partially sealed cement floor that drains south to an area of earth that appears to be free draining. Minor volumes of chemicals are stored in the workshop including a 210L drum of fuel and small 20L drums of oil and cleaning products.

A motor vehicle workshop adjoins the previous park reception and residence. Based on the HAIL, the hazardous substances that may be associated with the motor vehicle workshop include polycyclic aromatic hydrocarbons (PAHs), solvents, and metals contained in waste oil.

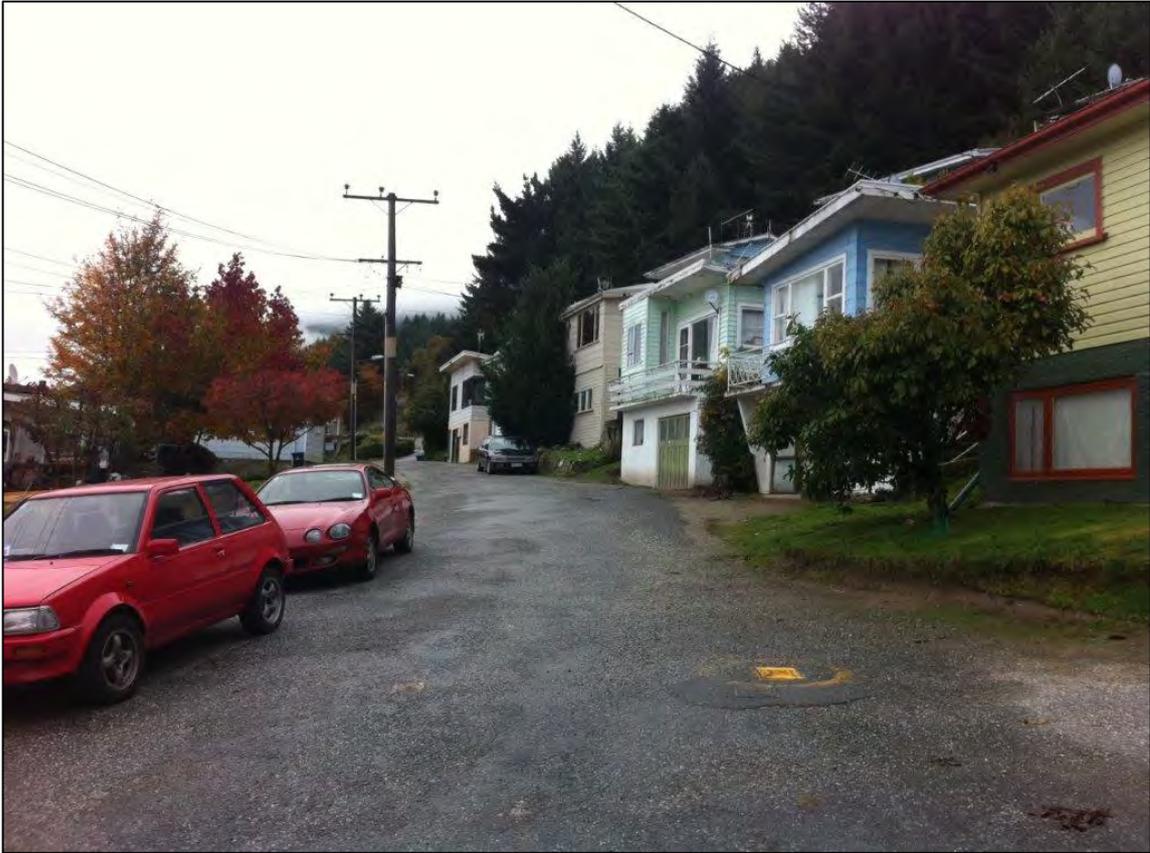
Plate 6: Cribs within Lynch Block

All of these buildings were constructed prior to 1980 and consequently may contain asbestos in building materials and/or insulation. These buildings appeared to be in good structural condition (Plate 6). Waste water from the cribs is reticulated to the main town waste water system, as shown in the QLDC sewers plan in Appendix B. It is believed that sewage waste water has been reticulated from ablutions for as long as it has been possible to be connected to the mains sewage lines (Andrea Jarvis, pers. Comm. 2014). Powerlines are shown in electrical plans included Appendix B.
