19 January 2015

**MILLBROOK MACAULEY LAND: APPRAISAL OF KNOWN AND INFERRED HAZARDS
AND POTENTIALLY ADVERSE GEOTECHNICAL FEATURES AT SITE**

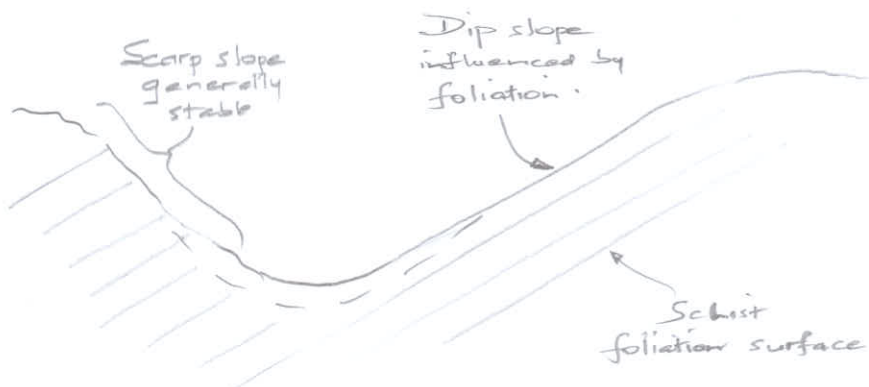
- Greyschist dominates on site.
- Planar, thin foliations dip to the WSW at about 30°.
- Strike ridges are locally prominent landforms in the plateau area.
- Foliation influences terrain morphologies in the vicinity of incised gullies.

- No significant discontinuities, such as faults, were observed in outcrop.
 - Jointing is not well developed. Steeper slopes not prone to rockfall, as a consequence.

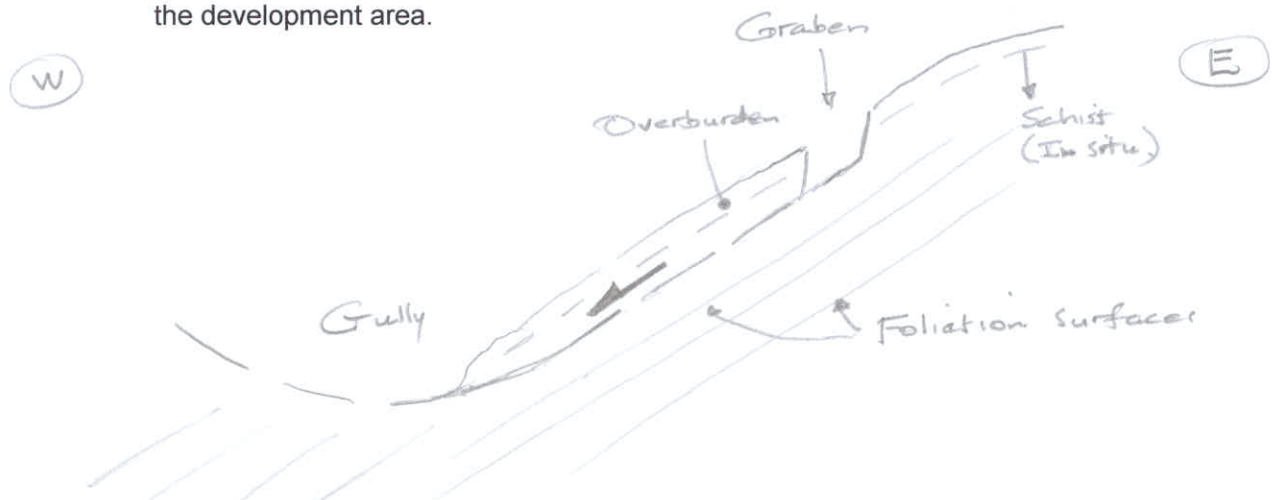
- There is a small, recent landslide on the east flank of a deep gully in the western region of the development area.

- The foliation failure is not going to impact on any proposed construction area but is a good example of a dip slope failure in schist in a specific terrain. (Note also the potential for a like failure in any major dwelling excavations).
- On the gully wall opposing the above there is evidence for an old failure in a schist scarp slope. I have annotated the approximate vacated outline, and it is unlikely to regress, but it proves that scarp slopes are not necessarily absolutely stable, in the long term.
- Approximately 100m south-west of the above slide feature there is an assessed area of soil creep; probably a till capping on schist, creeping under wet conditions. Of no significance in a development context.

Ensure an adequate setback from the slope crest is implemented for pertinent platforms or design a stable foundation.

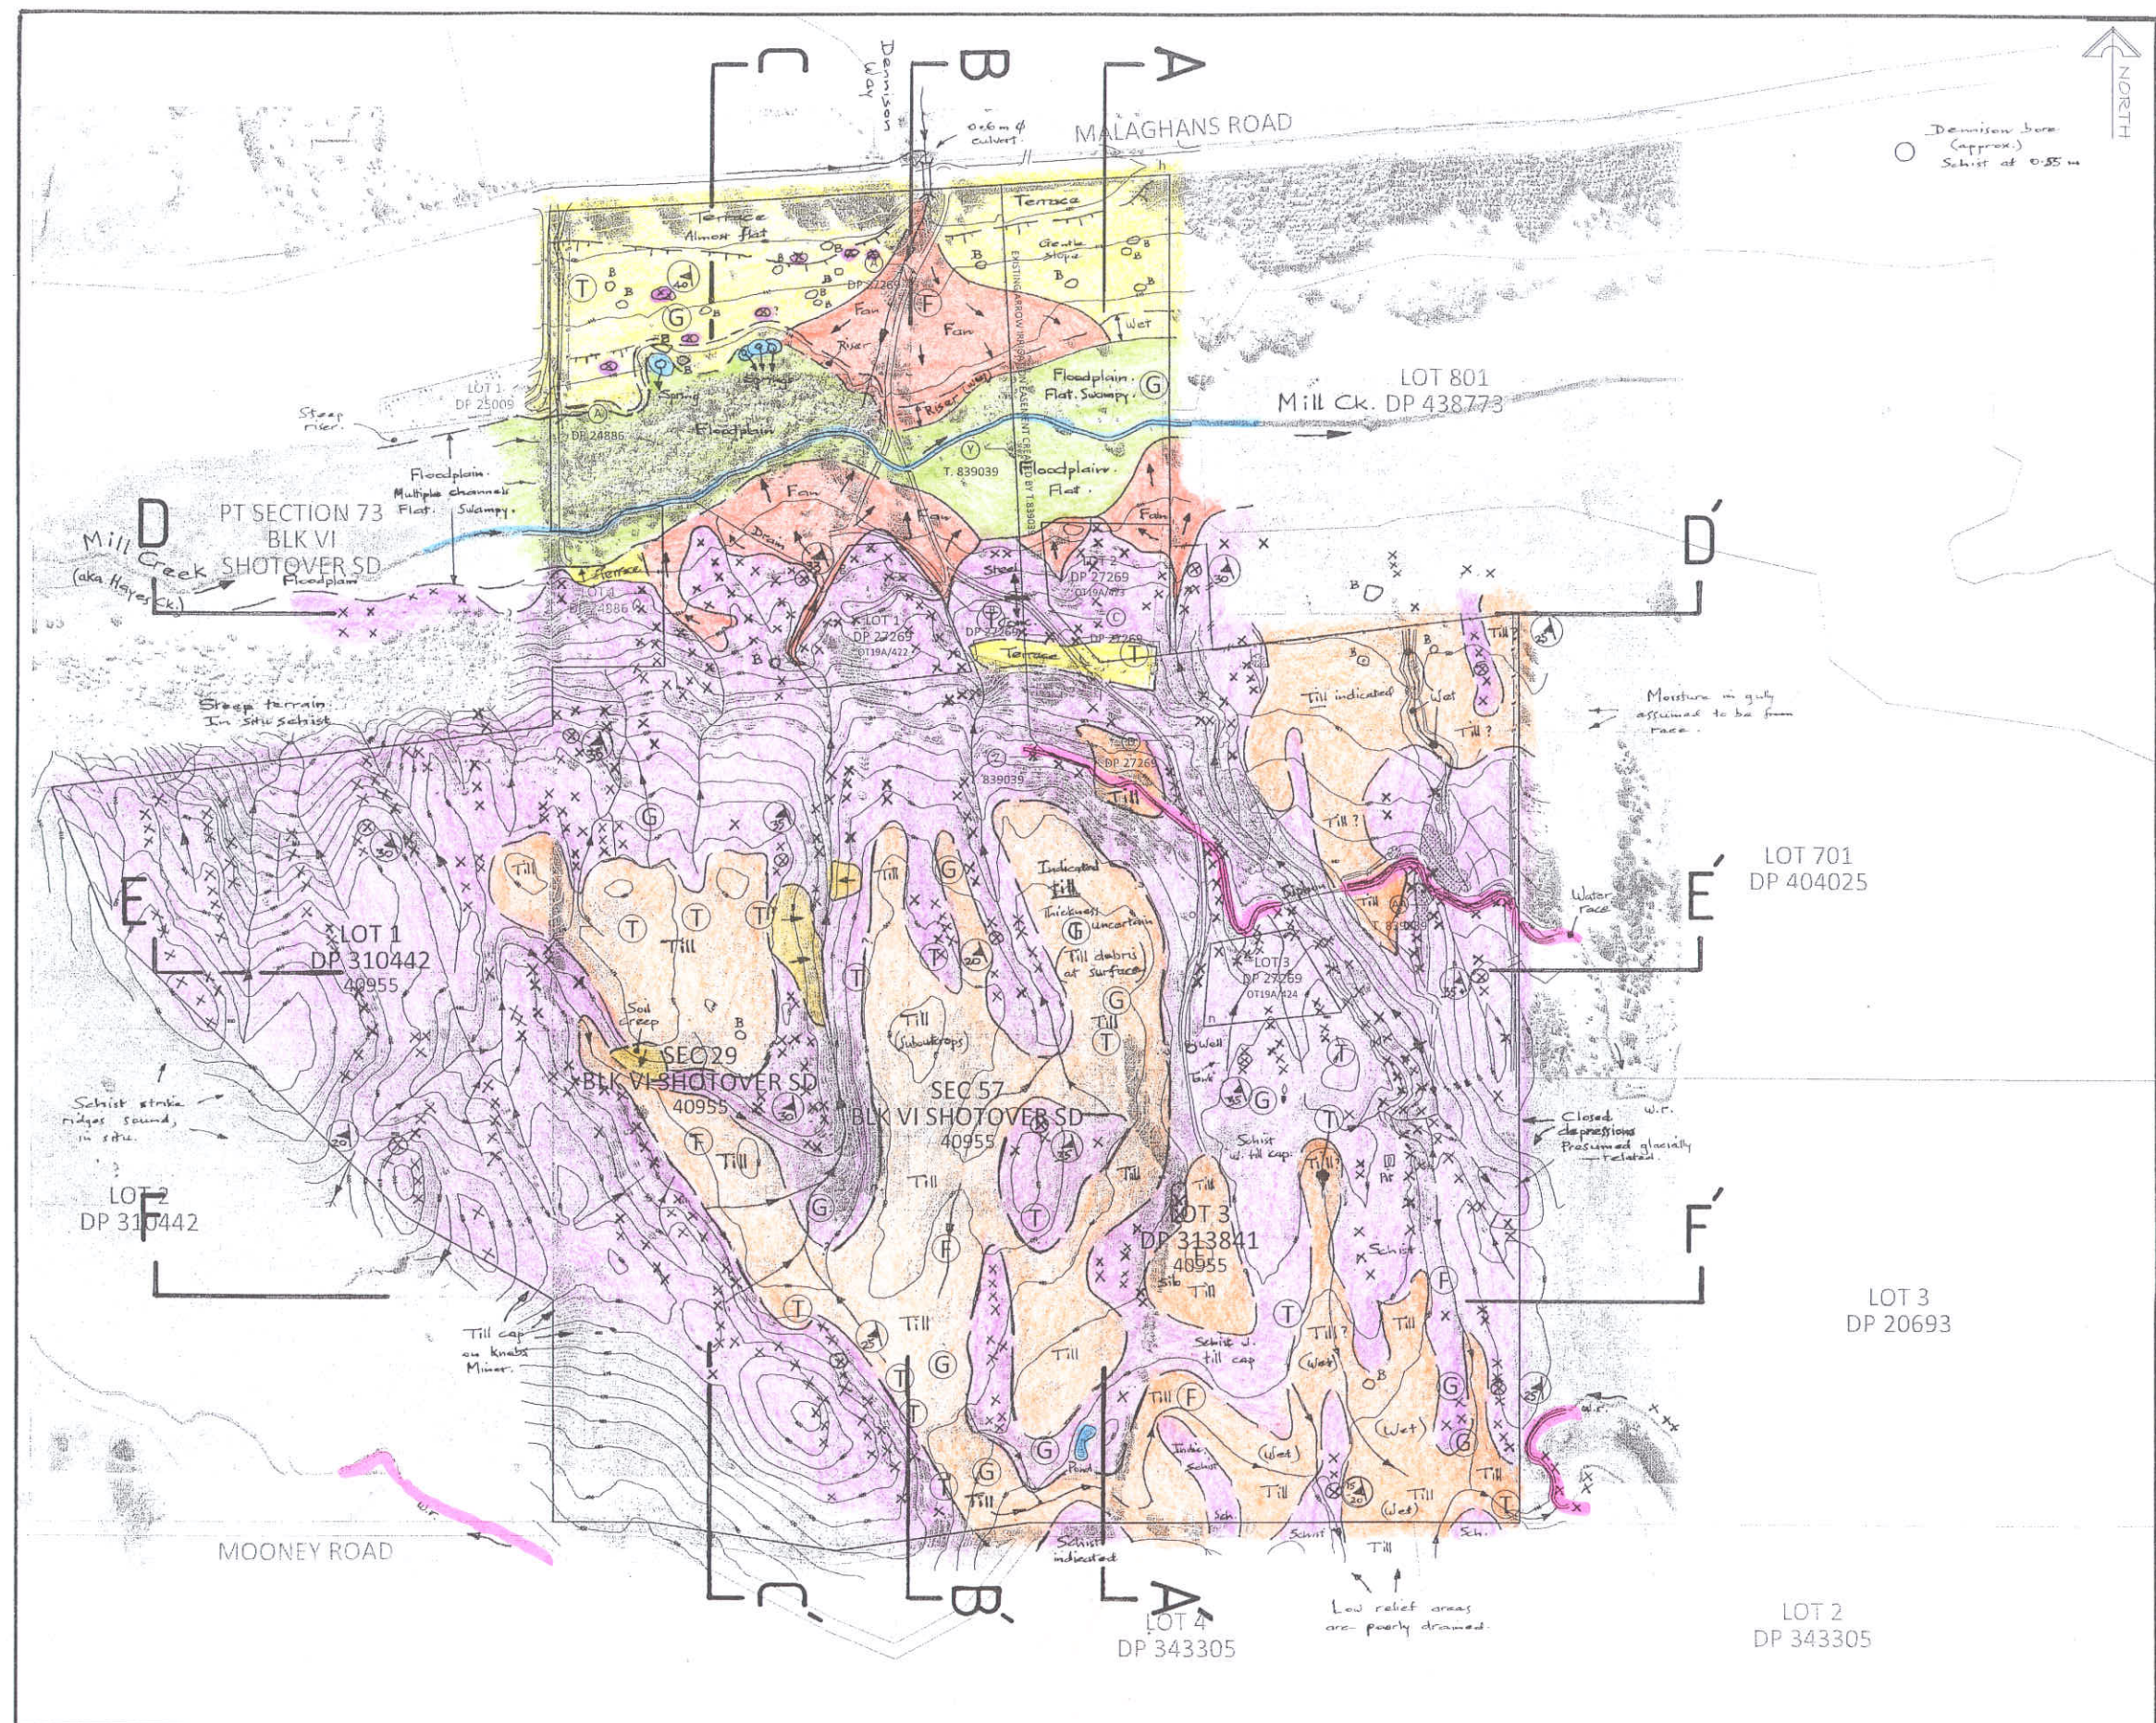
Fig. 2a

- (i) Schist is the basement lithology in the region. At the site it is prominent in outcrop to the south of Mill Creek and there are several small outcrops close to Malaghans Road (Fig. 2a) which suggest schist is close to the surface in the northern sector.

- (iv) Stream fans, of various dimensions, flank the Mill Creek floodplain (Fig. 2a). While not obviously active, each is potentially subject to stream incursions during future rainstorm events.

- (v) Landslide deposits are minor, and limited to the walls of one gully in the central - west region of the plateau area (Fig. 2a). In general, the slopes, at all inclinations, are not affected by mass movement.

Of interest is seepage along the axis of a gully close to the eastern property boundary (Fig. 2a). The seepage can only originate as race leakage from a non-specific but reasonably defined point at the gully head adjoining the race.

Two significant springs are present along the true left side of the floodplain, upstream from the access road (Fig. 2a). It is assumed both are sourced in subcatchments north of Malaghans Road and west of Dennison Way and both notionally drain to the south via gutters in the schist, now overlain by alluvium (or till). Flow volumes are unknown; it is assumed they will be seasonably variable.

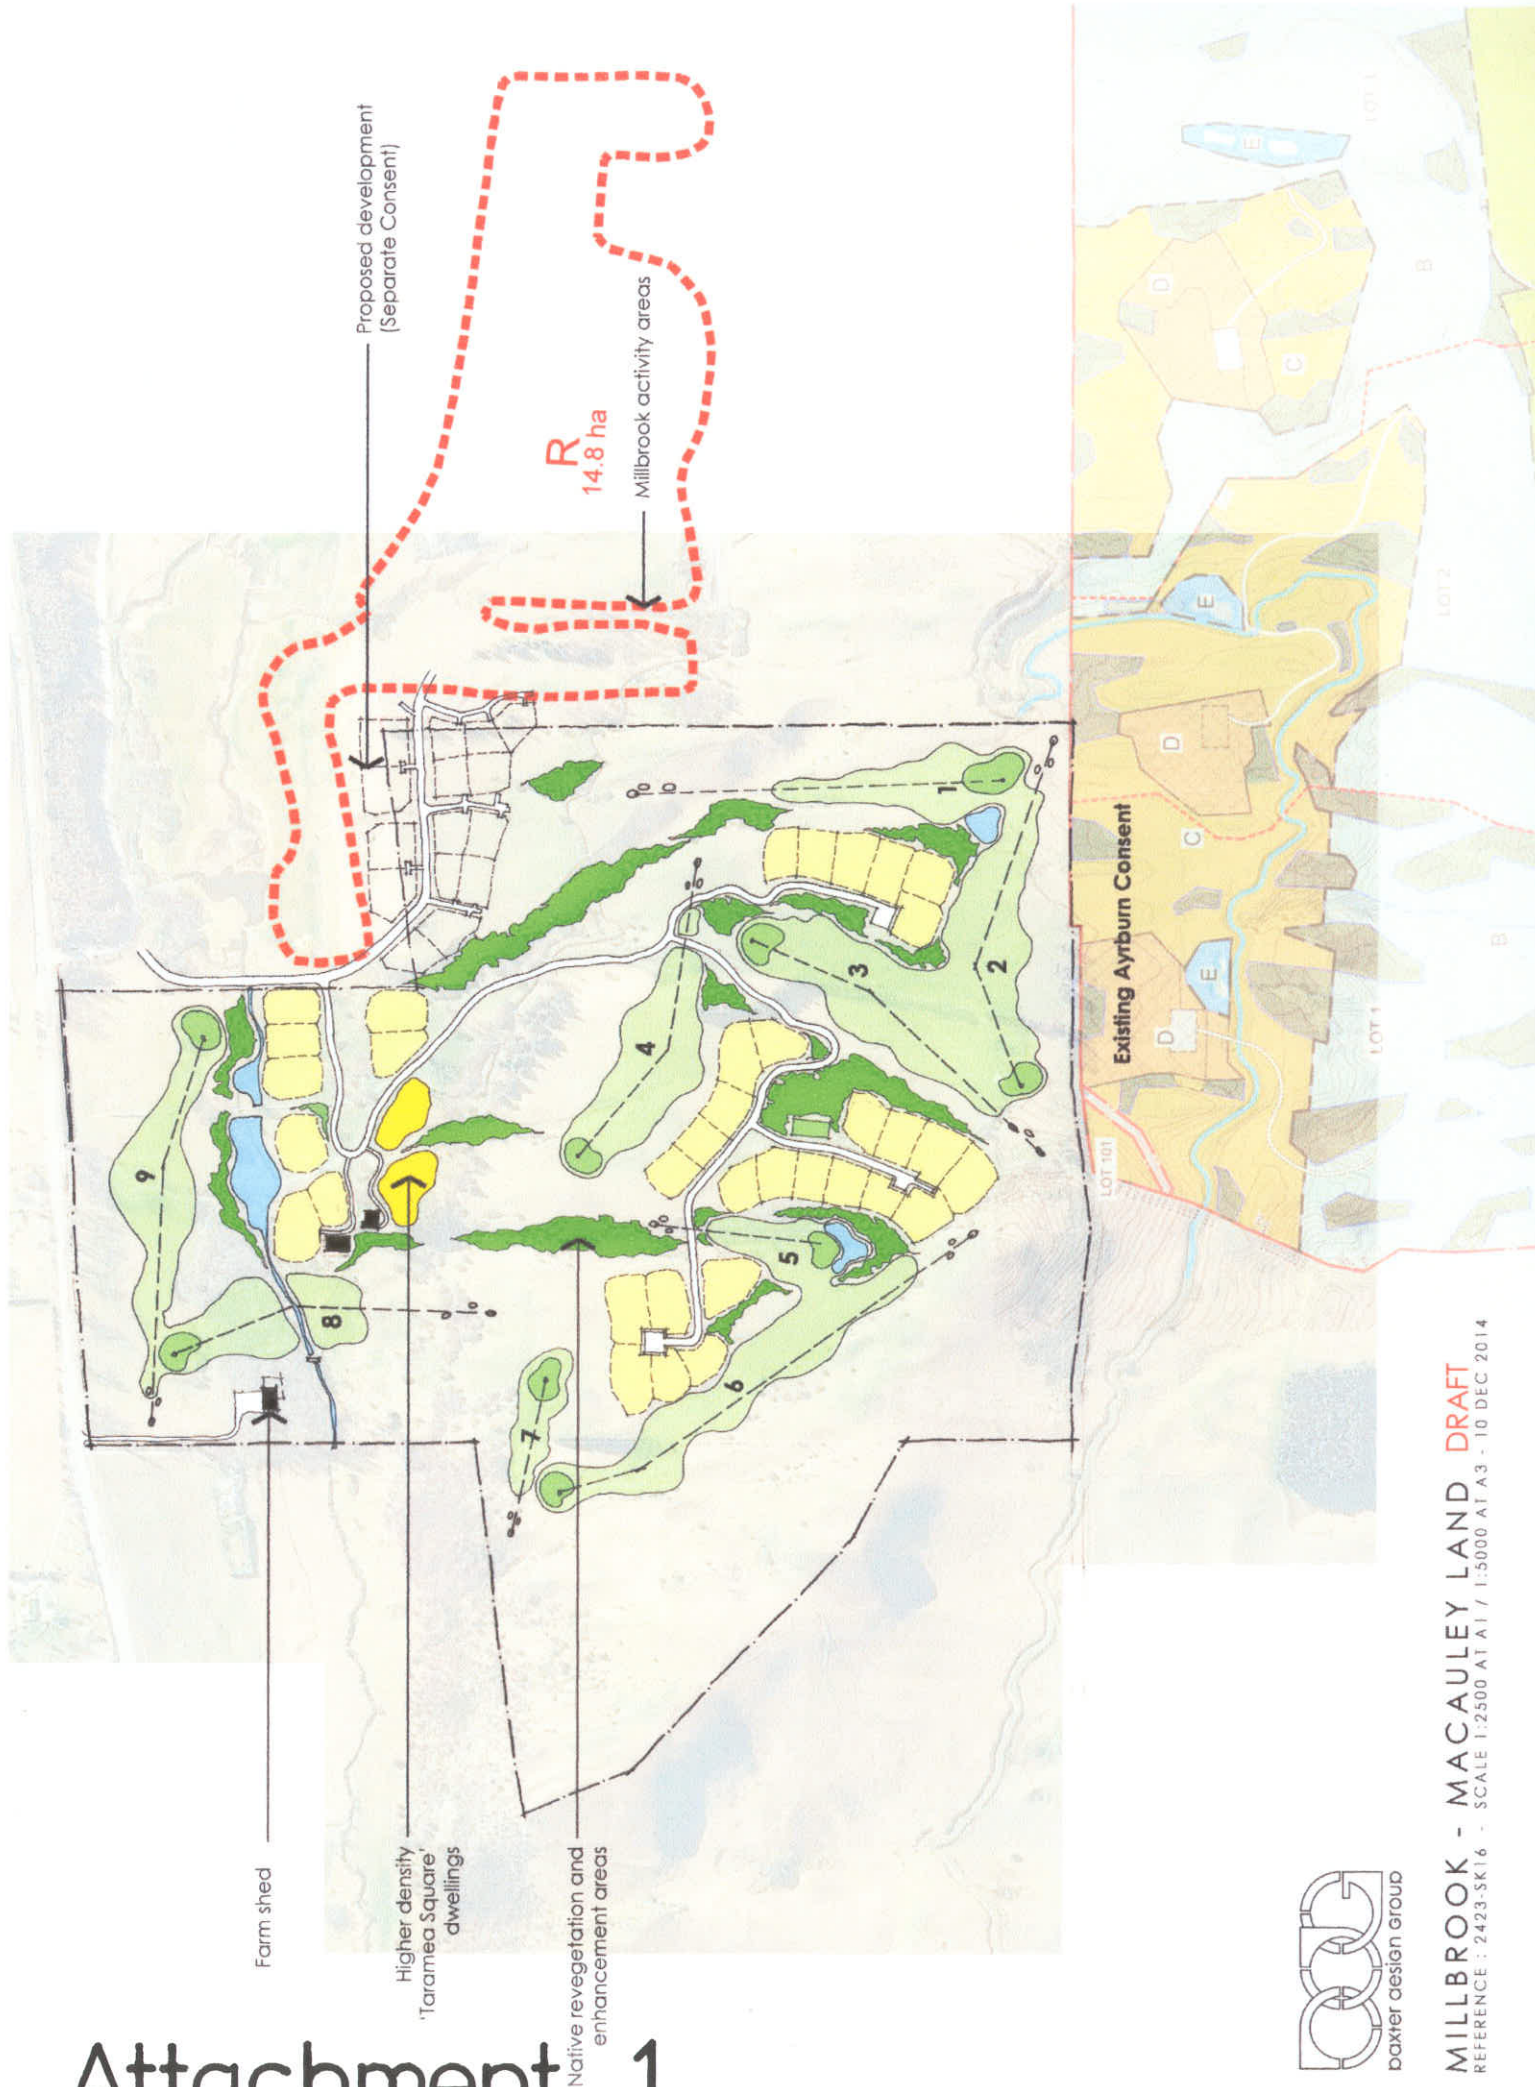
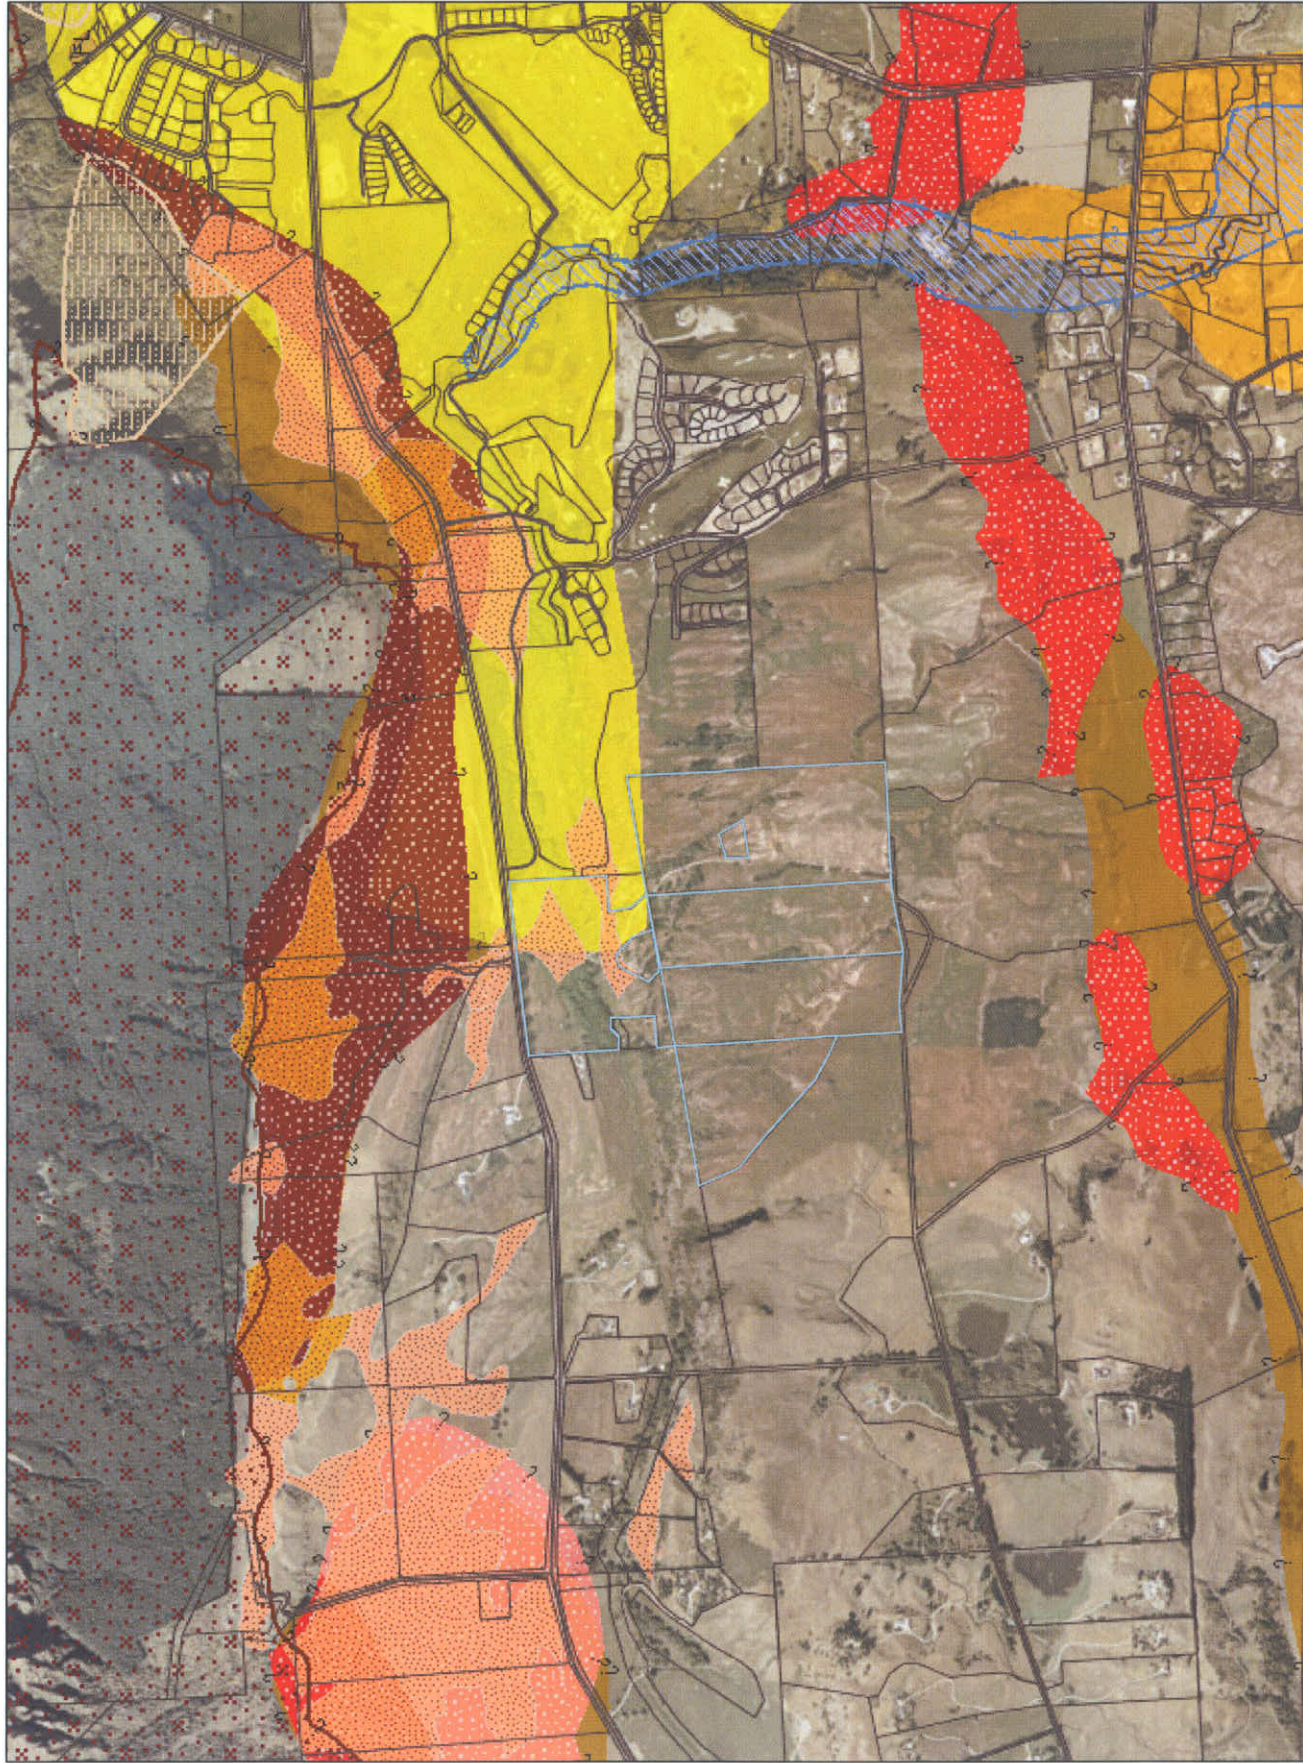
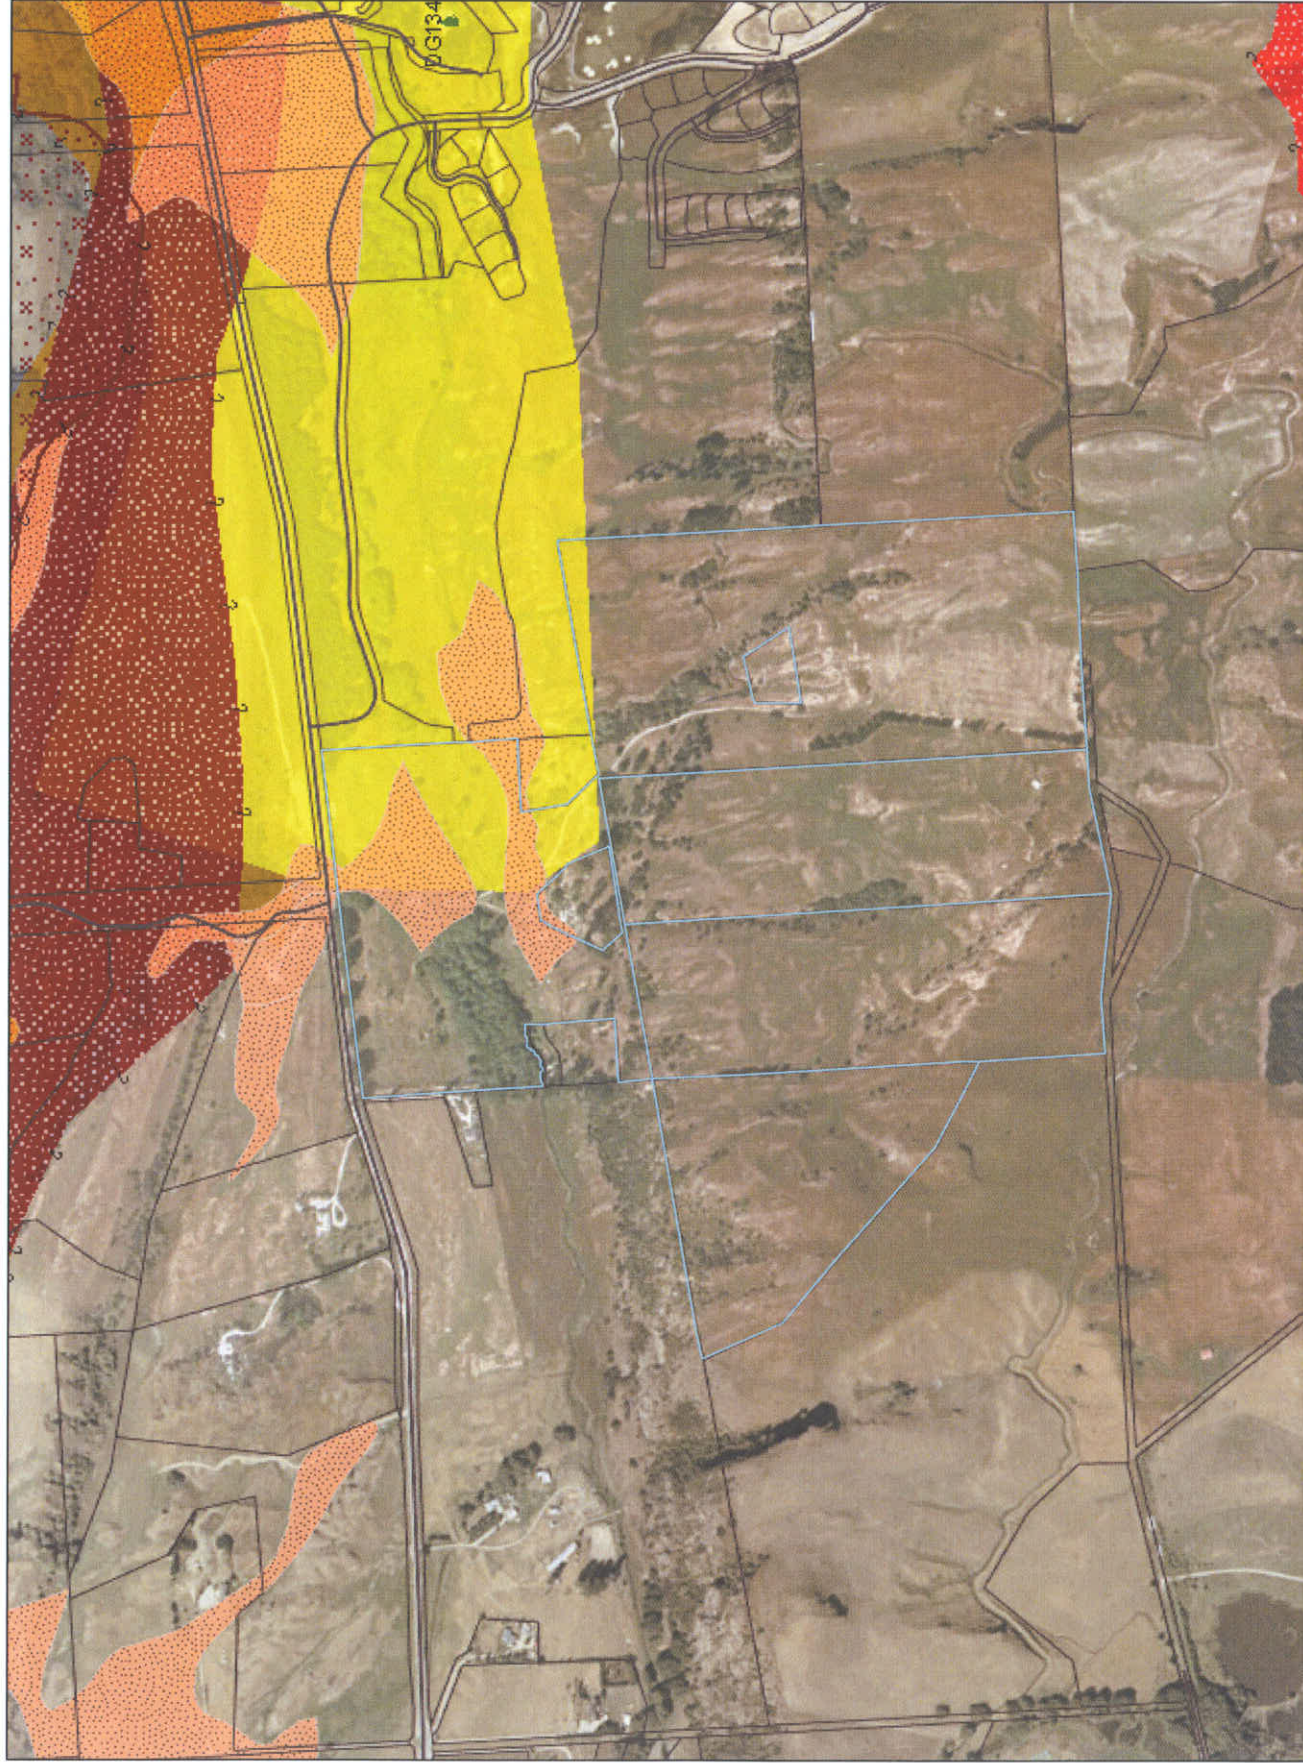
Attachment 2b

(i) Liquefaction, categorised as LIC 1 (P), which implies a low risk. Comment:

- For some reason, unknown to QLDC staff, the hazard ceases in an upvalley direction at the position of the present site access road, whereas similar valley floor conditions extend well to the west.

In a pragmatic sense, it would be prudent to accept all of the north embayment at the site is categorised as LIC 1 (P) in the QLDC classification.

- The designated liquefaction risk zone clearly incorporates areas which are known, or inferred to be, in situ schist. A refinement of the zone is clearly warranted.
- It is acknowledged that the valley floor floodplain comprises at least some weak sediments with unknown liquefaction susceptibility. Depending on final development proposals, some subsurface investigations in the fill deposits may be required on the right bank.

(ii) Alluvial fan, an ORC assessment, subclassified as "fan less recently active".

As previously mentioned, all the lower fan elements must be subject to some flows during storm events, which will need addressing in sympathy with the development proposals.
