Geotechnical Hazards – Preliminary Assessment Proposed Mt Cardrona Station Private Plan Change

October 2016

GeoSolve Ref: 160677

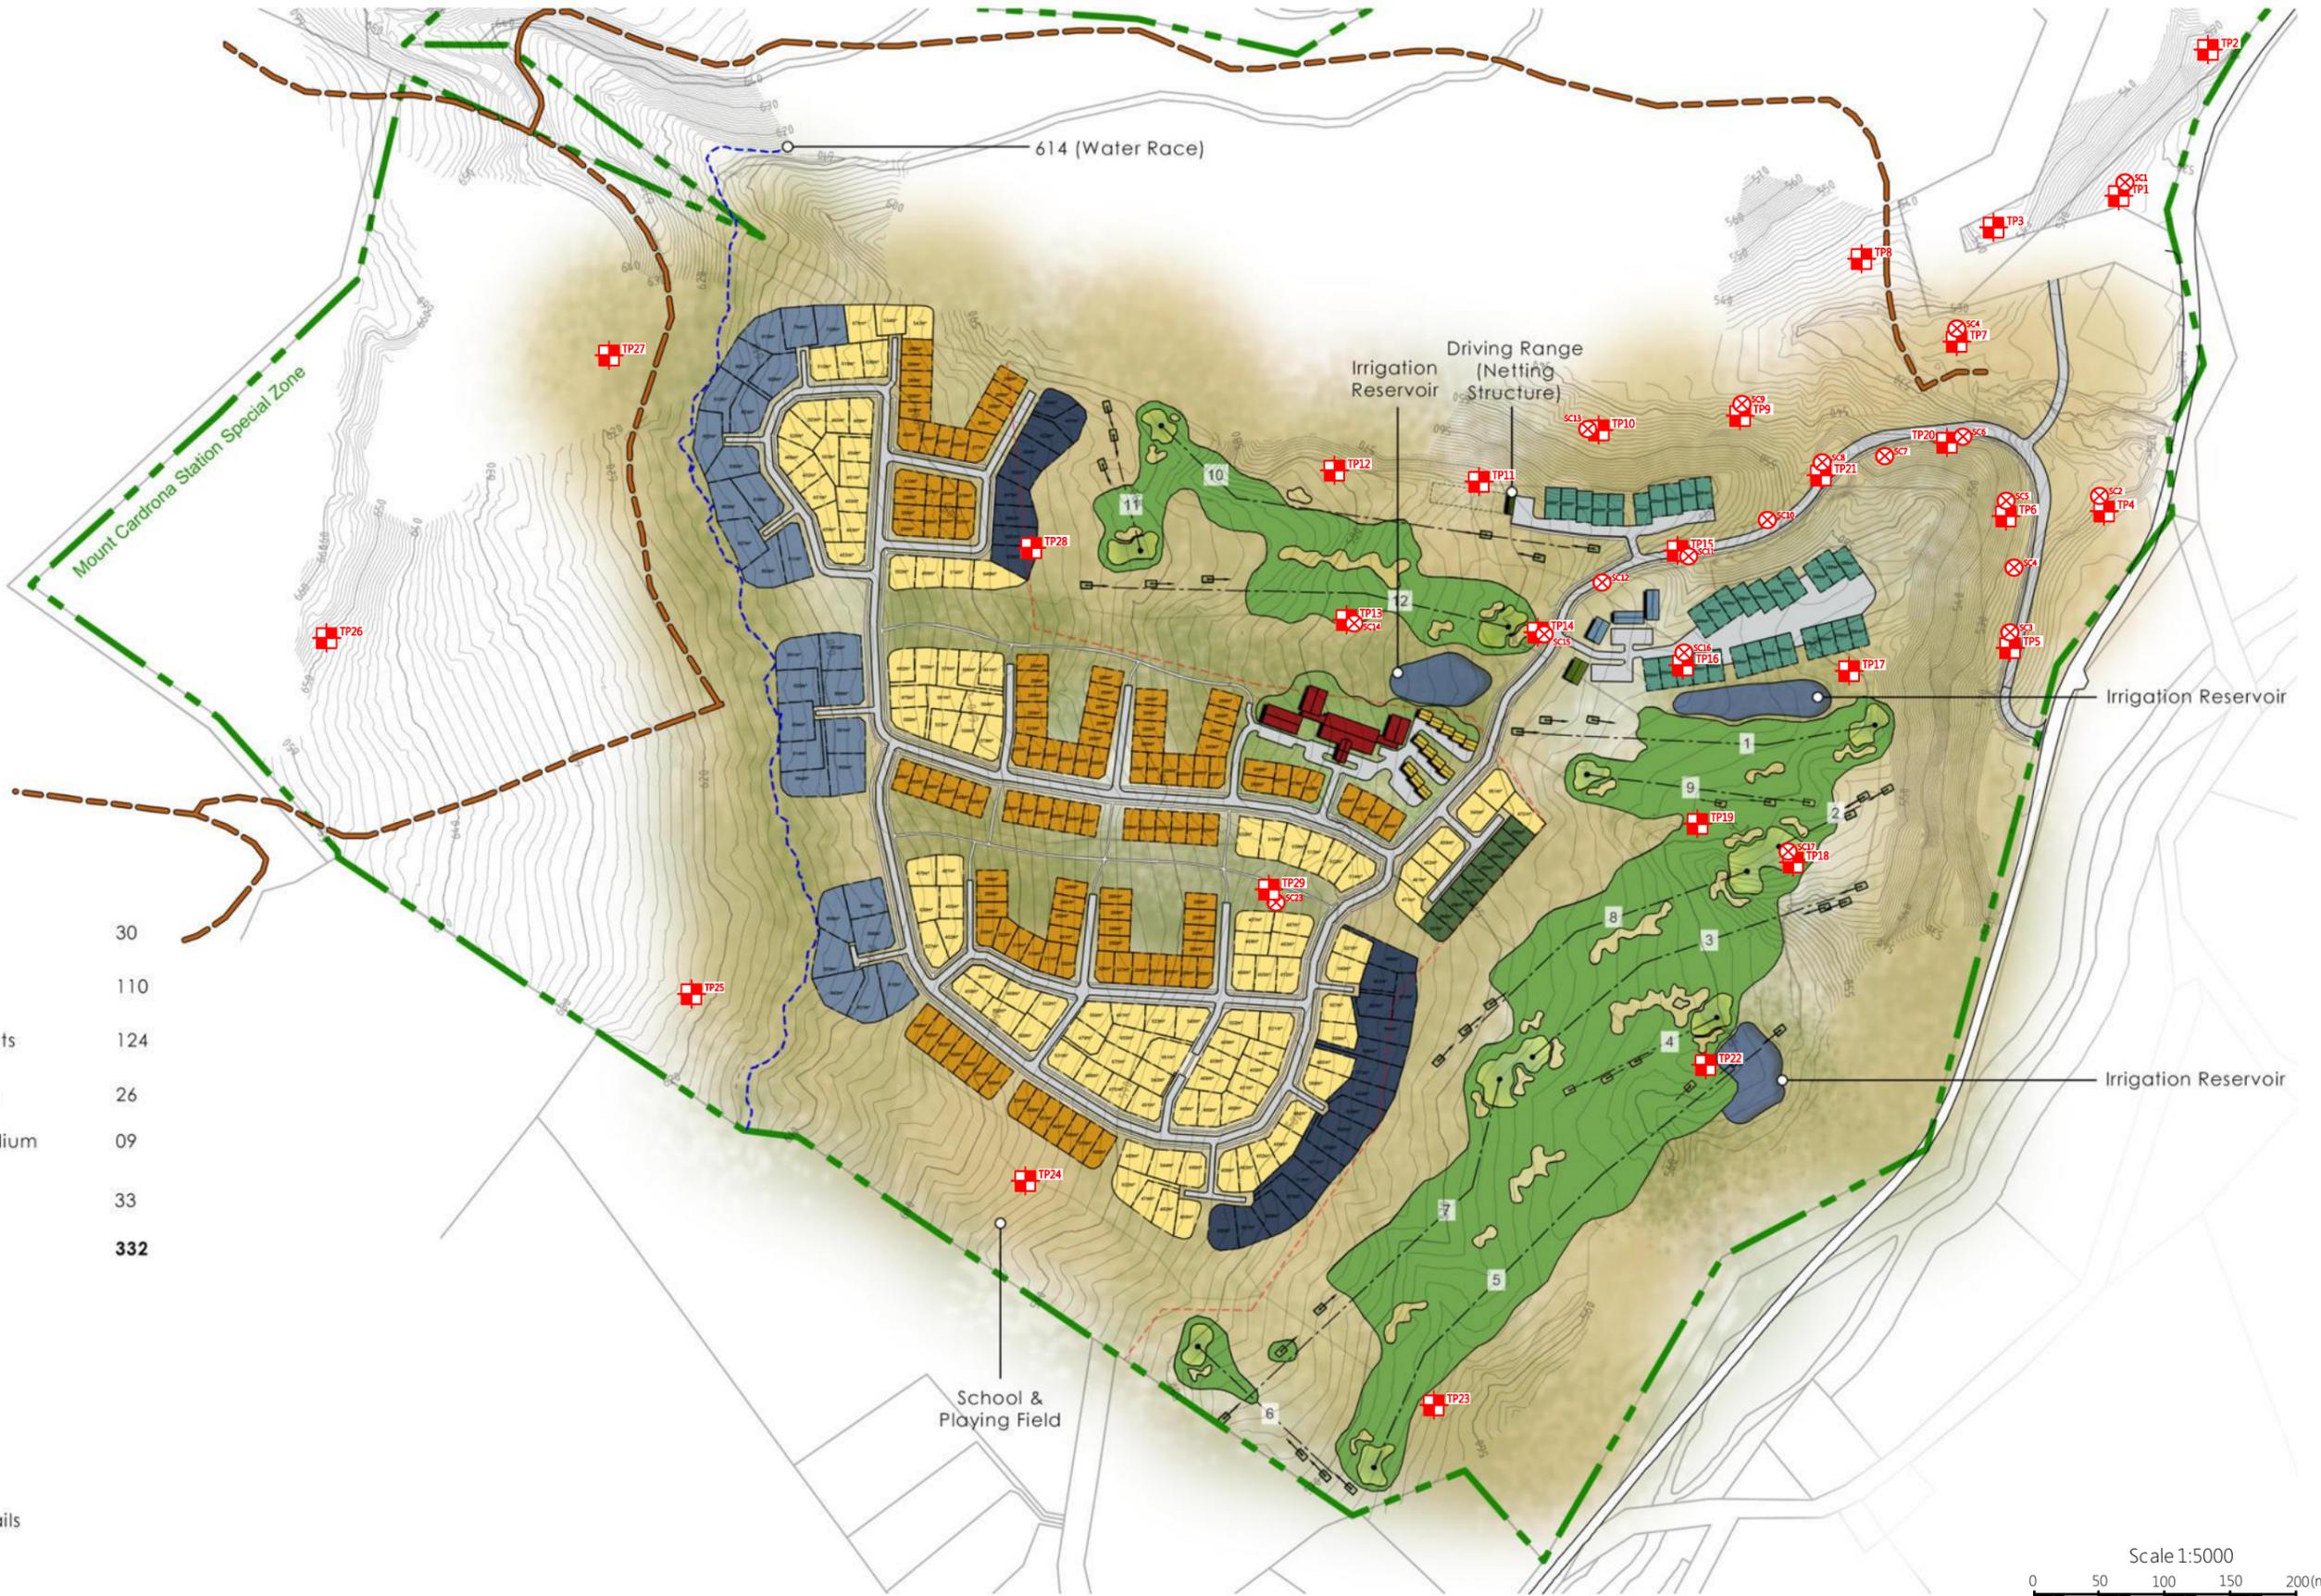
BROWN AND COMPANY PLANNING GROUP
 Geotechnical Assessment
 Mt Cardrona Station Plan Change
 Site Investigation Plan

Site investigations have included the excavation of twenty-nine test pits to a maximum depth of 5 m. A number of these test pits cover the proposed development area.

Locations of test pits are shown in Figure 1, Appendix A. All test pit logs are contained in Appendix B.

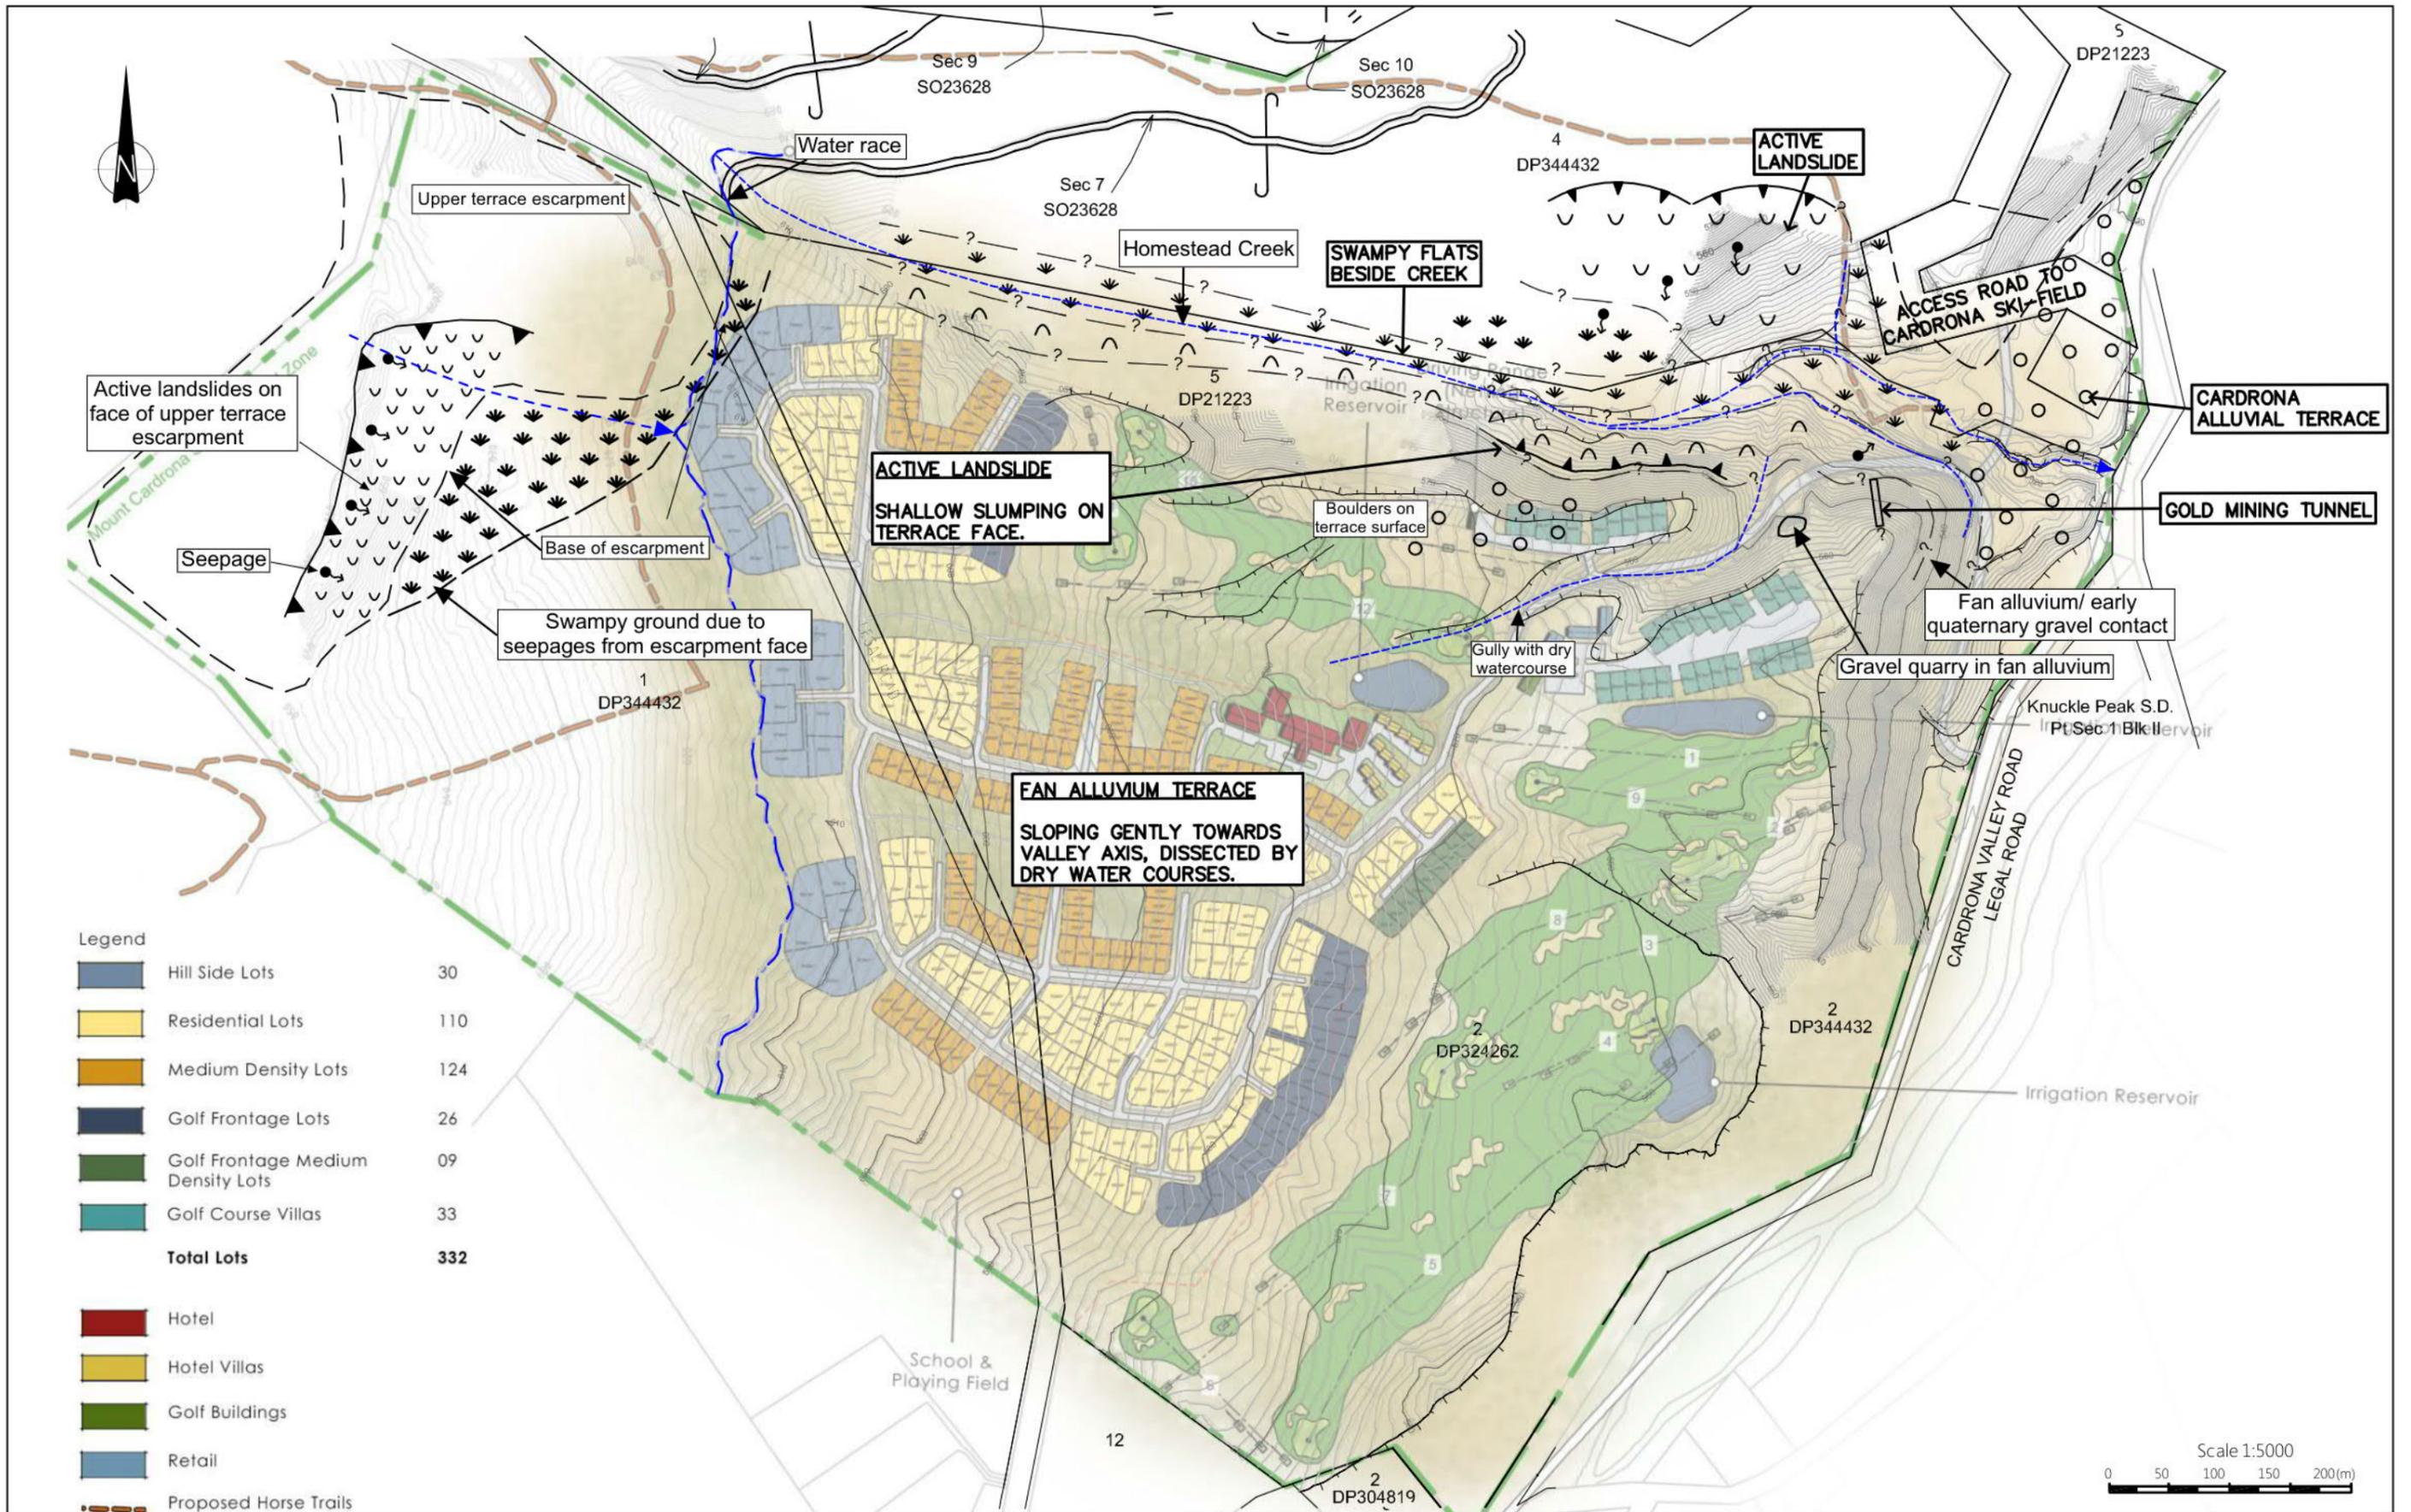
FIG No. Appendix A - Figure 2

An engineering geological appraisal has also been undertaken to assess geomorphology and surface conditions. Geomorphological mapping was completed, including outcrop mapping of the exposed soil materials (see Figure 2, Appendix A).

Current QLDC and ORC mapping identifies alluvial fan hazard and active faulting hazards within and near the proposed site area (Figure 3, Appendix A). Detailed geological mapping has also identified shallow landslide and mining hazards in the site area (Figure 2, Appendix A).

A site inspection and mapping was undertaken with relevant features observed and mapped (Figure 2, Appendix A).

Geological mapping has identified active landslides on steeper slopes north and south of Homestead Creek and on the face of the upper escarpment west of the proposed development area (see Figure 2, Appendix A).

These are considered to be slowly creeping slides, probably developed in underlying Early Quaternary Gravels. Movement appears to be associated with groundwater seepages.

A gold mining tunnel hosted by Early Quaternary Gravel was observed northeast of the Golf Course Villas (see Figure 2, Appendix A). There is a possibility that further tunnels are present as the interface between the Early Quaternary Gravel and the overlying alluvial fan deposits was a widely targeted gold-bearing horizon during the gold rush era. The tunnels are however likely to be of limited length (perhaps 10 m maximum) and restricted to the incised margins of the fan deposits. Tunnels are therefore not expected to present any geotechnical concerns for the plan change area (subject to localised verification and checking of final plans).

It is recommended that development be avoided in these areas, and that detailed landslide investigations be carried out for any proposed developments in their immediate vicinity.

The mining tunnel east of the Golf Course Villas will need to be traced to confirm its extent (including any drives that feed from it). If construction is proposed in the tunnel the area it should be

backfilled to the required foundation level using suitable engineered fill placed in accordance with NZS 4431:1989.
