NATURAL HAZARDS ASSESSMENT REPORT

JOB TITLE	HOMESTEAD TRUSTEES HAZARDS GEOTECH
ADDRESS	HOMESTEAD BAY, JACKS POINT
JOB NUMBER	50504
	9 June 17

Client: Homestead Bay Trustees Limited  
Private Bag 39534,  
Takapuna  
Auckland

50504 Homestead GeoHazard Report

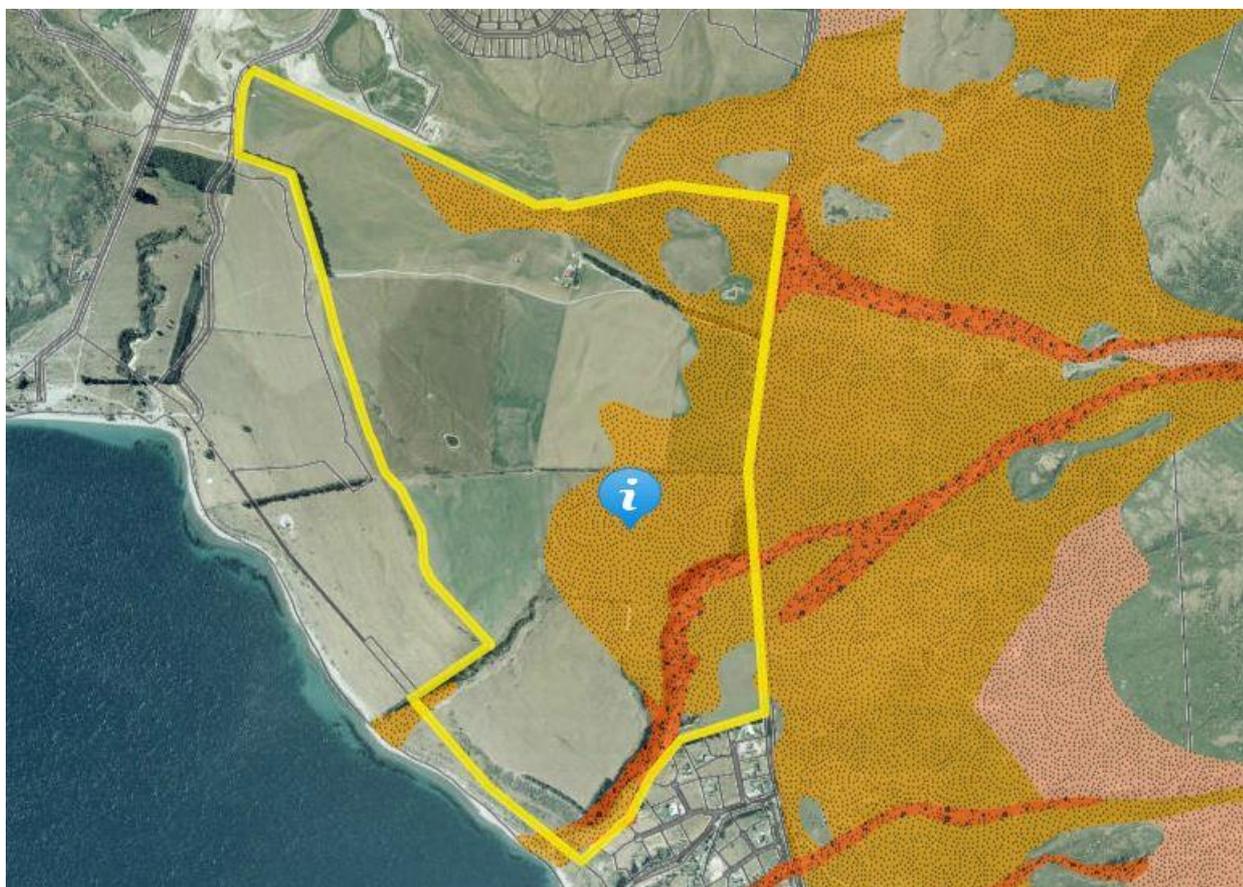
This hazard is confined to the deeply incised gully that is present in the southern end of the site, and shown in red below with black dots on the map below.

The deeply incised nature of the gully is providing active confinement of this bed loading and it is unlikely that the bed would aggregate out of the confined area available. We would recommend that should any earthworks or development be located within this gully that a full detailed investigation and assessment is conducted to determine the potential effects.

This is shown as the orange with black dots above.

Previous reporting by Fluent Solutions - Gary Dent addressed the alluvial fan hazard for the Jacks point plan zoning and we subsequently reviewed this reporting and concurred the hazard is unlikely to affect the site given the geological time scale for past “recent” activity with deposition during high lake levels.

At this high level assessment stage we would encourage the gully channel to be retained as it is presently.

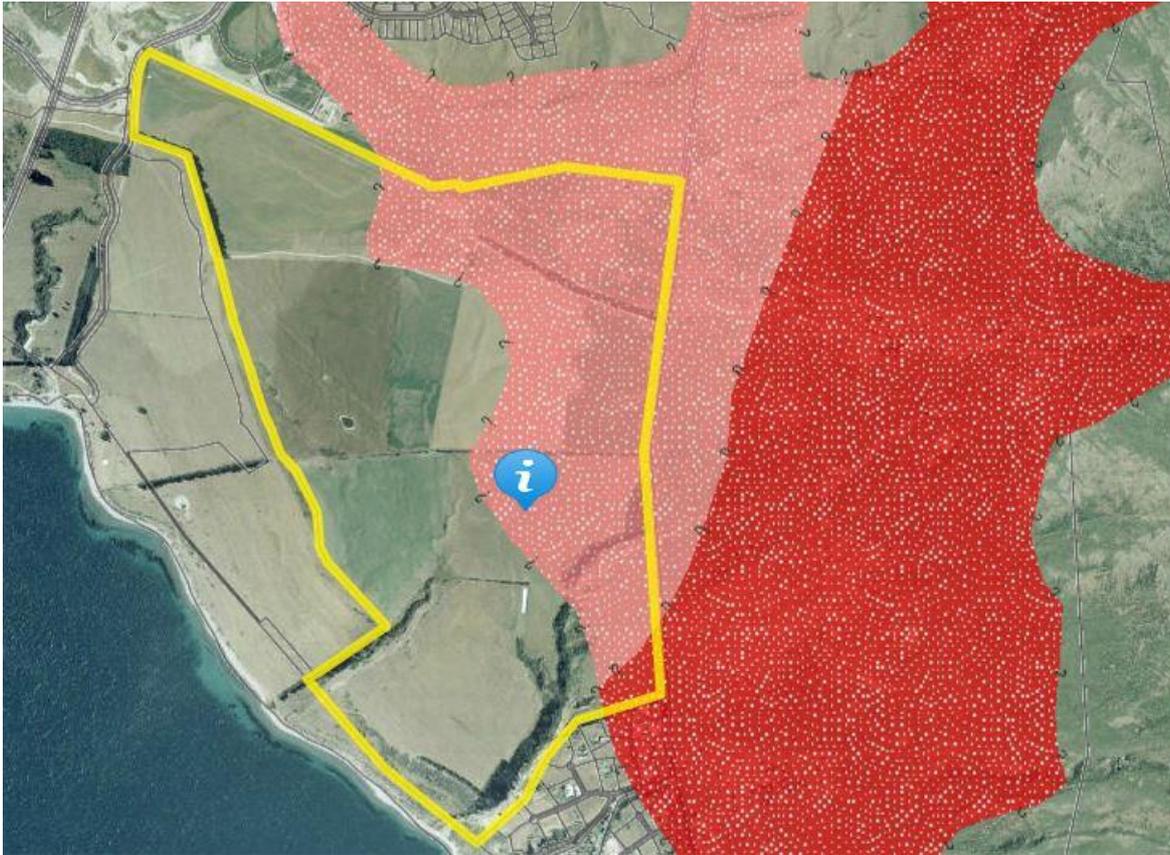
This is indicated by the grey pink with white spots area on the plan below, we note this area is showing question marks as to the boundary of its extent into the site.

This hazard is typically a flooding triggered event with moderate sediment loading and shallow flow depths. The topographical contour of the site and preexisting flow paths are likely to contain any potential from this hazard, with any flow passing through area B and into the Jacks point subdivision area. We understand that this hazard has been previously address by the developers of Jacks point, however we have not been able to obtain a copy of any related reporting by the close of evidential submission.

This is shown as the Red area in the above image, and is typically triggered by seismic or high rainfall events with the resulting debris typically not travelling very far as the topography flattens out. The presence of SH6 and its drainage channels are further expected to provide some form of protection from this potential hazard.

Once again while a high level assessment is provided here, mitigation options are available should detailed investigations at subdivision Consent applications confirm potential mitigation measures are required.

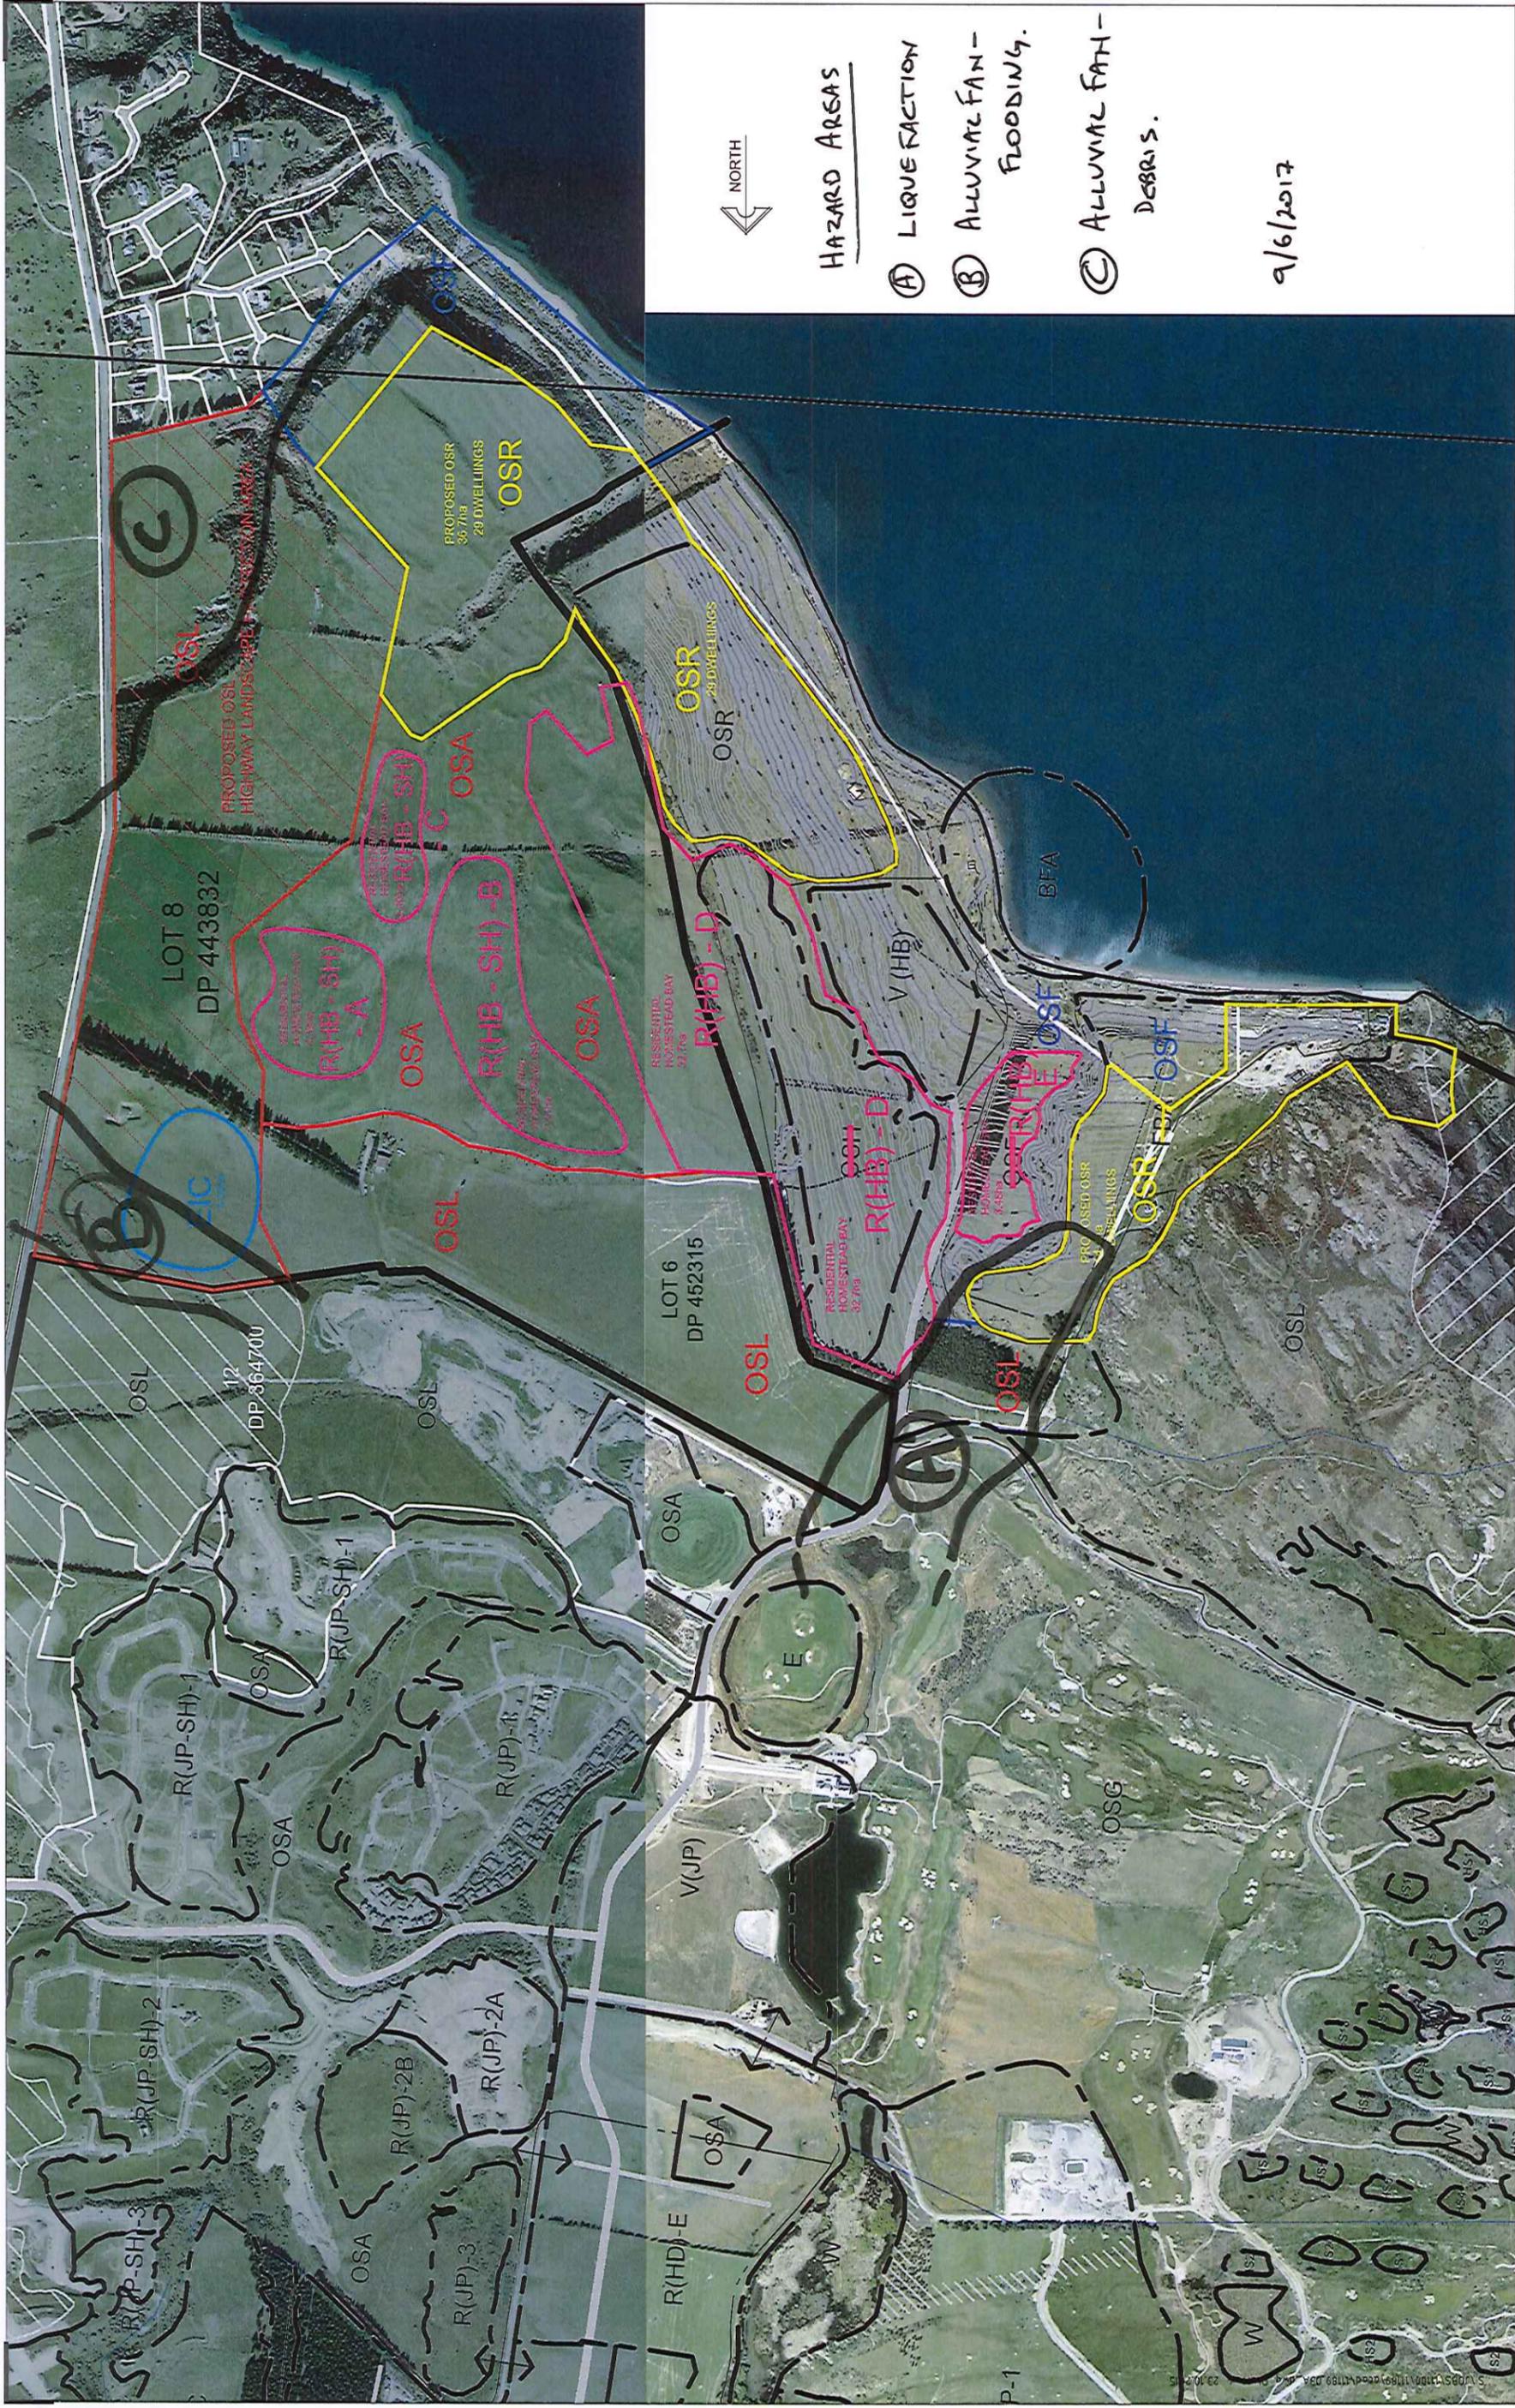
**HAZARD AREAS**

The only potential areas of the development that may be subject to specific liquefaction engineering and designed foundations for structures is likely to be a small area in the western most portion of LOT6 DP 452315 (OSL)

We have sketched the approximate extent of area that could be subject to this hazard on the plan "Hazard Areas" in Appendix A. It must be noted that standard investigation and design would be expected to mitigate this potential hazard hence this area is not precluded from development.

We have marked up the area we consider to be more appropriate on the “Hazard Areas” in Appendix A. shown as area B

We have assessed the area to potentially encroach into the development and have shown this as area C on the “Hazard Areas” plan in Appendix A.

- (A) LIQUEFACTION
- (B) ALLUVIAL FAN - FLOODING.
- (C) ALLUVIAL FAN - DEBRIS.
