Environmental Effects of On-Site Sewage Management in Glenorchy Stage 2: Investigations

QLDC

September 2018

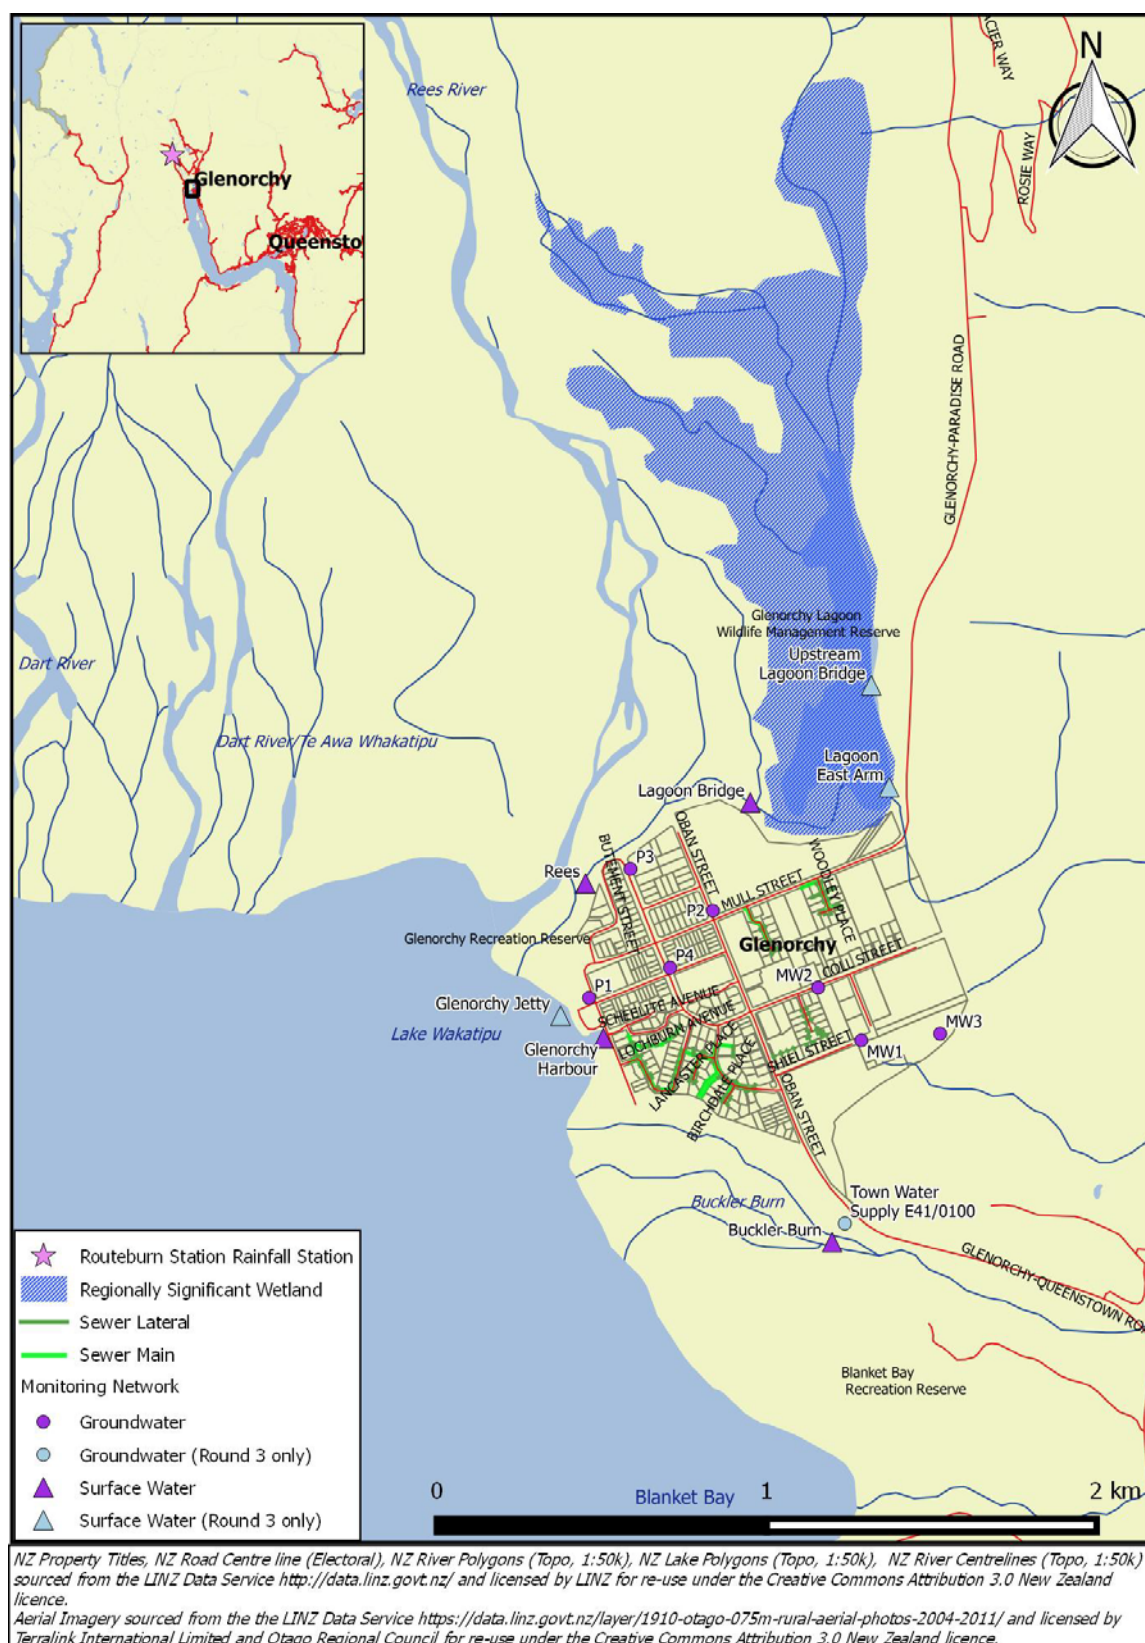
Figure 1: Glenorchy Township and Monitoring Network

Glenorchy Township is located on a river delta at the head of Lake Wakatipu (Figure 1). The township is bordered by the lake to the west and old river terraces at the foot of the Richardson Mountains to the east. The Glenorchy Lagoon and Rees River lie to the north and to the south the Buckler Burn River define the township's natural boundaries. Queenstown Lakes District Council (QLDC) commenced investigations into the provision of a reticulated sewerage scheme for Glenorchy in 2005. Both QLDC and Otago Regional Council (ORC) propose to implement the sewerage scheme in order to:

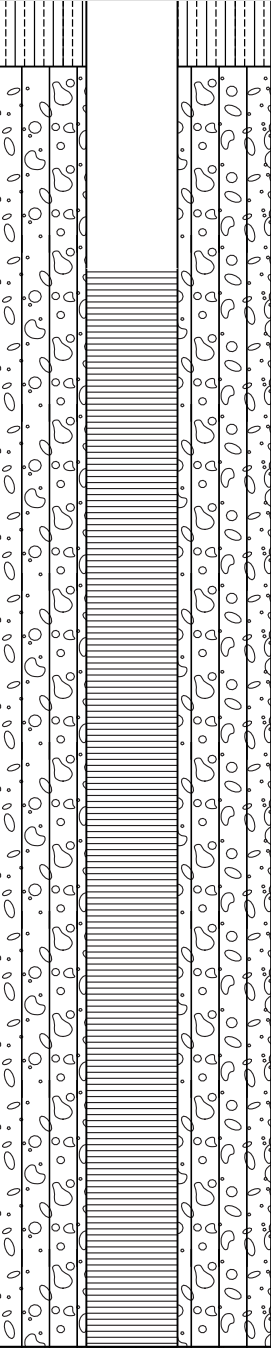
BORE LOG P4

Casing
1		Wet	Grey SAND with minor silt and clay		
1.5			Poorly sorted GRAVEL with minor cobble, minor sand and silt		
2					Screen
2.5					
3					
3.5					
4					
4.5					
5					
5.5					
6					
6.5					
7					
7.5					
8					
8.5					
9					
9.5					
10			Termination Depth at:10
