Davis Consulting Group: Preliminary Site Investigation (PSI) Report  
and Addendum

# Proposed Rezoning of Lakeview Queenstown Preliminary Site Investigation

*July 2014*

**Proposed Rezoning of Lakeview, Queenstown**  
**Preliminary Site Investigation**

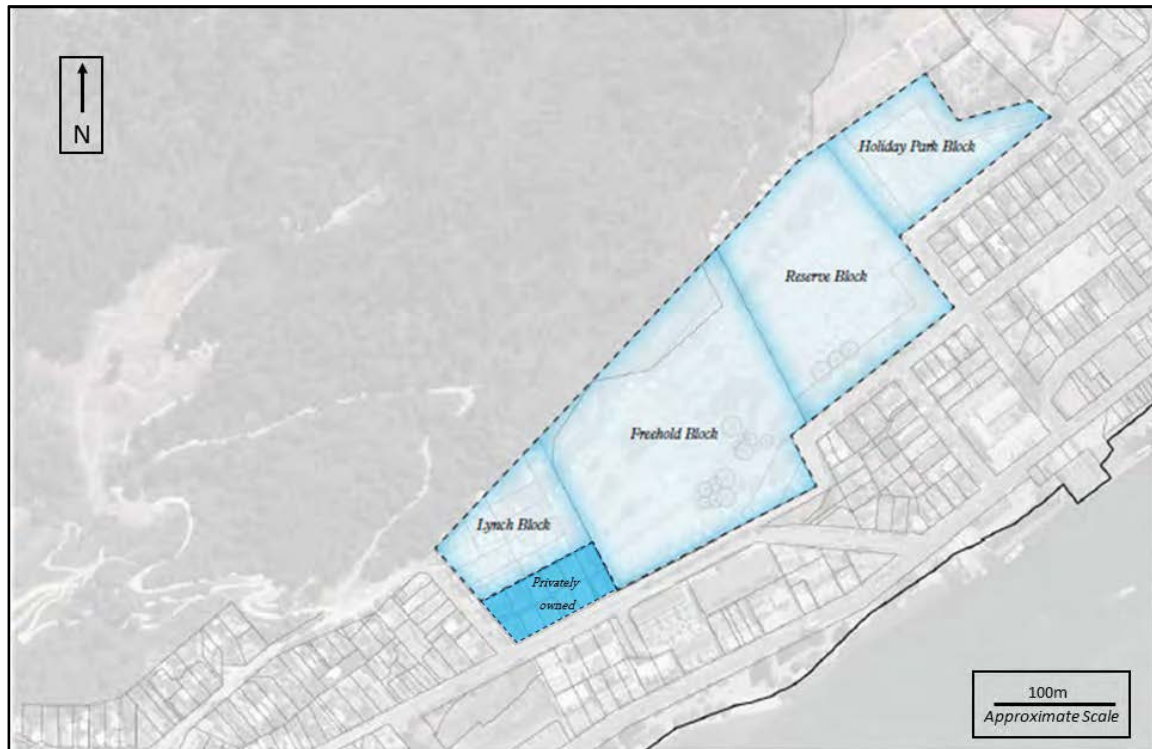
Figure 2: Proposed Lakeview Sub-Zone. Council owned sub-blocks and privately owned land.

Site investigation took place within the Lynch, Freehold, Reserve and Holiday Park Blocks of the Lakeview Sub-Zone. These four sub-blocks are shown in Figure 2, shaded light blue. The section of privately owned land in the south-west corner of the Lakeview Sub-Zone was excluded from investigation. This is shaded blue in Figure 2.

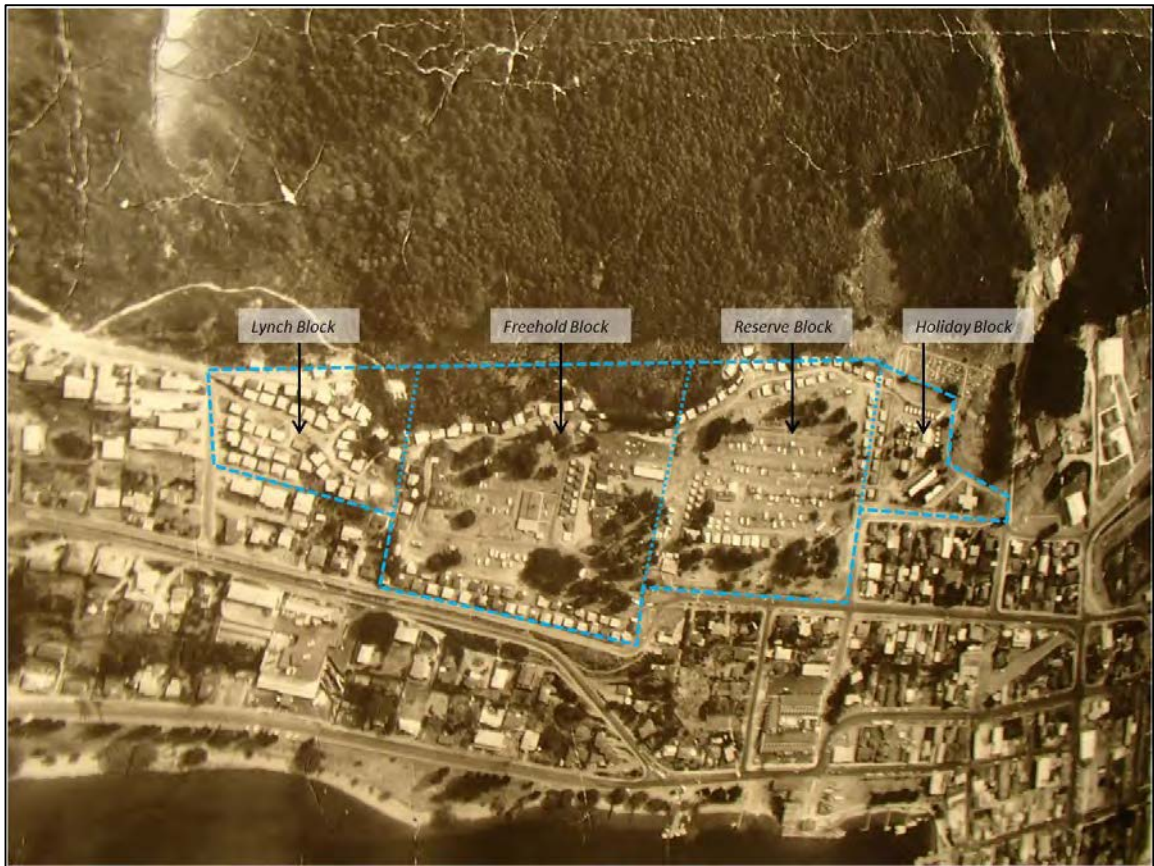
Figure 4: 1970 Aerial Photograph

From as early as 1950 the Holiday Park Block was used as overflow camping for the main camp ground area to the west (David Clarke, pers. comm. 2014). Plans submitted to the council in 1959 proposed a campground, cribs, ablution block, buildings for staff residence and power transmission lines within the site (QLDC E Docs, 2014) (Appendix B). These facilities were established by 1970 as observed in the 1970 aerial photograph (Figure 4). By 2000, the original buildings were demolished and the Holiday Park Block was redeveloped into the park that is present today.

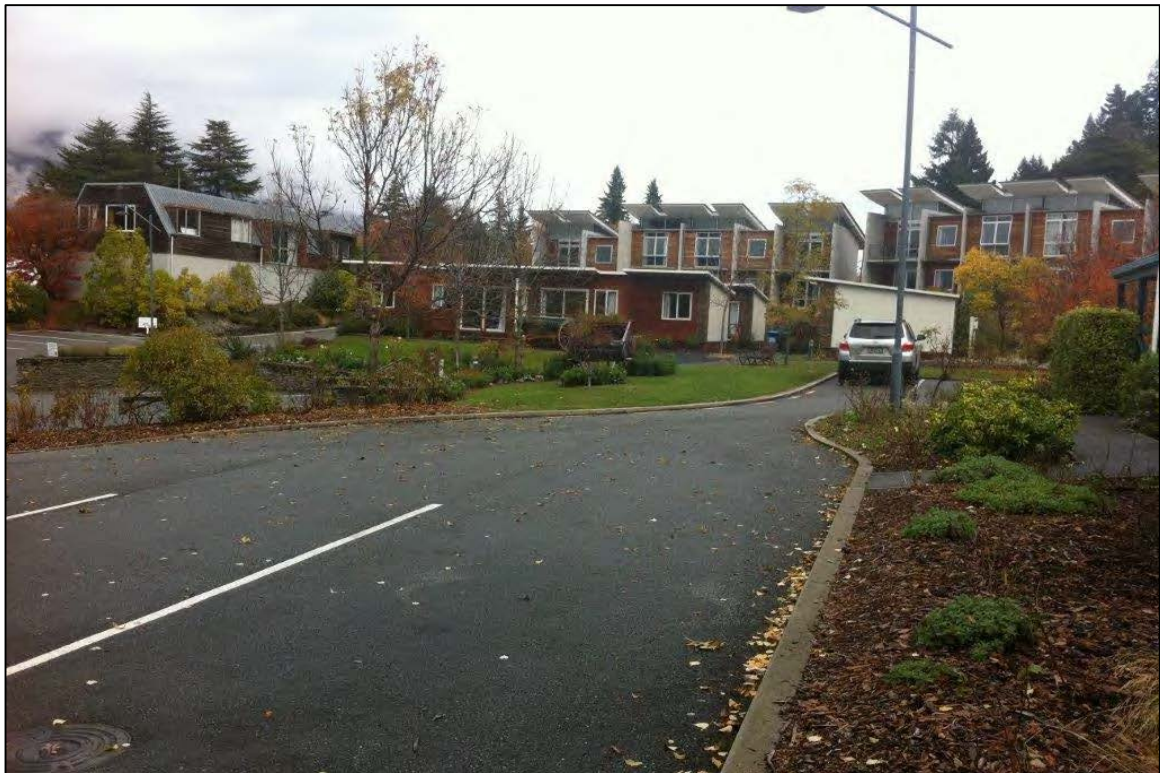
**Plate 1:** Holiday park facilities

The existing holiday park is shown in the 2013 aerial photograph (see Figure 5). Current facilities include a public waste water dump station, ablution block, motel units and holiday park reception (Plate 1). A plan of the holiday park is included in Appendix B. Waste water from the ablutions and waste water dump stations is reticulated to the main town waste water system, as

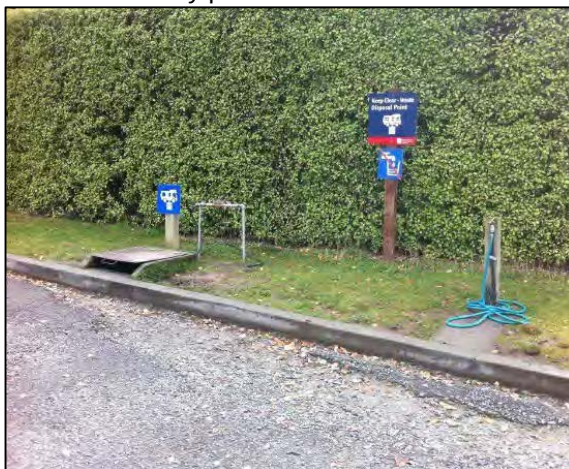
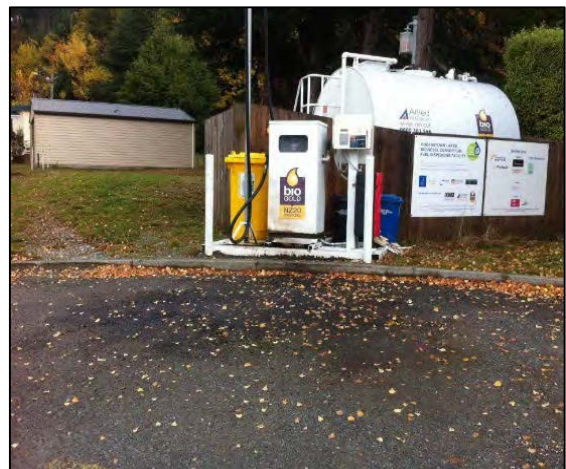
**Plate 2:** Public waste water dump station and diesel tank and fuel pump on cemetery road

A public waste water dump station and allied petroleum diesel tank and fuel pump bowser are located to the north of the project boundary on Cemetery Road (Plate 2). There is no evidence of onsite septic or effluent disposal fields on the site. Power is distributed by underground electrical utilities and a transformer is located to the west of the carpark area.

On the north east corner of the Lakeview Site, along Cemetery Road there is a diesel tank and fuel pump bowser. The HAIL lists the bulk storage of fuel as a hazardous activity with the potential to cause ground contamination. The diesel tank was in good structural condition however it does not appear to be bunded. The associated fuelling pump/bowser was also not bunded and spilt diesel has stained the ground over 4 square meters of roadway beside the fuelling area (Plate 2).

On the north east boundary of the Lakeview Site, along Cemetery Road, there is diesel tank and fuel pump bowser owned by Allied Petroleum. The tank was in good structural condition, but does not have a bund, and therefore could not have contained any spillage that may have occurred. The fuelling area was not banded to contain spillage during fuelling and consequently, diesel was observed in a layer over 4 square meters of roadway beside the fuelling area (Plate 2).

Hydrocarbon contamination in the vicinity of the bulk fuel storage facility is also highly unlikely to be more than localised contamination associated with small drips and spills. If a significant loss had occurred the district council or regional councils should have been informed. Neither council holds any records associated with any fuel spills on the site.

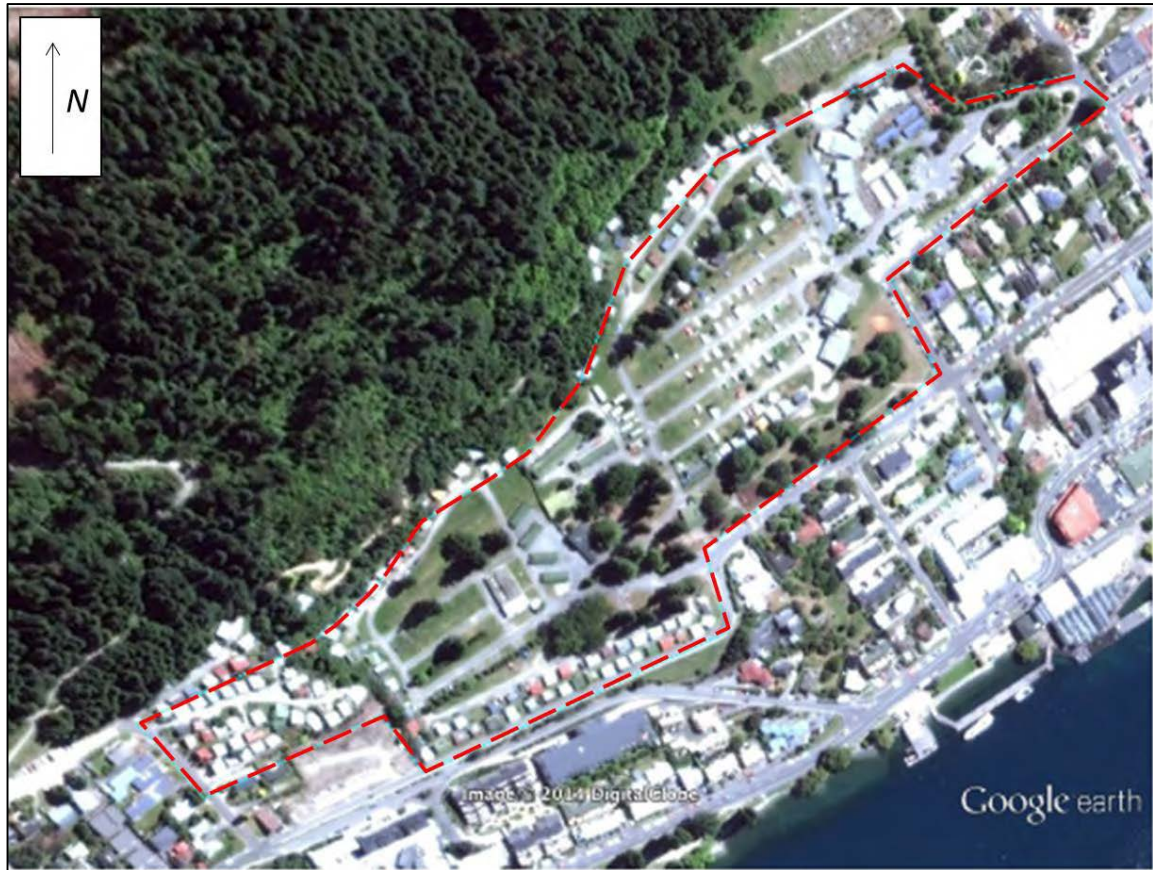
Figure 5: 2013 Aerial Photograph

Existing buildings and facilities are shown in the 2013 aerial photograph (see Figure 5).

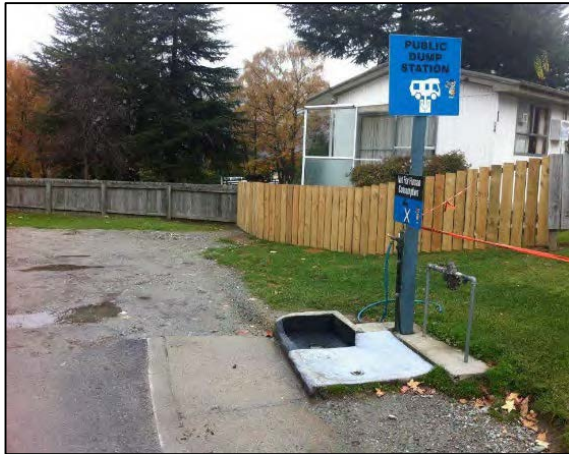
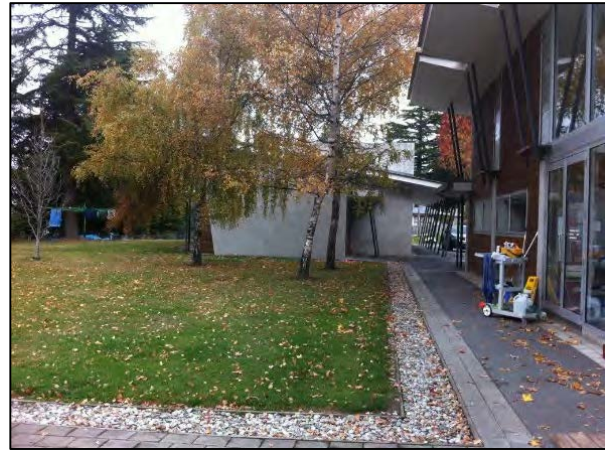
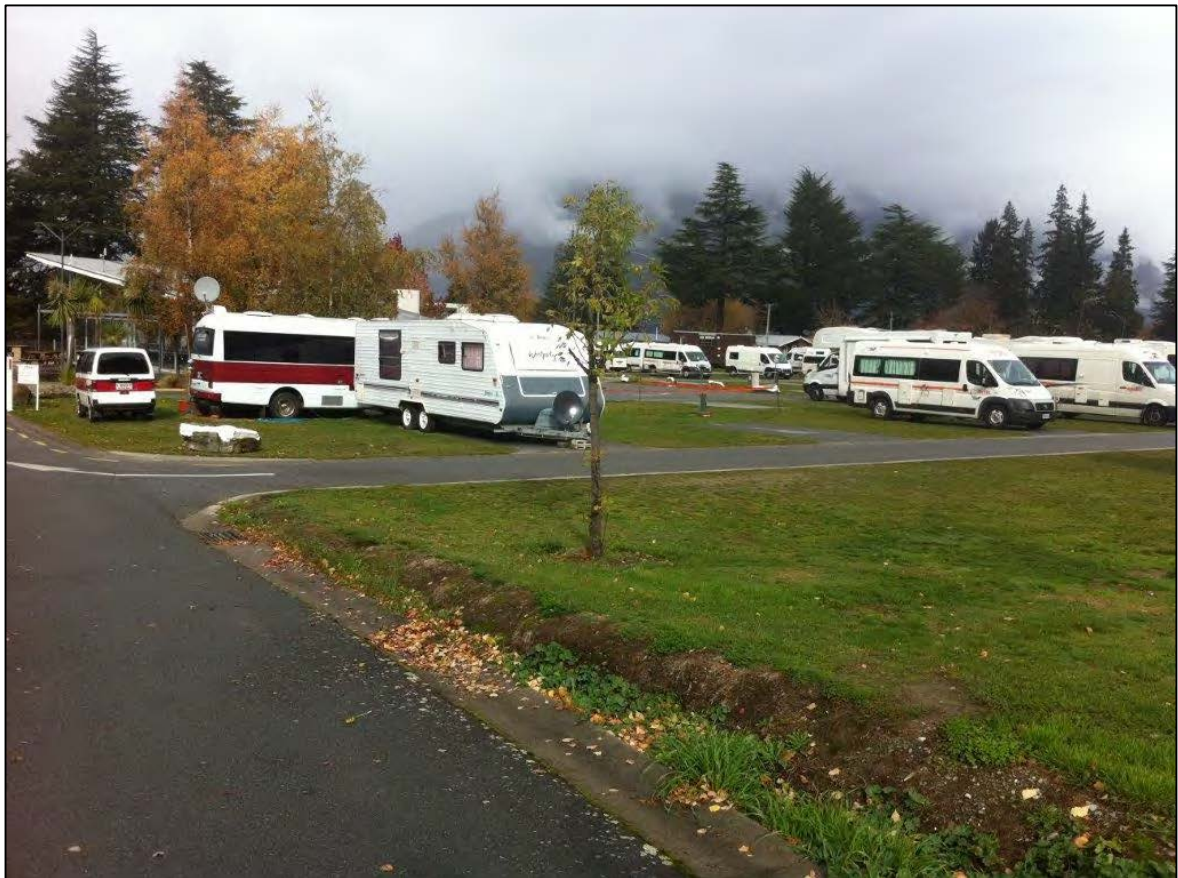
**Plate 3:** Operational Facilities on Reserve Block. Waste water dump station, ablution block and campervan parking

The present day holiday park is shown in the 2013 aerial photograph (see Figure 4). Current facilities on the Reserve Block include a waste water dump station, power lines, ablution block

and cribs (Plate 3). Waste water from the ablutions and waste water dump stations is reticulated to the main town waste water system, as shown in the QLDC sewage plan included in Appendix B. Waste water from the demolished ablution blocks was reticulated to the main town waste water system, as shown in the QLDC sewers plan in Appendix B. There is no evidence of onsite septs or effluent disposal fields on the Reserve Block. Powerlines and associated electrical transformers are shown in electrical plans are included Appendix B.

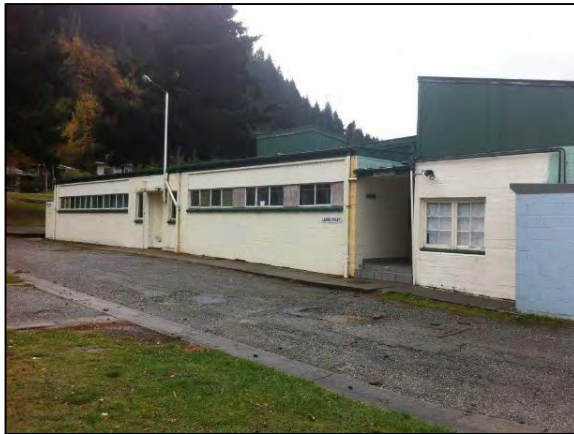
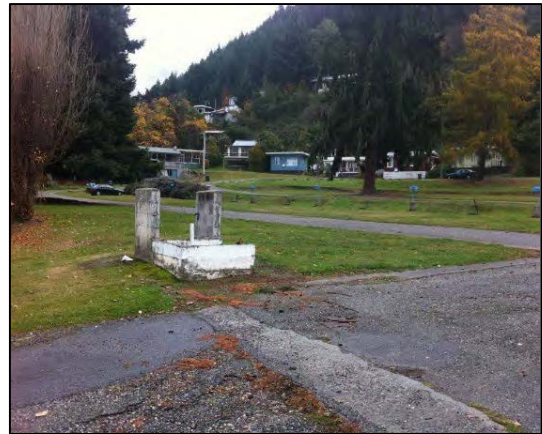
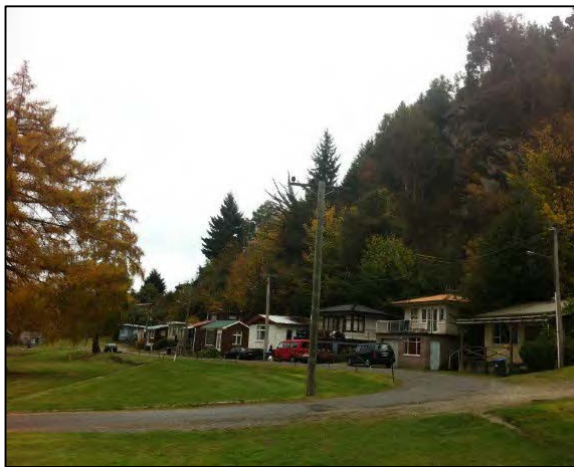
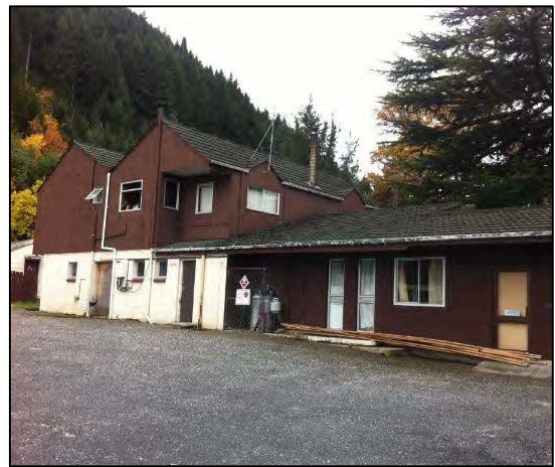
**Plate 4:** Closed holiday park facilities within Freehold Block. Ablutions block, waste water dump station, power lines, park administration and store (left to right).

Closed holiday park facilities remaining on site include two waste water dump stations, ablution block, motel units, power lines, original holiday park reception and caretaker residence (Plate 4). Many of these buildings were constructed prior to 1980 and consequently may contain asbestos in building materials and/or insulation. These buildings appeared to be in good structural condition.

It is understood that sewage wastewater has been reticulated from ablutions for as long as it has been possible to be connected to the mains sewage lines (Andrea Jarvis, pers. Comm. 2014). Plans showing sewage reticulation to the closed facilities are included in Appendix B. Powerlines and associated electrical transformers are shown in electrical plans included Appendix B.

As discussed above, it is possible pipelines, houses and ancillary buildings associated with the holiday park that were constructed before 1984 may contain asbestos. The buildings appear to be in good condition and the current risk to human health is considered to be low however any demolition work that may be associated with redevelopment of the site will require an asbestos survey.

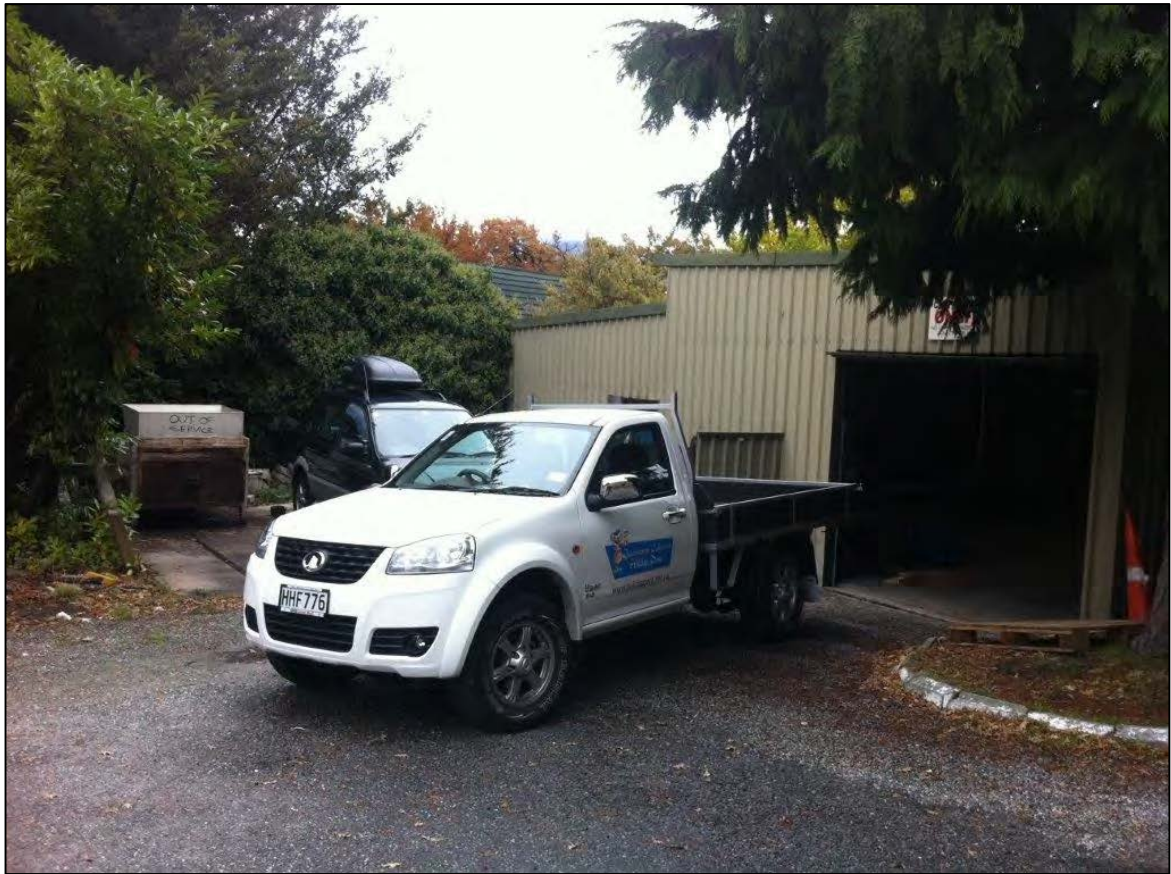
**Plate 5:** Freehold Block motor vehicle workshop (active)

The original holiday park workshop is still in use (Plate 5), located adjacent to the original park reception on the eastern boarder of Freehold Block. The workshop building has a partially sealed cement floor that drains south to an area of earth that appears to be free draining. Minor volumes of chemicals are stored in the workshop including a 210L drum of fuel and small 20L drums of oil and cleaning products.

A motor vehicle workshop adjoins the previous park reception and residence. Based on the HAIL, the hazardous substances that may be associated with the motor vehicle workshop include polycyclic aromatic hydrocarbons (PAHs), solvents, and metals contained in waste oil.

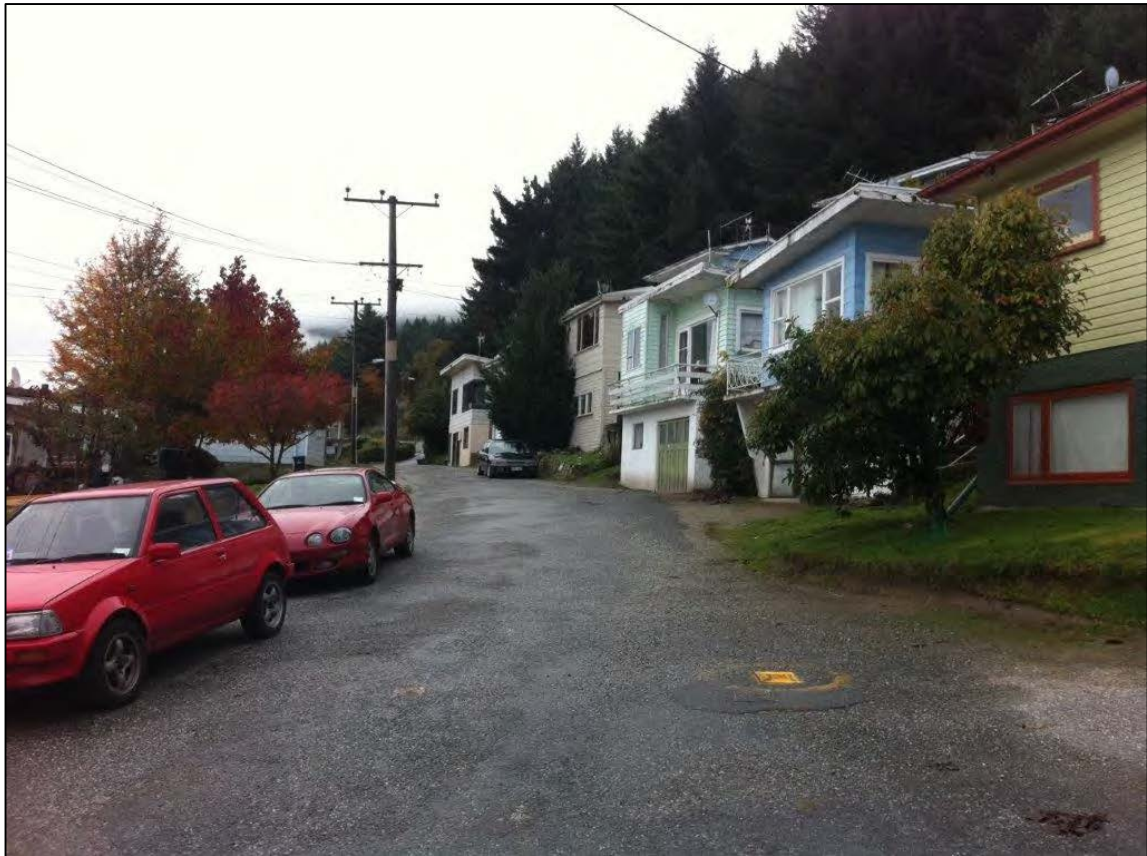
**Plate 6:** Cribs within Lynch Block

The western extent of the project area between Glasgow Street, Kilmarnock and Mountaineer Streets (Lynch Block) was gazetted into small residential sections in the 1870's (See Figure 3). The Heritage Impact Assessment undertaken for the site suggests the sections may have had activities on site associated with an arborist company and a sawmilling and logging company (New Zealand Heritage Properties Ltd, 2014). Throughout the 1930's to 1950's, eyewitness accounts describe this area as residential housing (Hamilton, 2012). There is currently over 30 occupied residential buildings within this area.

All of these buildings were constructed prior to 1980 and consequently may contain asbestos in building materials and/or insulation. These buildings appeared to be in good structural condition (Plate 6). Waste water from the cribs is reticulated to the main town waste water system, as shown in the QLDC sewers plan in Appendix B. It is believed that sewage waste water has been reticulated from ablutions for as long as it has been possible to be connected to the mains sewage lines (Andrea Jarvis, pers. Comm. 2014). Powerlines are shown in electrical plans included Appendix B.
