Millbrook Proposed District Plan Change Preliminary & Detailed Site Investigation

Millbrook Country Club Limited

February 2015

**Millbrook Ltd,
Proposed Landuse Change,
Preliminary & Detailed Site Investigation**

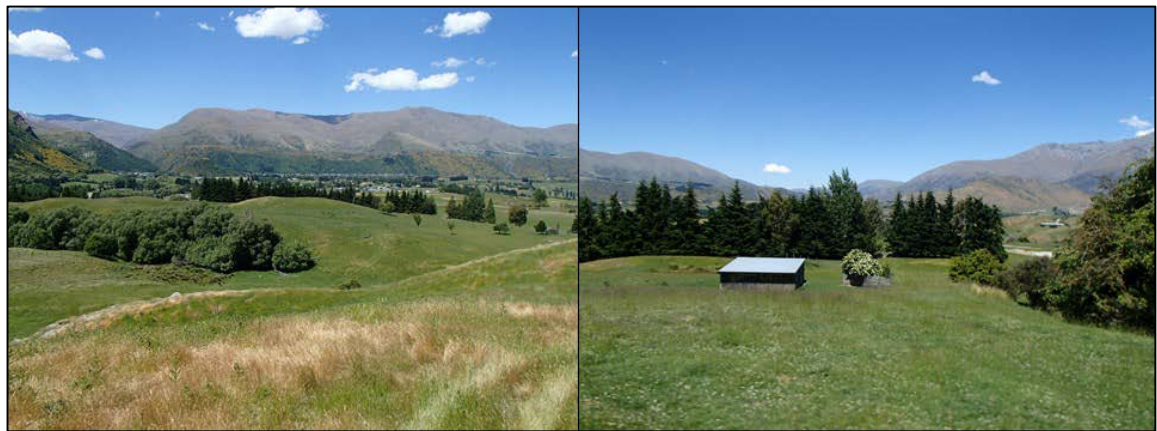
Plate 1: Left - Looking east from west side of property; Right - Looking east at hay shed.

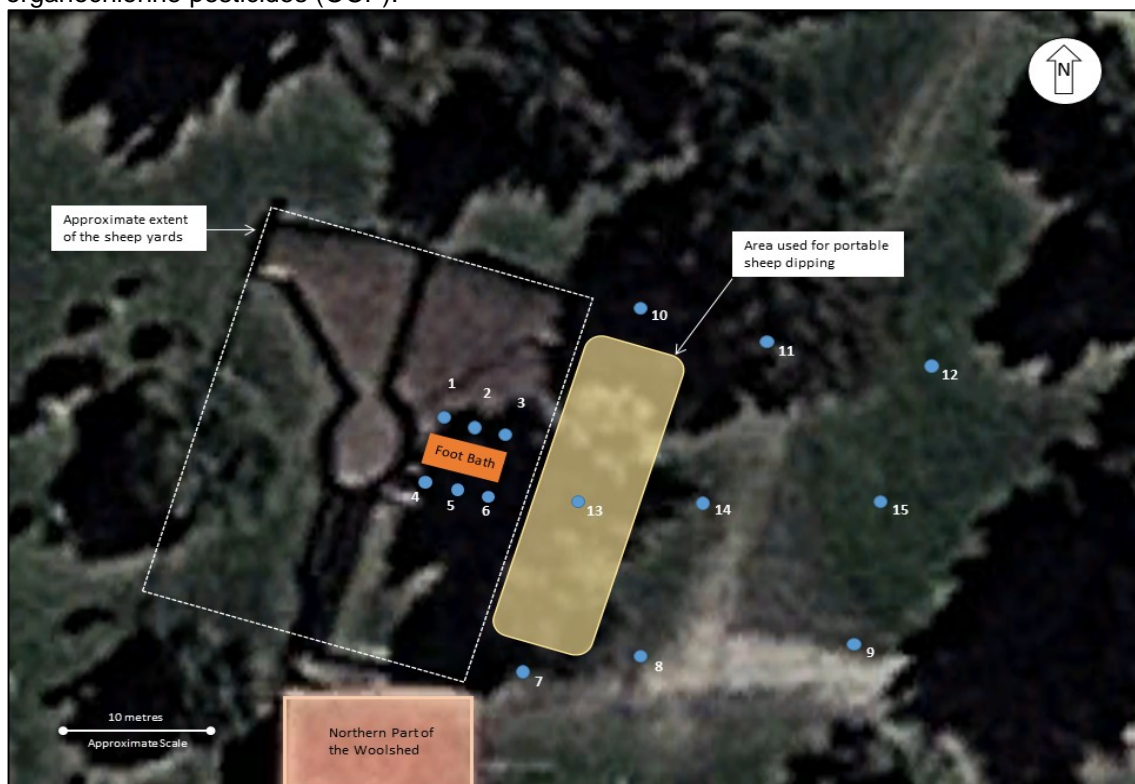
Figure 6: Sample Location Plan

Samples from each of the 15 locations in Figure 6 were analysed individually for arsenic and copper then composited into 5 groups for OCP analysis. The sampling depth of 0-0.1m for these sample sites is considered appropriate due to the nature of the potential contaminants present, such as organochlorine pesticides and heavy metals, which generally bind strongly to soils and are unlikely to leach to significant depths.

The soil sample locations are provided in Figure 6 and summarised in Table 3 below.

- Dieldrin concentrations were below laboratory detection limits in composite samples 'C7-8-9', 'C10-11-12' and 'C13-14-15';
- Composite soil sample C1-2-3 has a dieldrin concentration of 0.083 mg/kg, which is below the adopted guideline value; and
- Composite soil sample 'C4-5-6' exceeded the adopted guideline value of 0.86 mg/kg for dieldrin, with a concentration of 1.18 mg/kg.

Based on the investigation results there has been some impact to soils to the south of the footpath that could be a risk to human health if regularly exposed to these soils over a long duration (years). It is expected that the area of impact is relatively localised and confined to the area within the yards to the south of the footpath. DCG recommends that the extent of the impacted soils is delineated and remedial measures undertaken to remove this risk from site.

In summary DCG considers the site is suitable for residential activity provided remedial work is undertaken in the vicinity of the footbath situated in the stockyards adjacent to the woolshed.
