Preliminary Site Investigation
34 Brecon Street, Queenstown

Brecon Street Partnership Limited

August 2014

**34 Brecon Street, Queenstown
Preliminary Site Investigation**

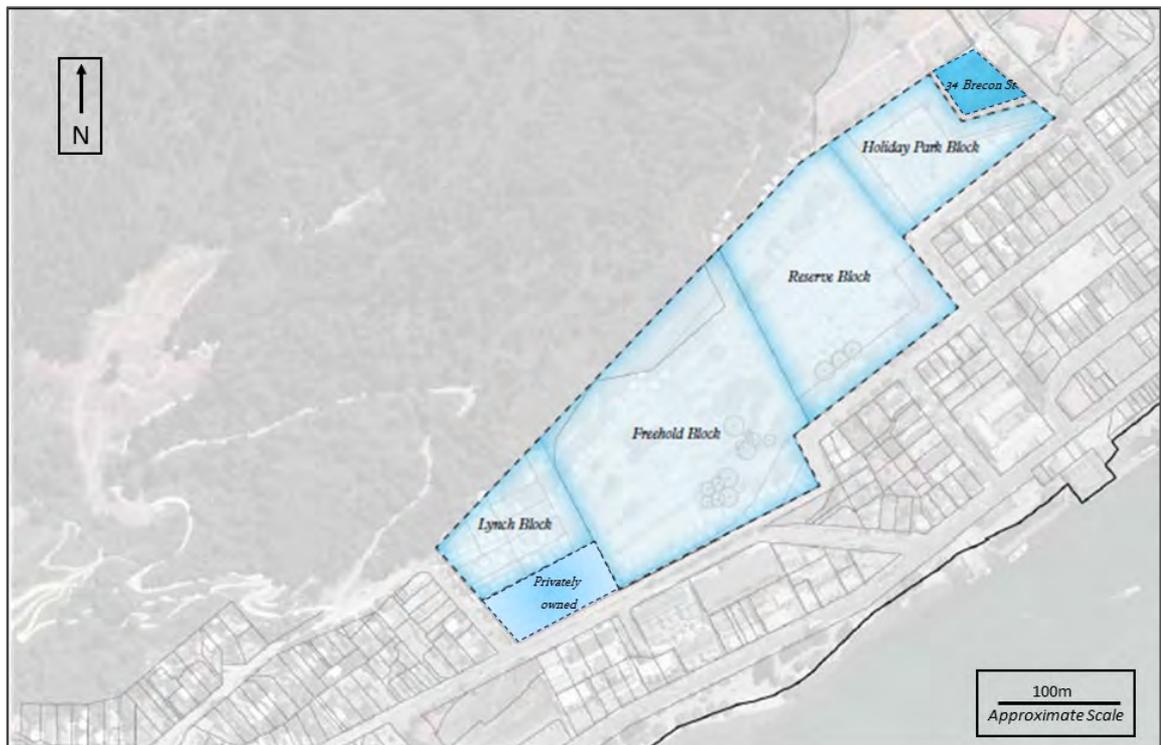
The site under investigation is located at 34 Brecon Street, to the east of the Lakeview Site investigated by DCG in June/July 2014. The site is located to the west of Queenstown's Central Business District, north of Isle St and between Cemetery Road and Brecon Street (Figure 1). The legal description of the land parcel is Lot 1 DP 27703.

Figure 1: 34 Brecon Street site (dark blue) relative to proposed Lakeview Sub-Zone (light blue).

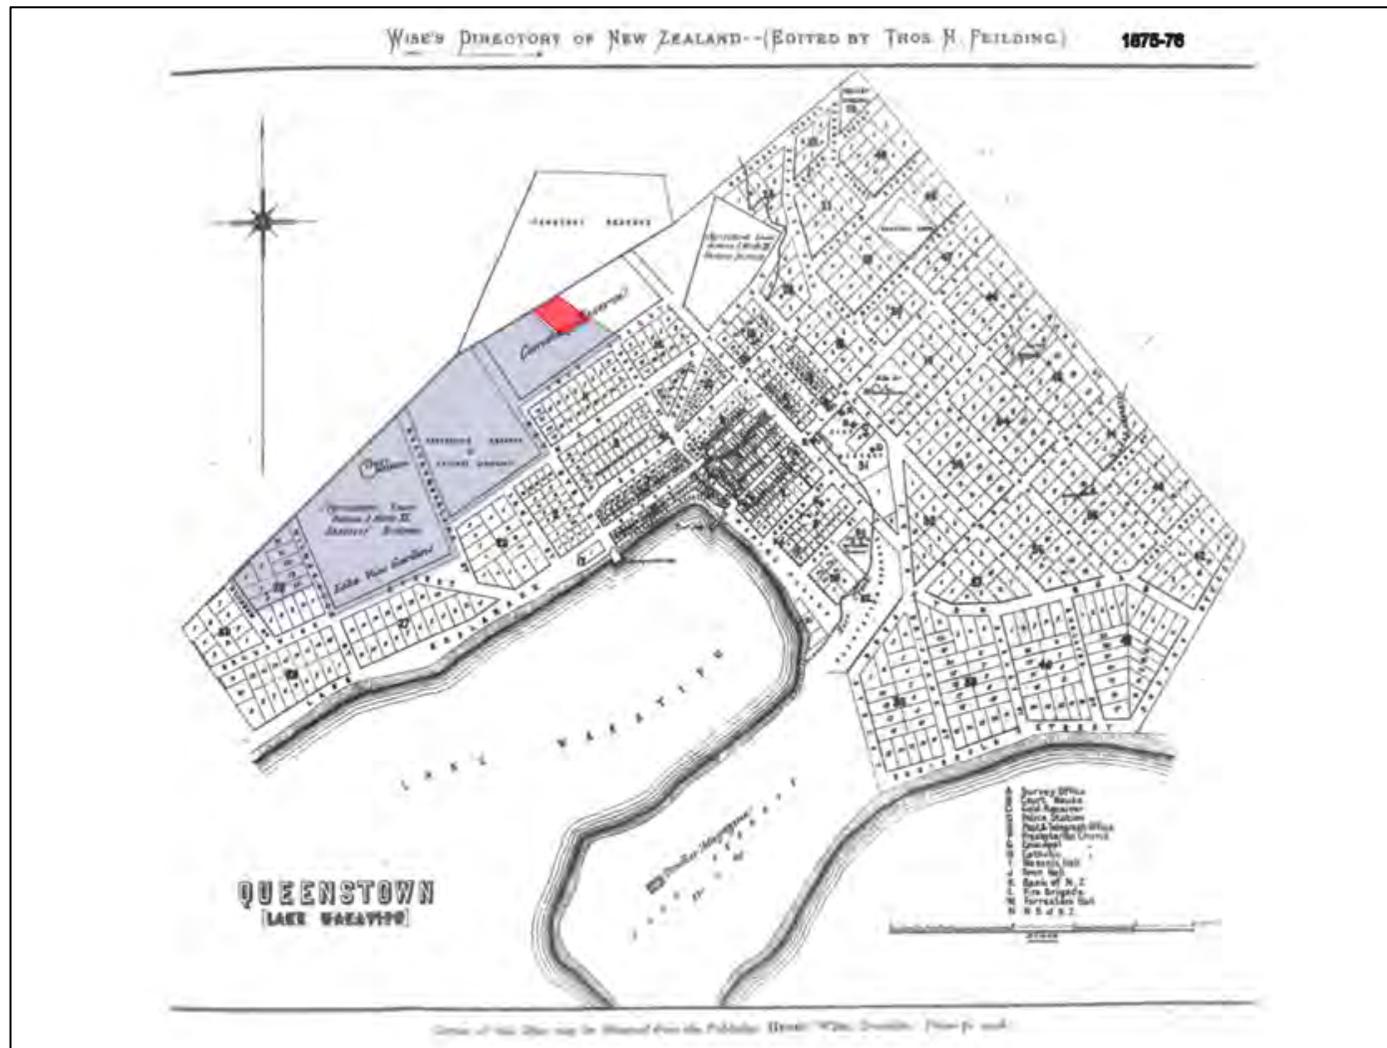
Figure 2: 1875 Plan of Queenstown showing the study area (red) and the council owned land of the proposed Lakeview Sub-Zone (grey)

The Brecon Street site was gazetted as a cemetery reserve in the 1870's (Figure 2), however it is unlikely that this site was utilised for this purpose. Historical photography indicates the cemetery has always been situated on land to the north of the present mini golf car park. The cemetery can be seen in the background of Plate 2, beyond the mini golf carpark.

Figure 2 presents a plan of Queenstown in 1875-76 from the Wises Directory of New Zealand.

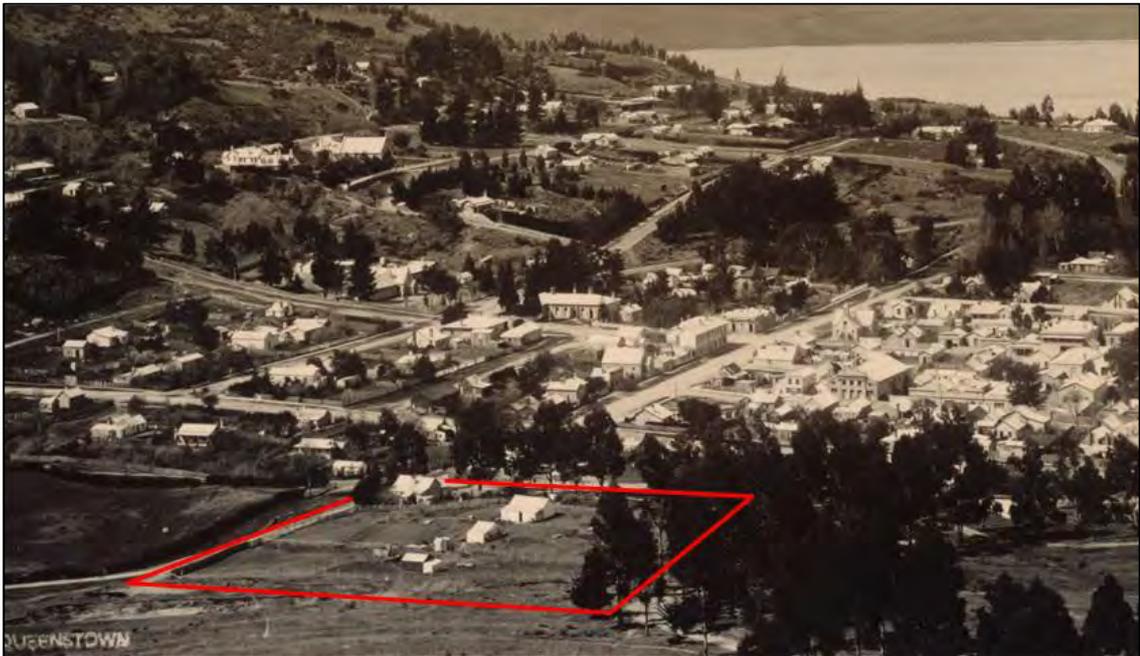
Photographs from the early 1900's show buildings and fences within the site (Plate 1). Historical accounts suggest that there was no agricultural or industrial activities in the area of the site (A. McGuire pers comm, 2014) (Hamilton, 2012).

Plate 1: Photograph of Queenstown in 1903 showing the 34 Brecon Street site (within red perimeter).

Powerlines run to the north of the site, as seen in Plate 1, and there is no evidence of historical or present electrical transformers within the site.

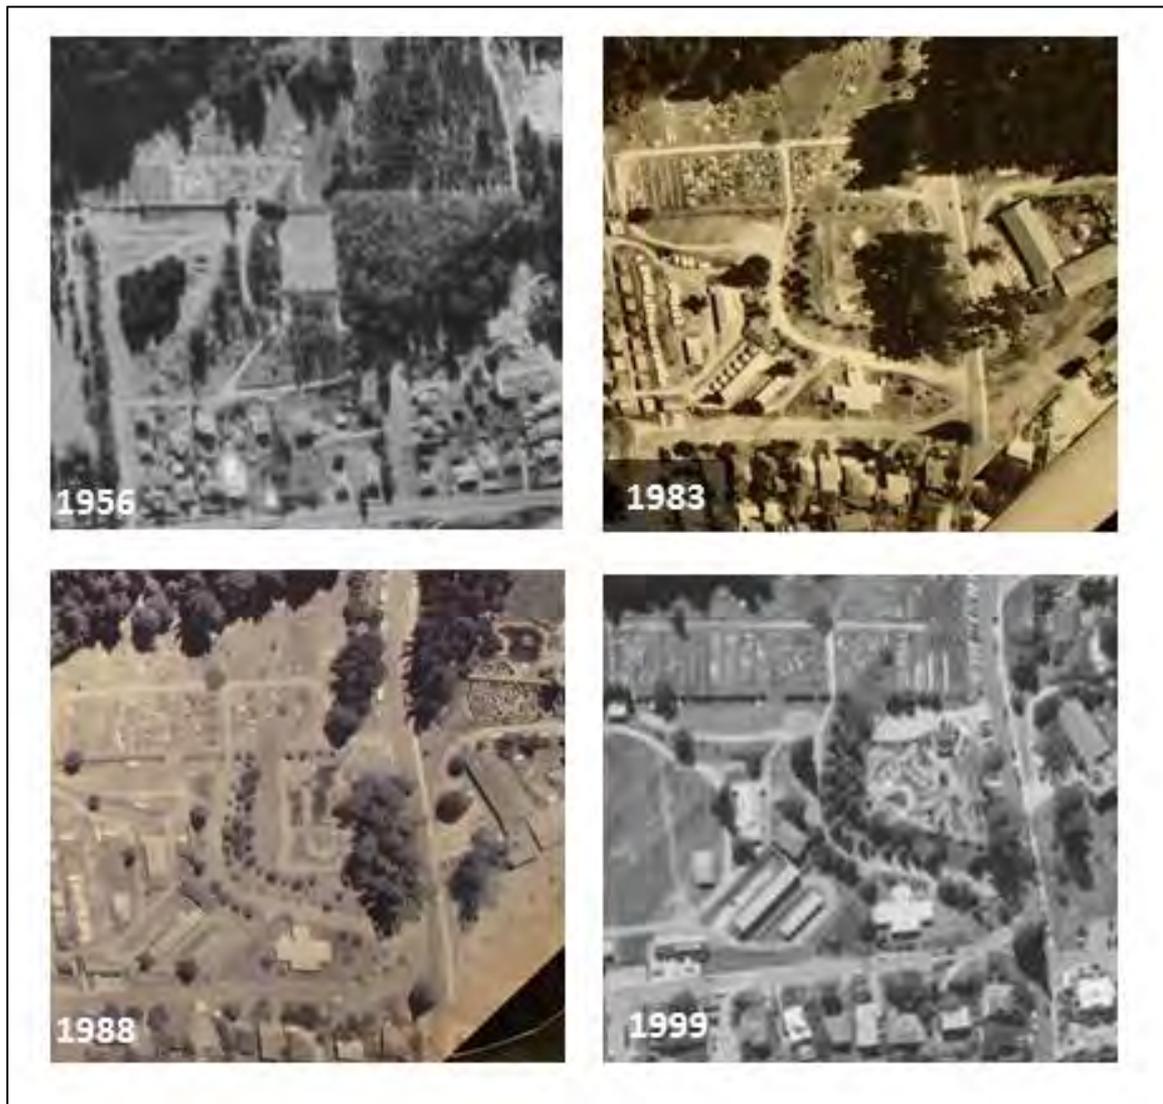
Historically, the land has been gazetted as recreation reserve administered by the District Council. Photos from the 1950's depict tennis courts and in the 1970's the site was converted to a bicycle motocross track. The site was developed into a mini golf course in the early 1990's. This succession of landuses can be seen in Figure 3.

Figure 3: Aerial photographs of the Brecon Street site from 1956 to 1999.

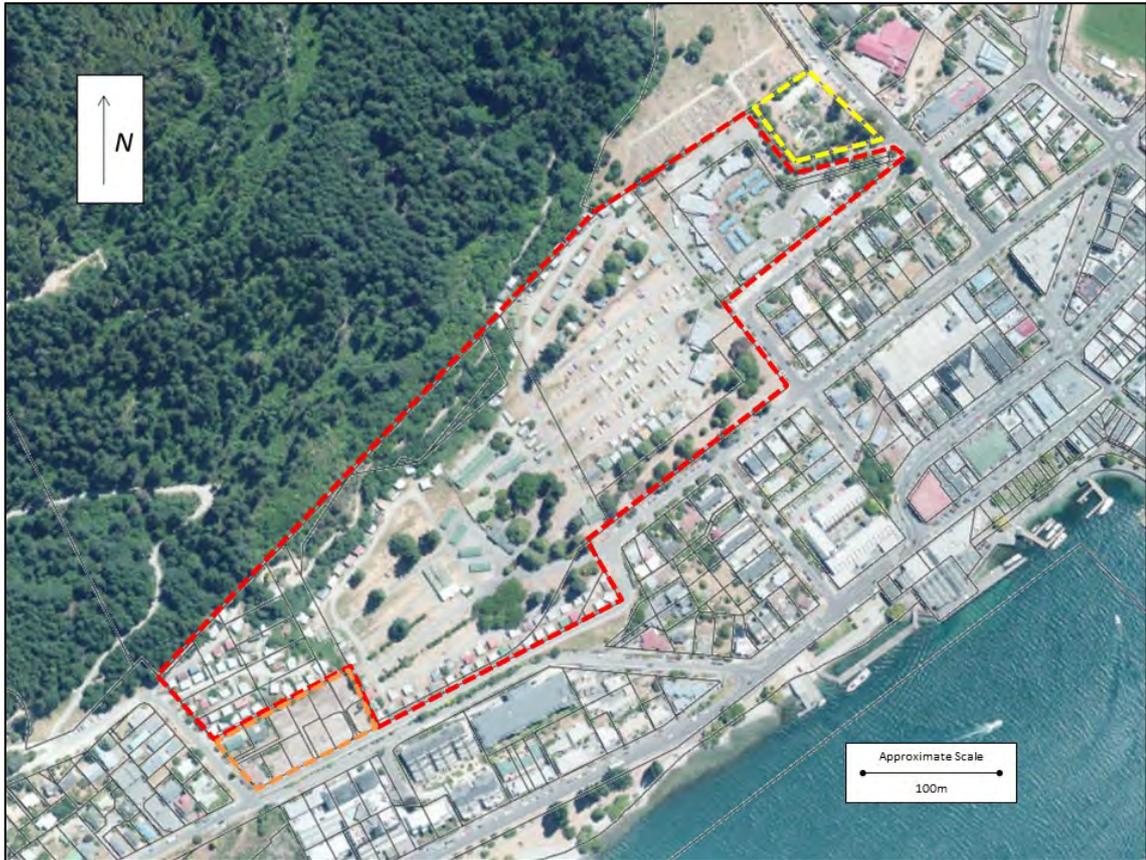
Figure 4: 2013 Aerial Photograph. 34 Brecon Street (yellow). Proposed Lakeview Sub-Zone council owned sub-blocks (red) and privately owned land (orange).

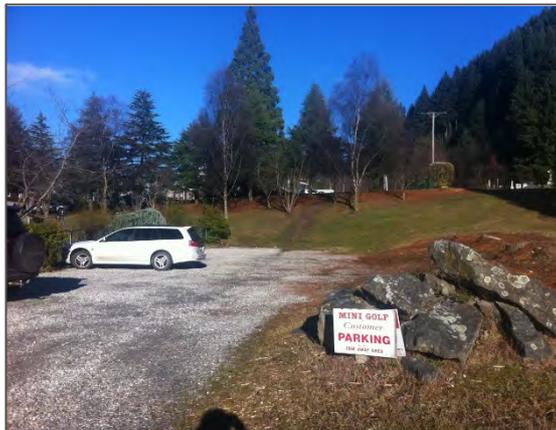
Plate 2: Mini golf carpark showing cemetery and powerlines in background

The cemetery can be seen in the background of Plate 2, beyond the mini golf carpark. The cemetery is approximately 20 meters from the mini golf fence and within several meters of the mini golf car park. There are no surface water features connecting the cemetery to the Brecon Street site and Hadley Consultants (2014)

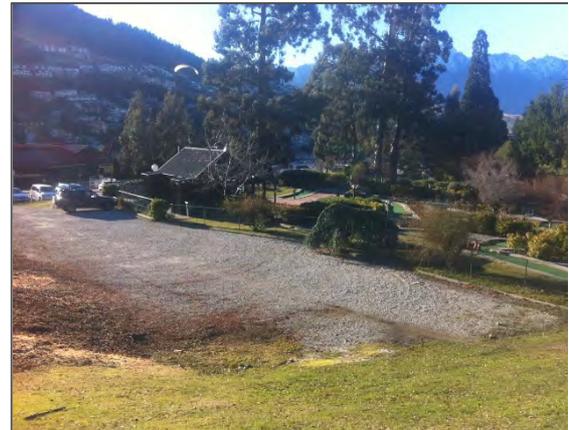
Plate 3: Mini golf carpark and kiosk building

Buildings and roadways observed within the project site were in good structural condition.

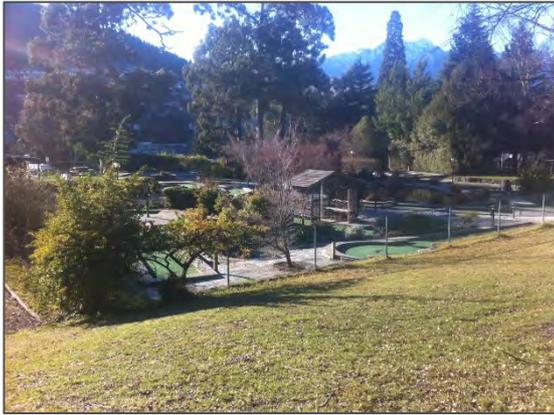
Plate 4: Mini golf course

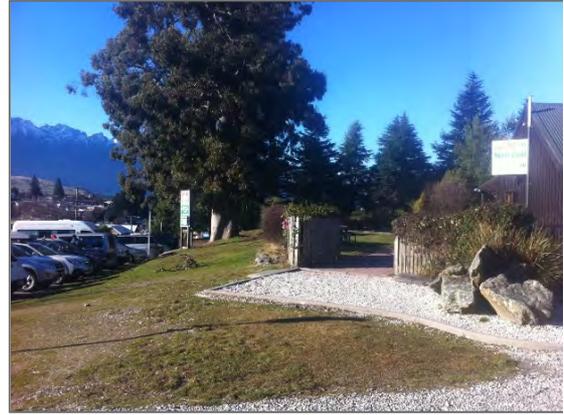
Plate 5: Mini golf course entrance

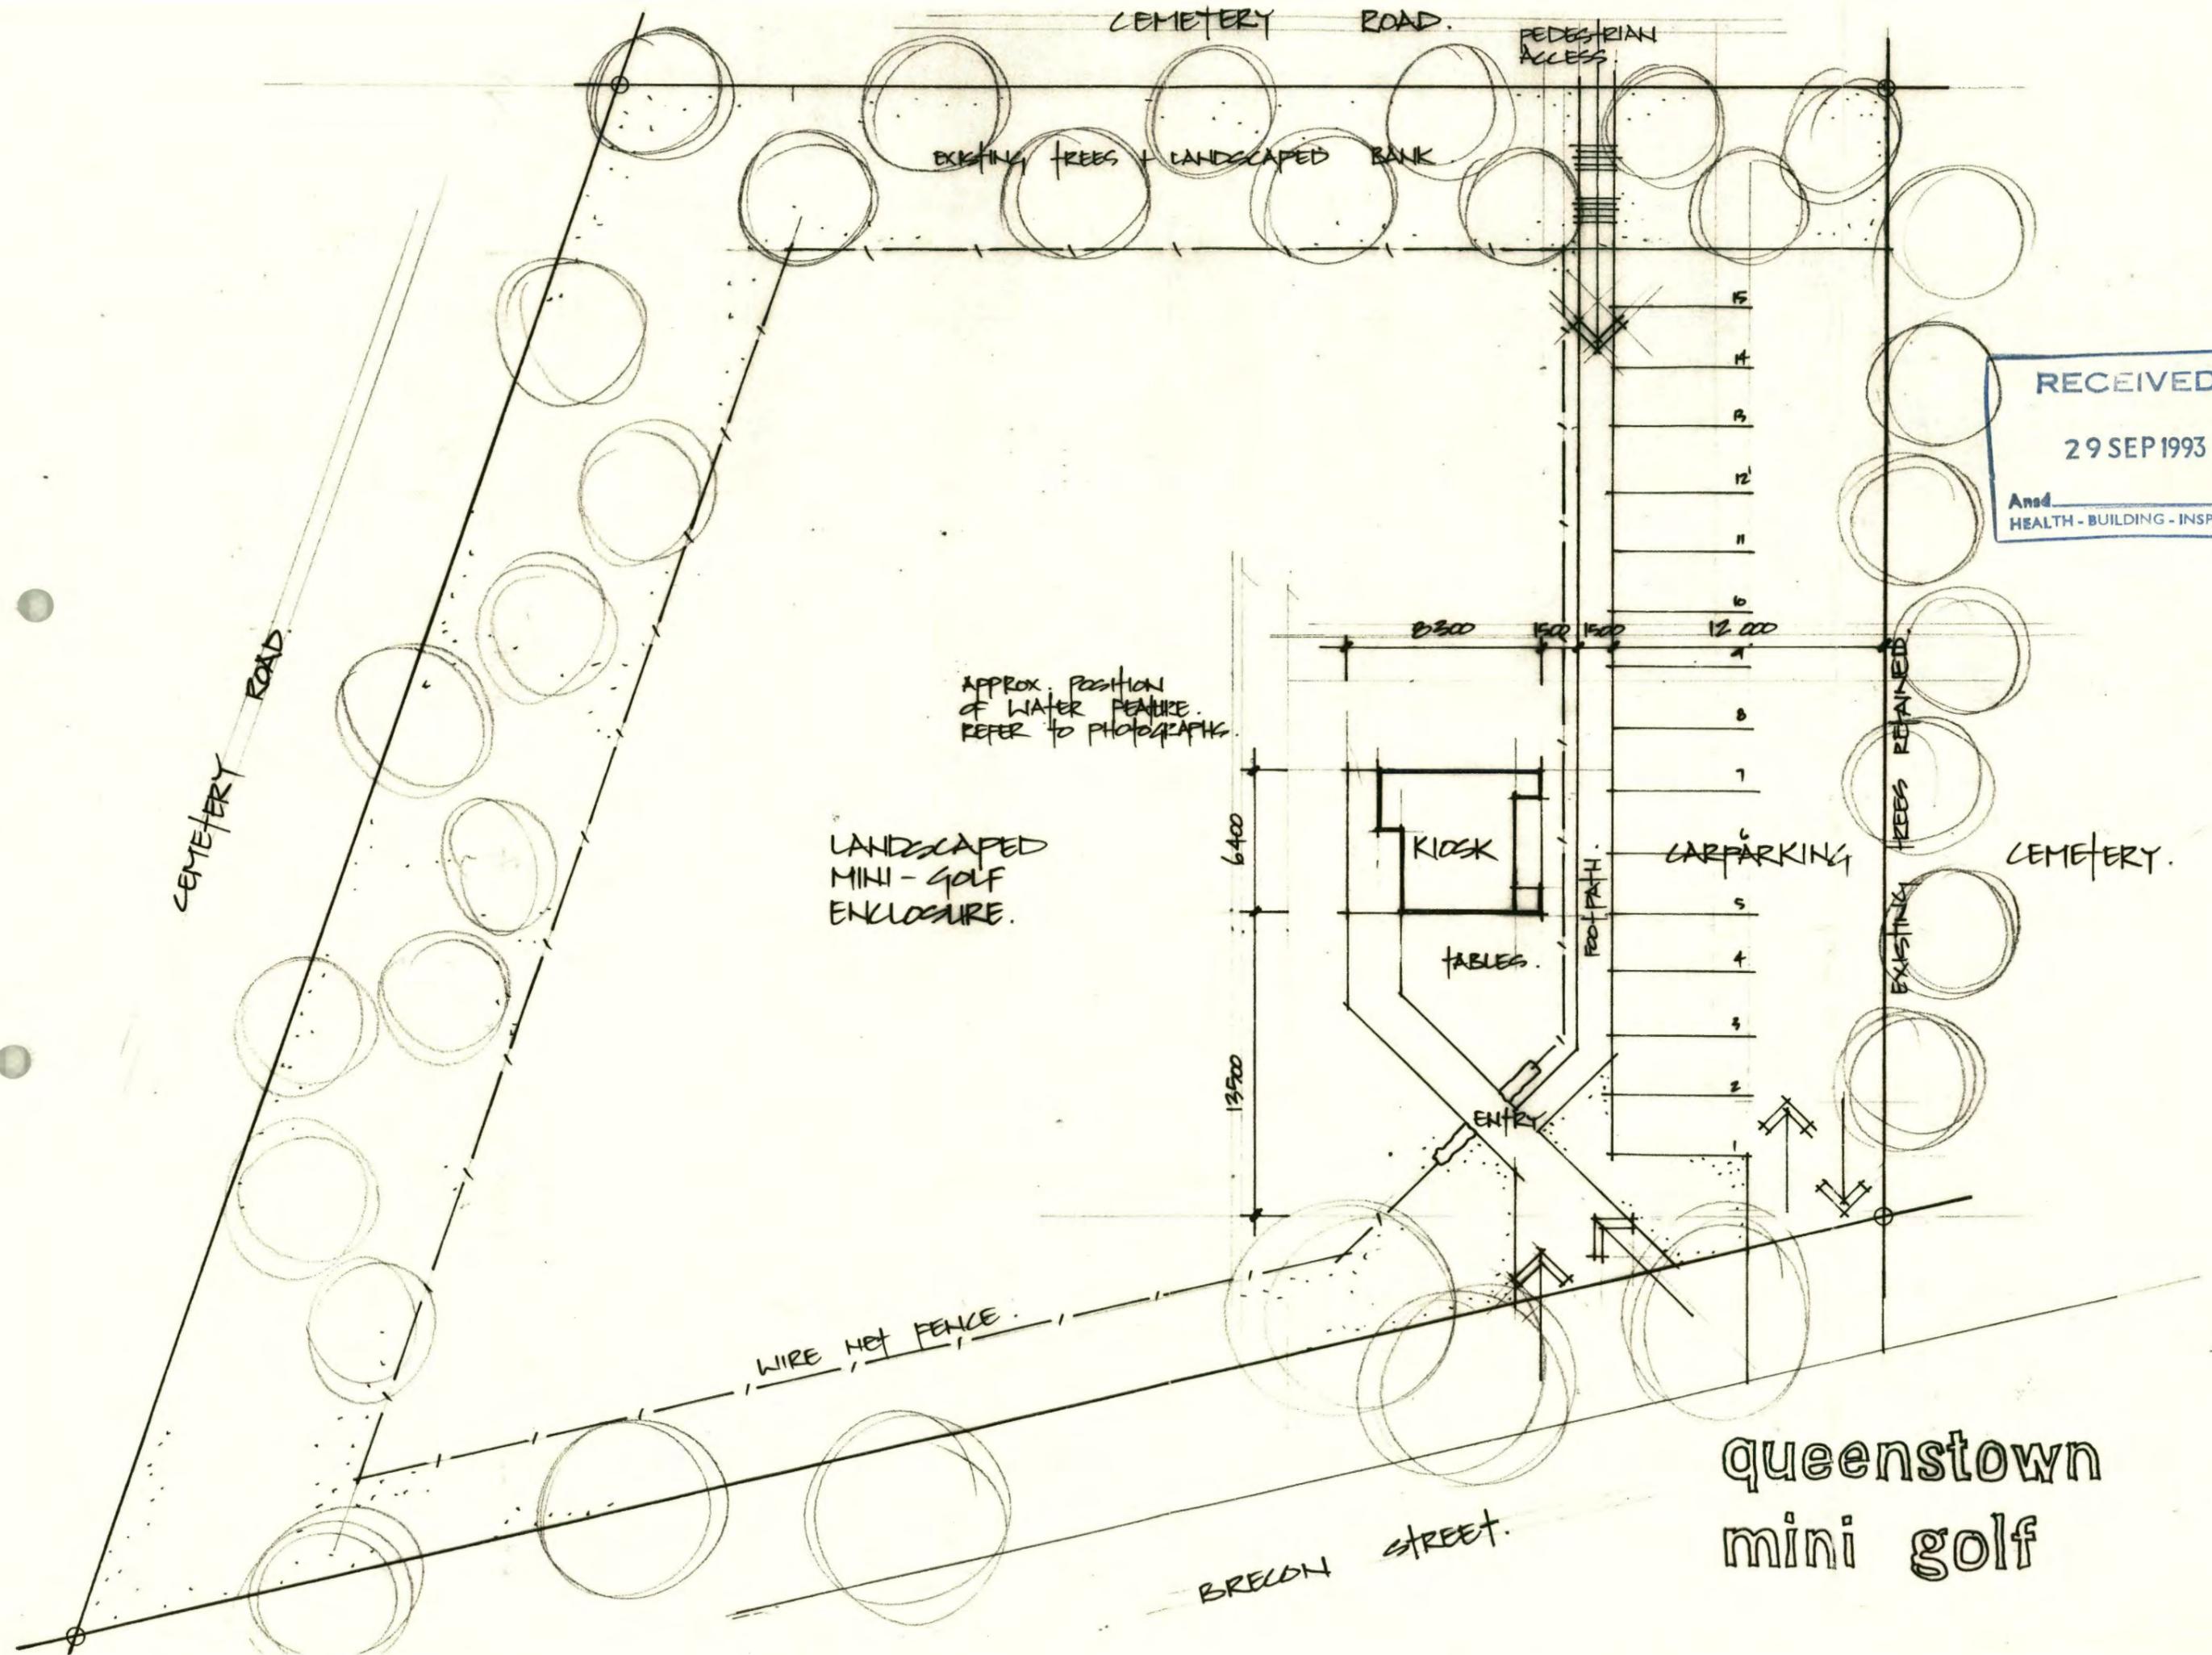
PROPOSED DRAINAGE PLAN

Sewage waste water is reticulated from the Kiosk ablutions to the mains sewage lines along Brecon Street as shown in plans included in Appendix B.

NEW SEWER CONNECTION
