# Geotechnical Hazards – Preliminary Assessment Proposed Mt Cardrona Station Private Plan Change

Brown and Company Planning Group

GeoSolve Ltd

October 2016

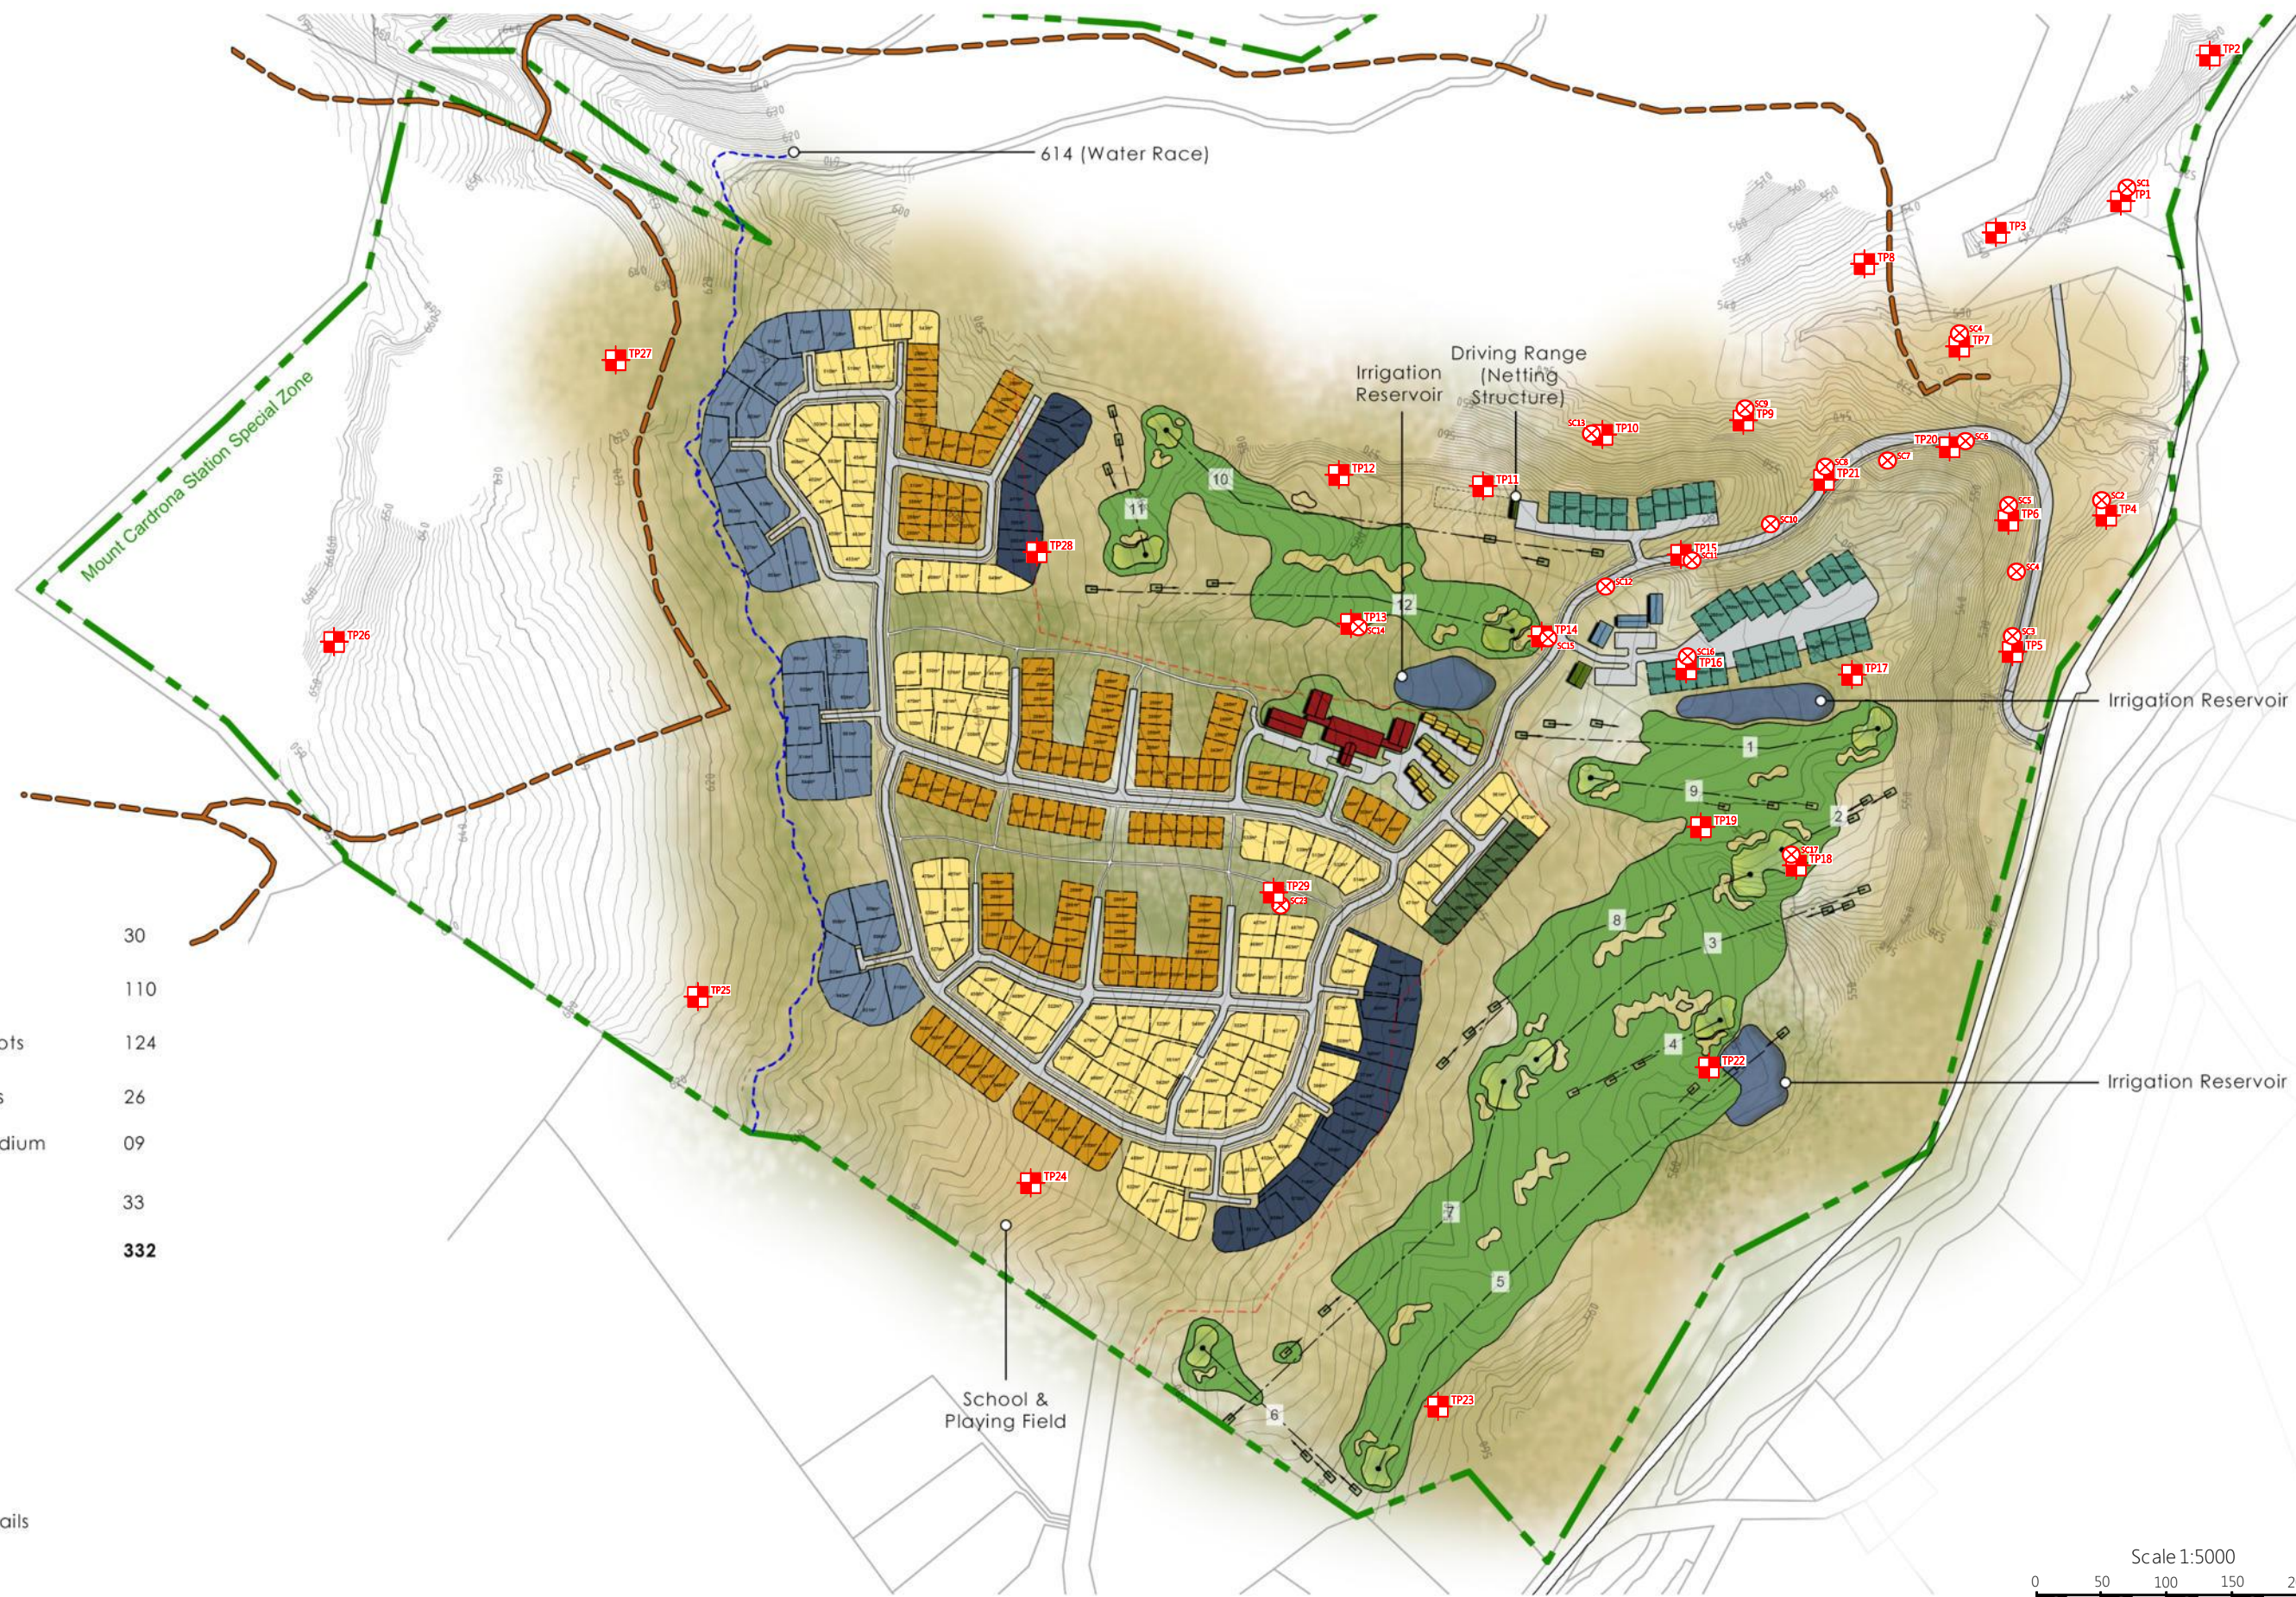
FIG No. Appendix A - Figure 1

Locations of test pits are shown in Figure 1, Appendix A. All test pit logs are contained in Appendix B.

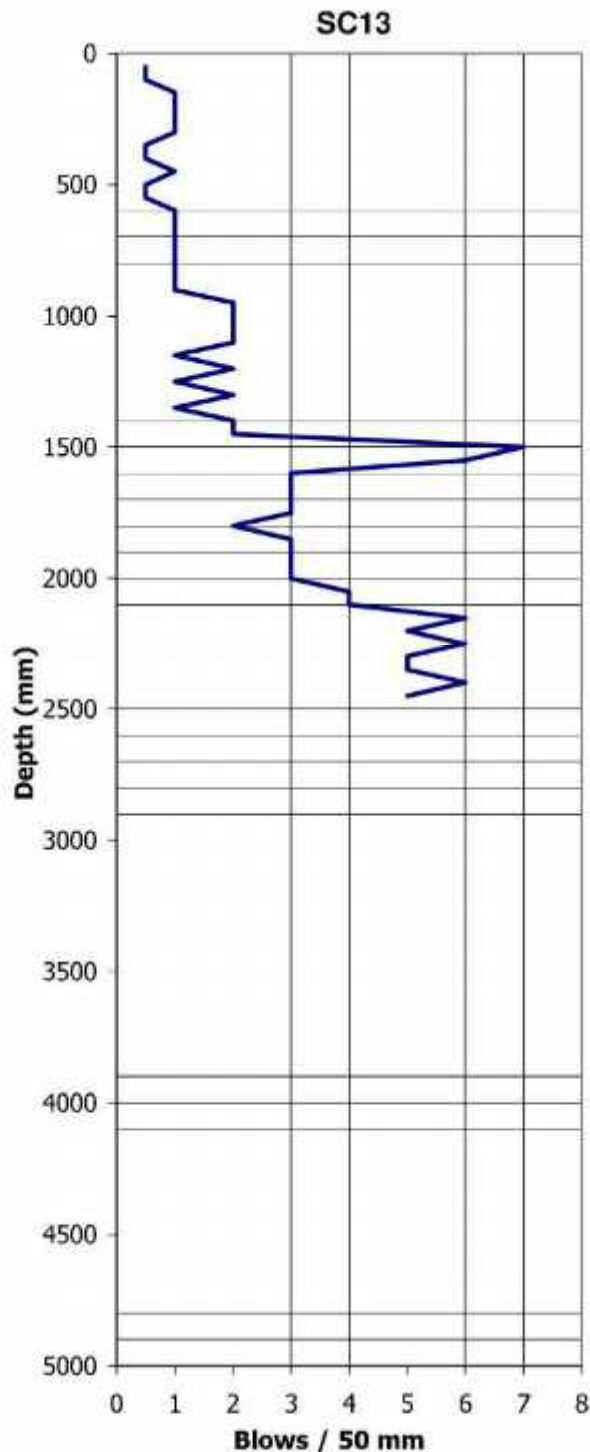
Job No: 160677  
Project: Mt Cardrona Station  
Location: Beside TP13  
RL: From Surface

Test Method Used: NZS 4402:1988 Test 6.5.2 Dynamic Cone Penetrometer

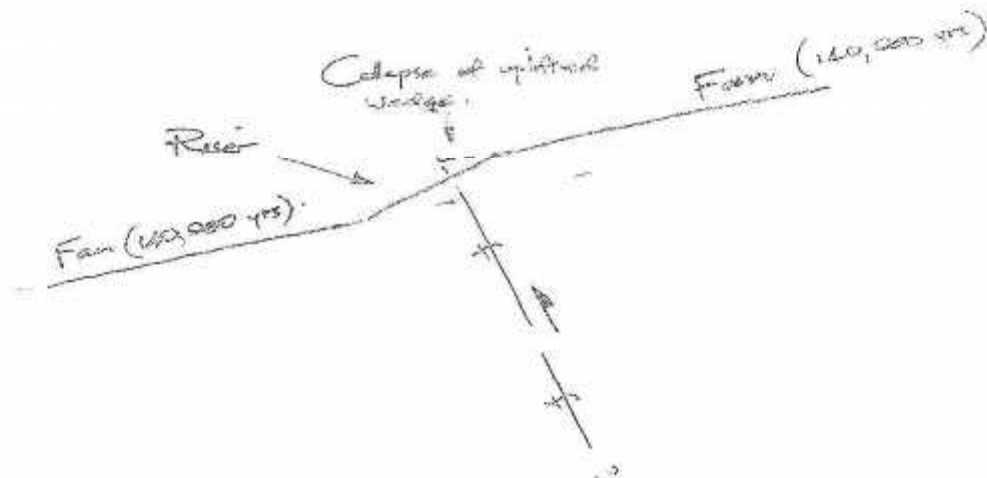
- The fault only dislocates the upper, prominent fan surface with an assessed 140,000 year age. A west-side-up displacement suggests reverse movement on a west-dipping plane.
- There is a prominent but eroded scarp on the Skifield Road at RL670 approximately (Photo 6).
- Across a gully, to the south of the road, a prominent, arcuate scarp is present which is also highlighted by springs. I suspect the arcuate nature is a function of stream incision and that the trace is on a line trending from the foreground in Photo 6.  
From contour profiling it is estimated the fault throw is about 10 – 15m. As indicated in the sketch below,

it is probable that the trace lies about at the centre of the fault riser; the initially uplifted margin of the western block would collapse then erode, to produce a debris apron on the downfaulted side.

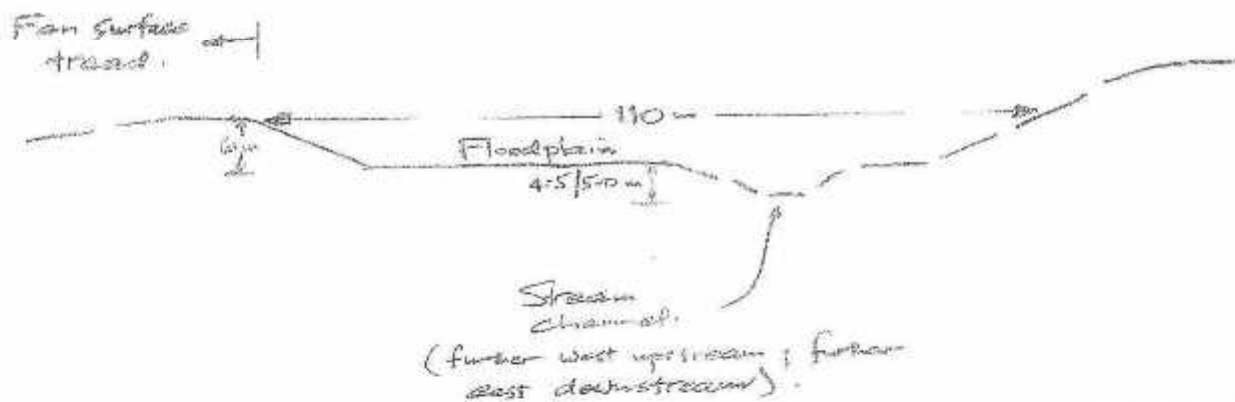
Section 1 Looking downstream  
Scale ca. 1:1000  
H = V.

The right margin, and marginal strip, of the fan is obviously a key feature in the overflow hazard scenario and I measured some sections, in a simple way, to illustrate channel geometries. An identified most susceptible left bank position was located just downstream from the fan apex (Section 1 on Fig. 3a) and a couple of other sections (Sections 2 and 3) were measured as well. It should be noted that the ORC Report Section 1130 corresponds closely with Section 1 while ORC 1020 and Section 3 are near each other.

- The deeply incised floodplain (6m below fan margin) and active stream channel (almost 5m below floodplain) on Section 1.
- Even more deeply incised profiles on Sections 2 and 3, relative to the fan margin.
- The large cross sectional area for each section below the level of the fan margin.
- On ORC Section 1130, a modelled 2m rise in fluid level in the stream channel during the peak flow for a worst case scenario involving a simultaneous rainstorm and dam break. When the overall channel dimensions are considered this is a negligible impact.
