Preliminary & Detailed Site Investigation

The Mt Cardrona Station Village

October 2016

*Davis Consulting Group Limited
11 Arrow Lane,
Arrowtown 9302
03 409 8664
Document ID:16109*

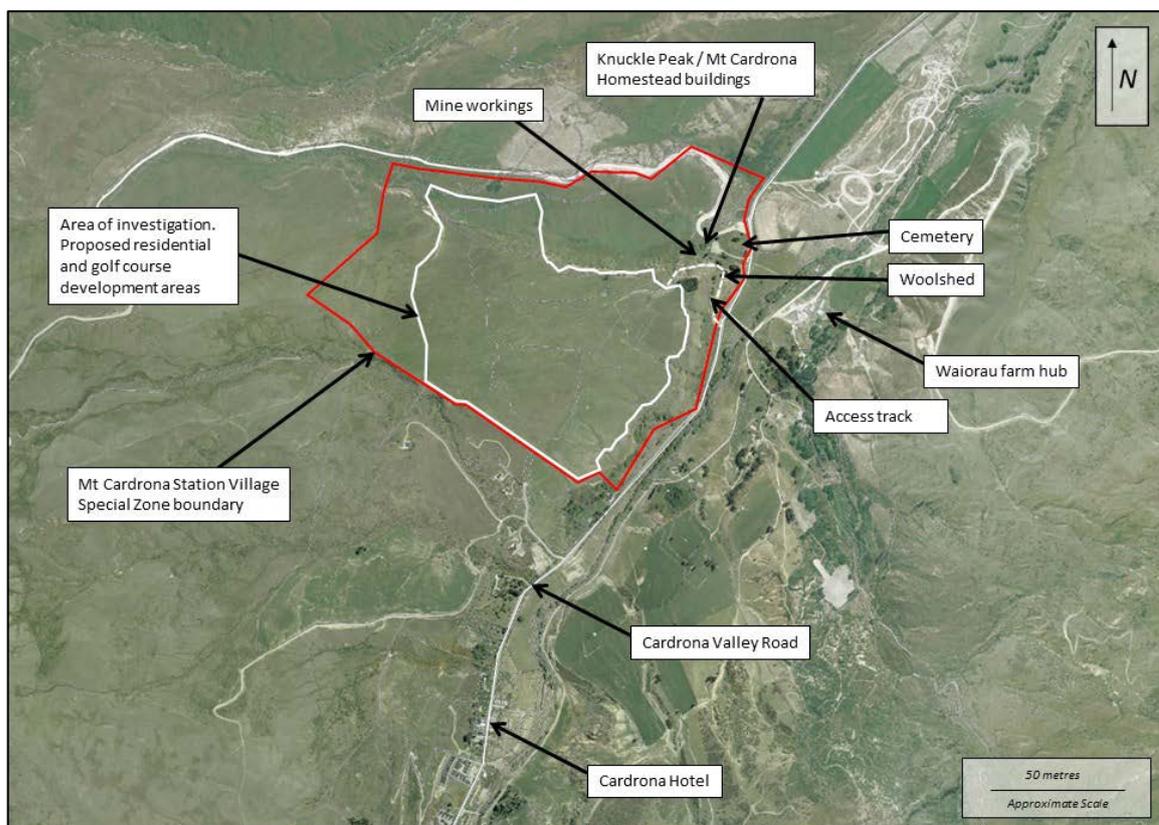
Figure 2: Site layout and surrounding land uses

The location of the homestead, mine workings, Cardrona Valley Road and Cardrona Cemetery relative to the study area are shown in Figure 2. These are all located outside the area of investigation.

Generally, pastoral land uses surround the site. To the south-west there are several residence along Pringles Creek Road. The Cardrona Valley Road runs along the base of the escarpment beyond the eastern boundary of the site. The Cardrona woolshed is located north-east of the site, along the access road (see Figure 2). At the time of the site investigation, this woolshed was operating as an office for horse riding tours operating across the station. The closed Cardrona Cemetery, Mt Cardrona Station homestead and associated buildings are located to the north-east of the study area, north of the access road at the base of the escarpment (see Plate 2 and Figure 2). At the time of investigation, the storage sheds and land surrounding were being used as offices and storage for non-hazardous materials. Several horses were maintained in a fenced paddock. The Cardrona cemetery is closed and is presently maintained as a heritage site. Some of the rubble from the destroyed Mt Cardrona Station homestead was still present. Material within the rubble included cement board, charred wood, iron and concrete. A closed septic system remained adjacent the rubble from the homestead (see Figure 2).

A small abandoned mine tunnel was observed within the escarpment, south of the Cardrona homestead (see Figure 2).

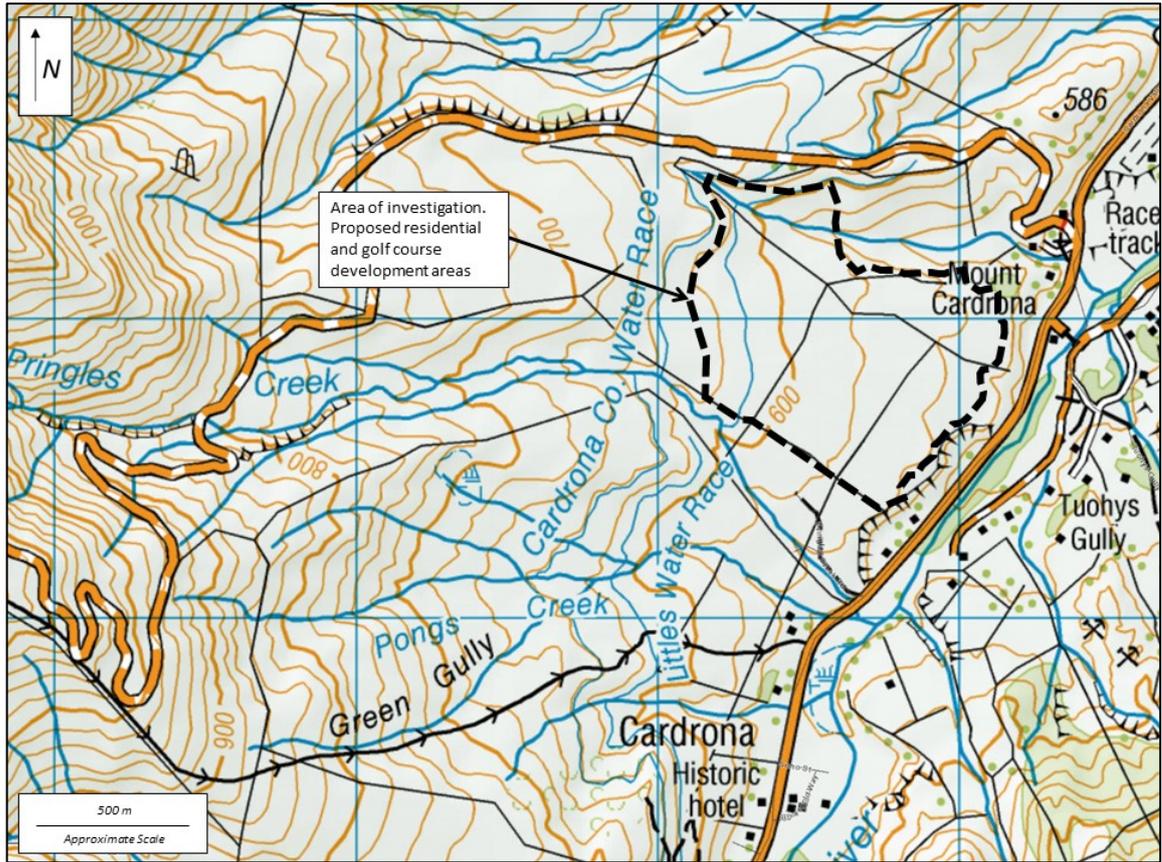
Figure 3: Topography of the project area

The area investigated for the Mt Cardrona Station Village residence and golf course sites is located on the Mt Cardrona Station Village Terrace, an alluvial fan surface, gently sloping downward to the south-east (see Plate 1). The topography of the site is shown in Figure 3. An escarpment runs along the south-eastern boundary of the site with land dropping steeply toward the Cardrona Valley Road. The Littles Water Race runs along the north-western boundary of the site. The south eastern boundary of the site is aligned with Pringles Creek, flowing south-east toward the Cardrona River. The northern boundary of the site is also aligned with a south-easterly flowing ephemeral water course.

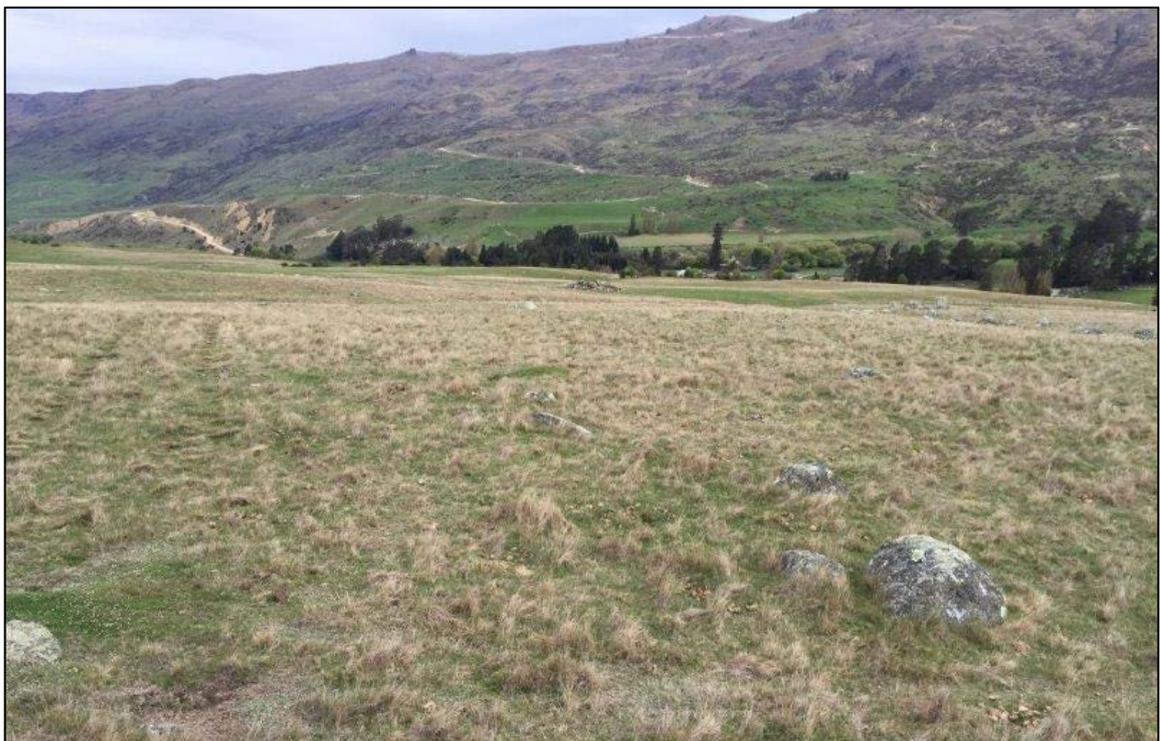
Plate 1: View of the site, looking north-east

At the time of investigation, the site was under pasture and fenced into several paddocks. The land was being used for horse trekking tours. No waste or fill material was observed within the study area.

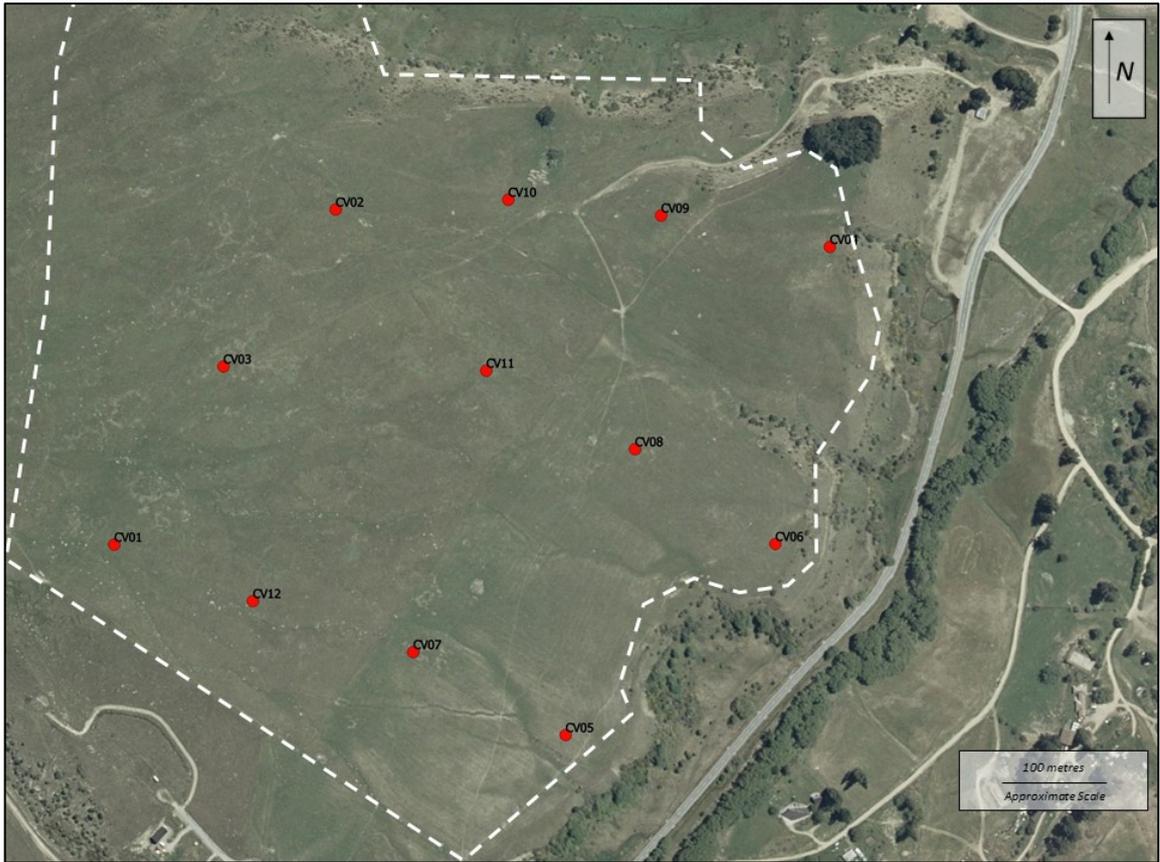
Figure 4: Sample locations

A total of 12 surface samples (0-0.1m) were collected across the site. Samples were submitted to the laboratory to be analysed as composites of 3 samples. The locations of soil samples collected across the site are presented in Figure 4 and a summary of soil samples and analysis is provided in Table 1.

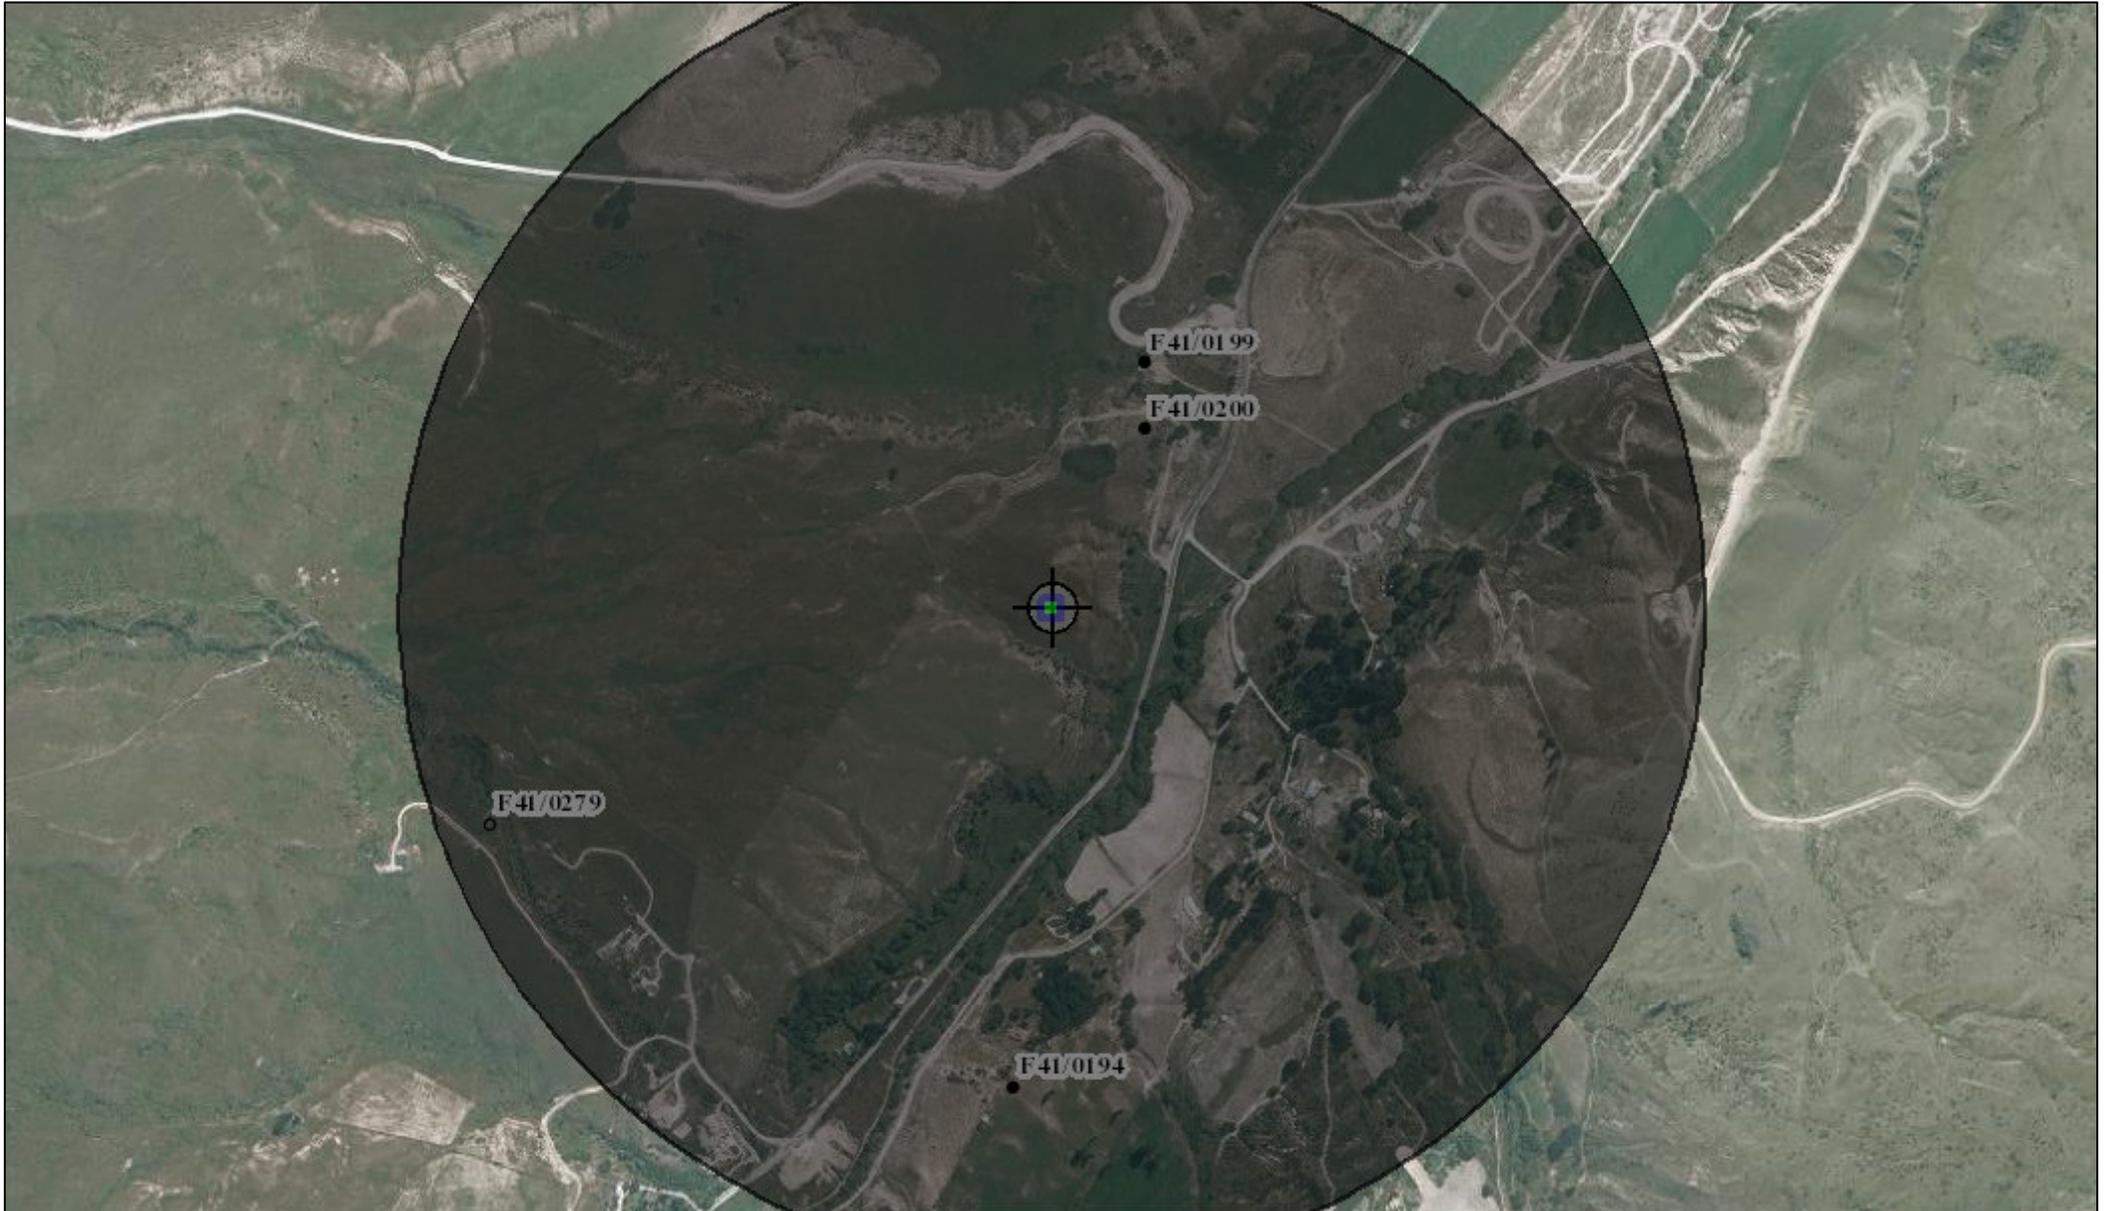
Cardrona Bore Search

The site investigation did not include a groundwater assessment. ORC holds records for 4 wells located within 1 km of the subject site. A total of 4 bores have been drilled within one kilometre of the site. The location of bores is provided in Appendix B. Bore uses are recorded as 3 for domestic use and 1 for scheme water.
