Natural Hazards at Makarora

April 2007

**Otago Regional Council
Private Bag 1954
70 Stafford Street
Dunedin**

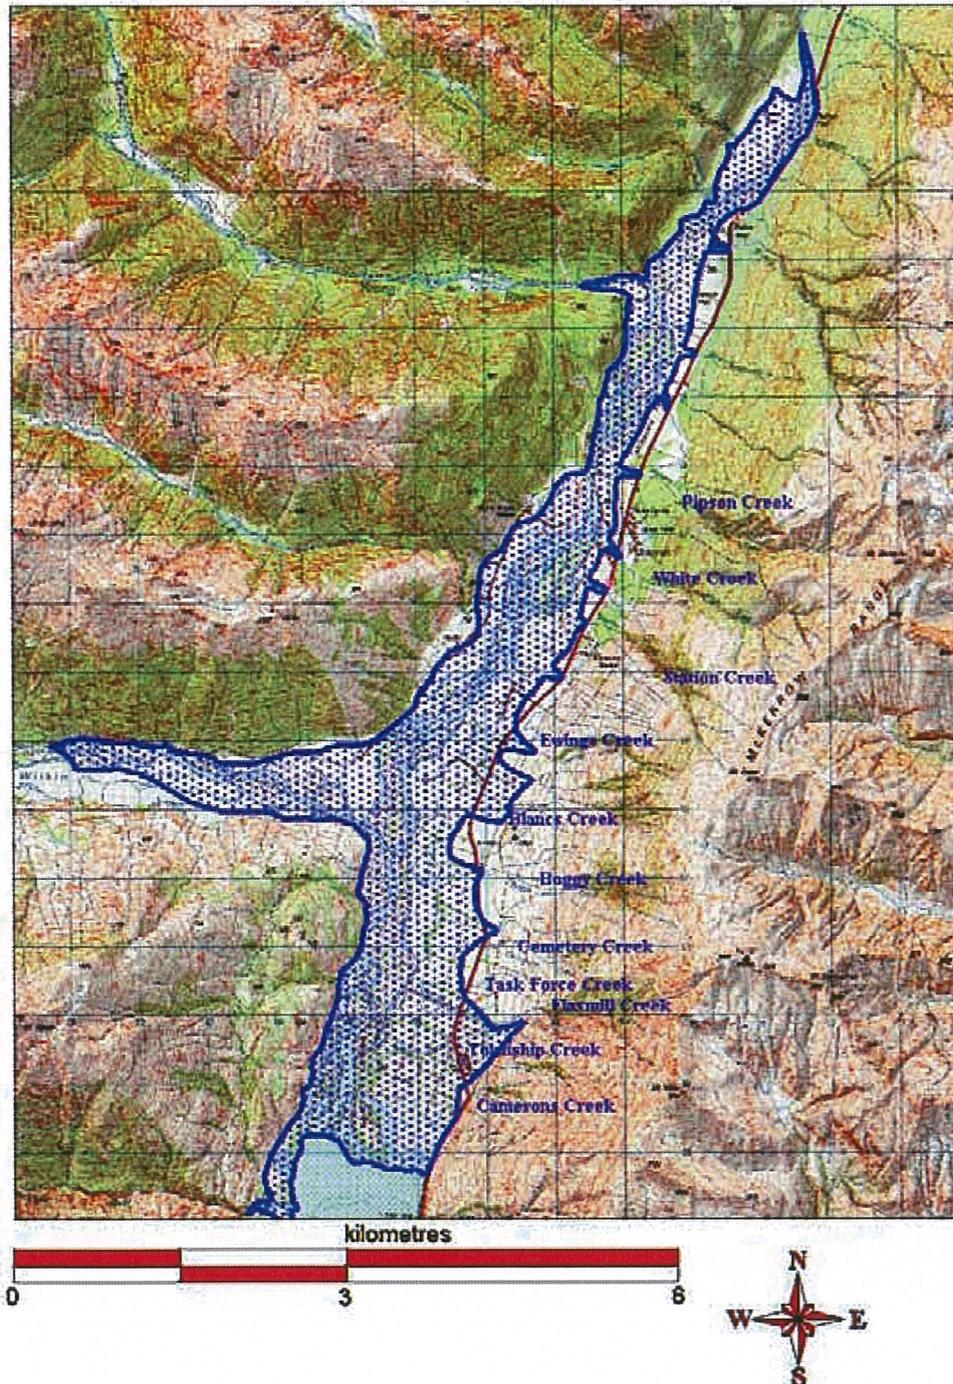
Figure 2: Area of Makarora valley potentially subject to flood hazards (ORC, 1999).

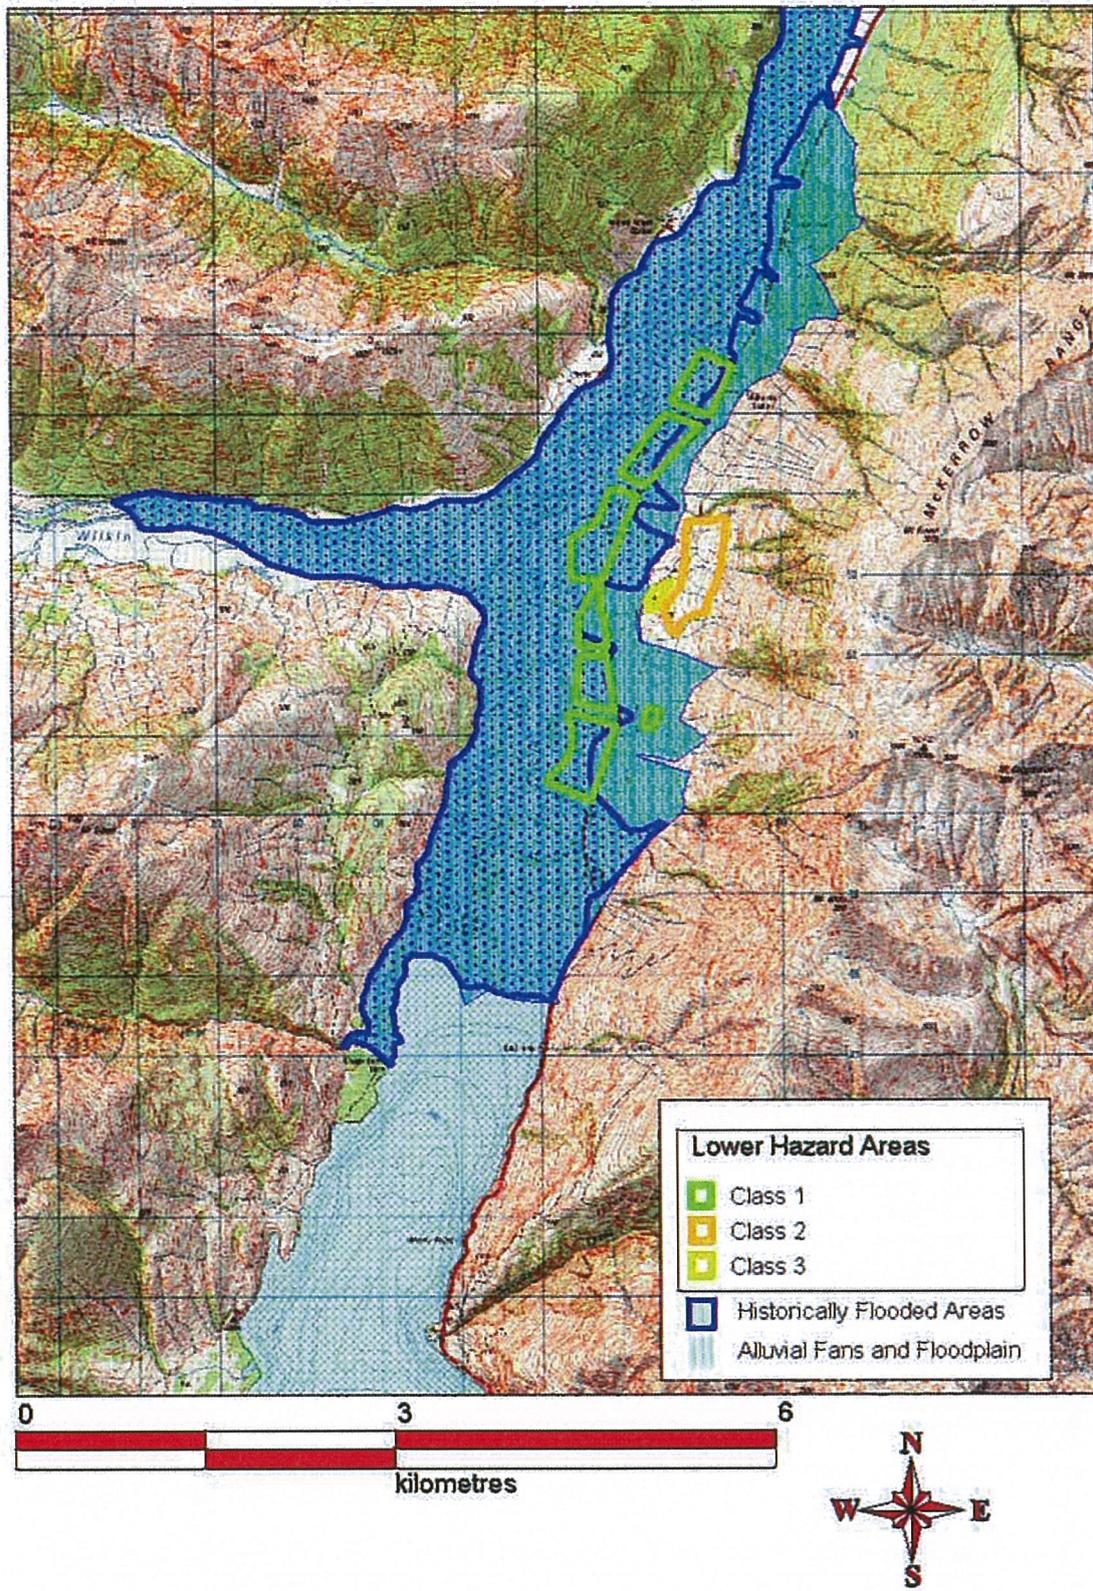
Figure 6: Combined flood and alluvial fan hazards, with lower hazard areas, Makarora valley.

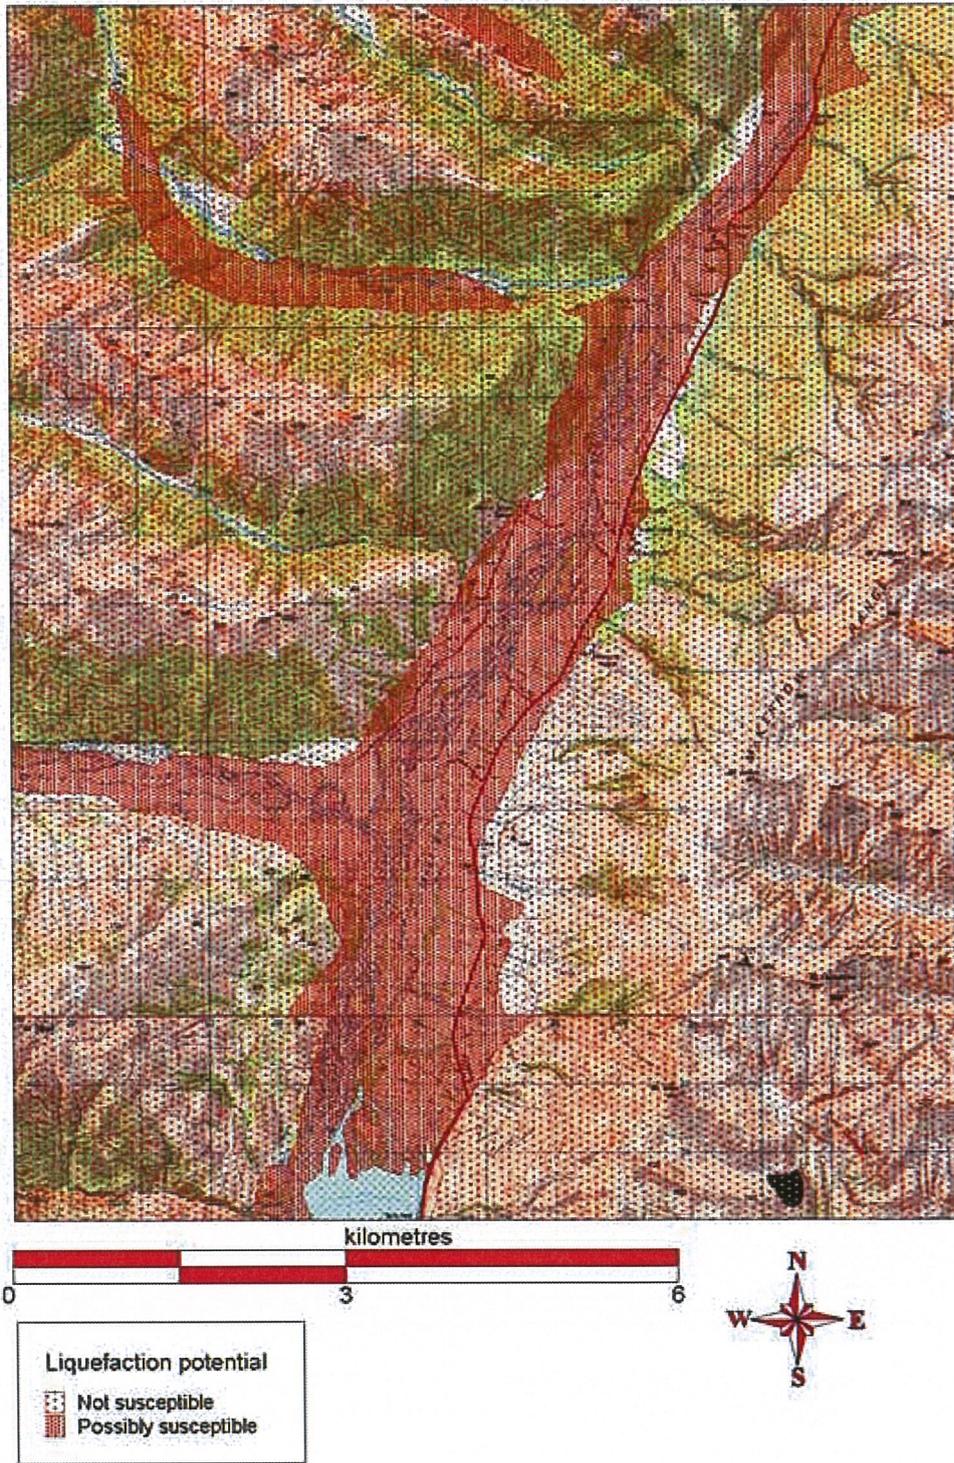
Figure 8: Land possibly susceptible to liquefaction induced by seismic shaking.

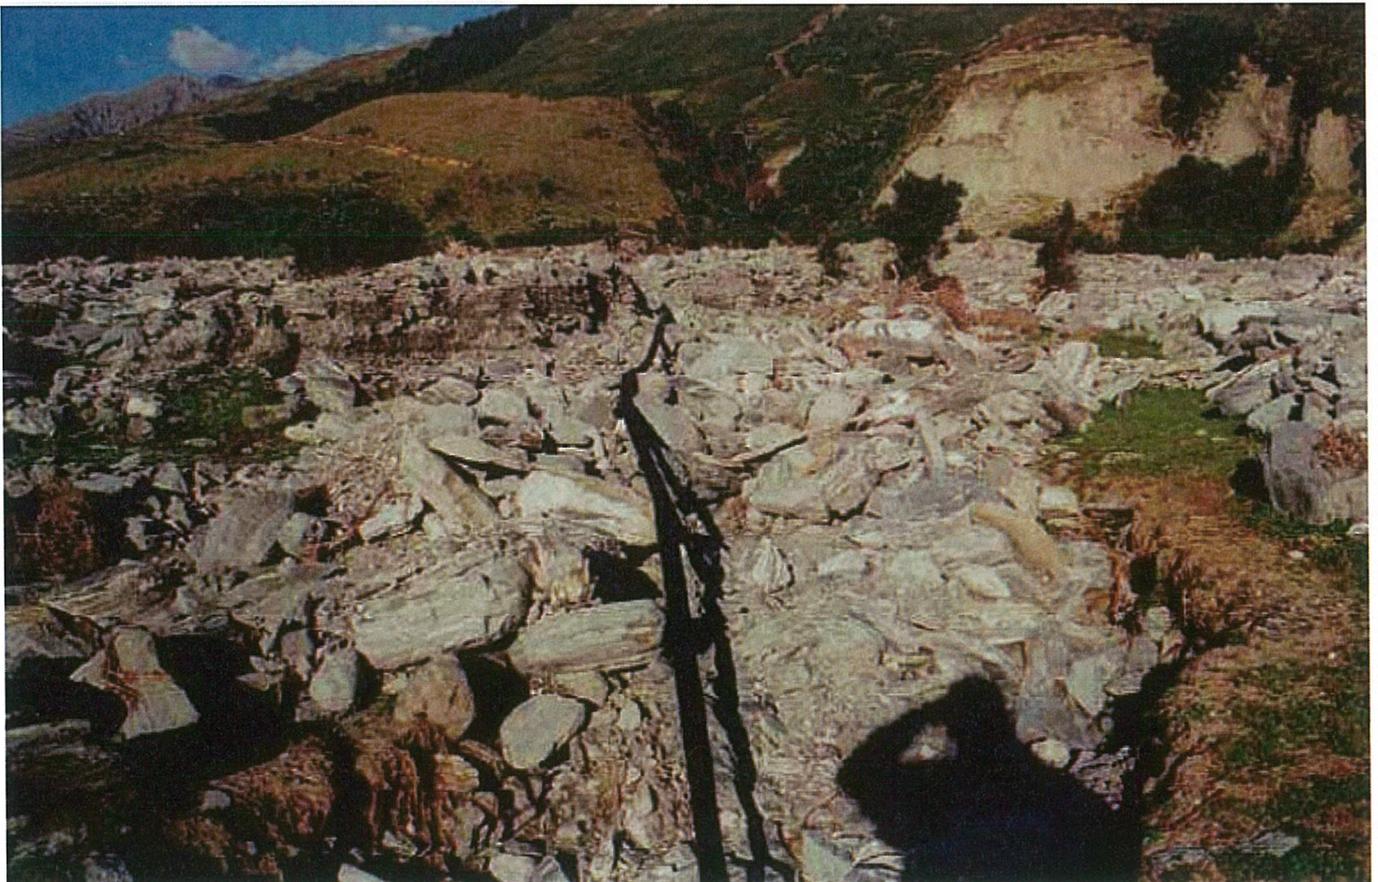
Figure 24: Water pipeline to intake, Ewings Creek (1994).

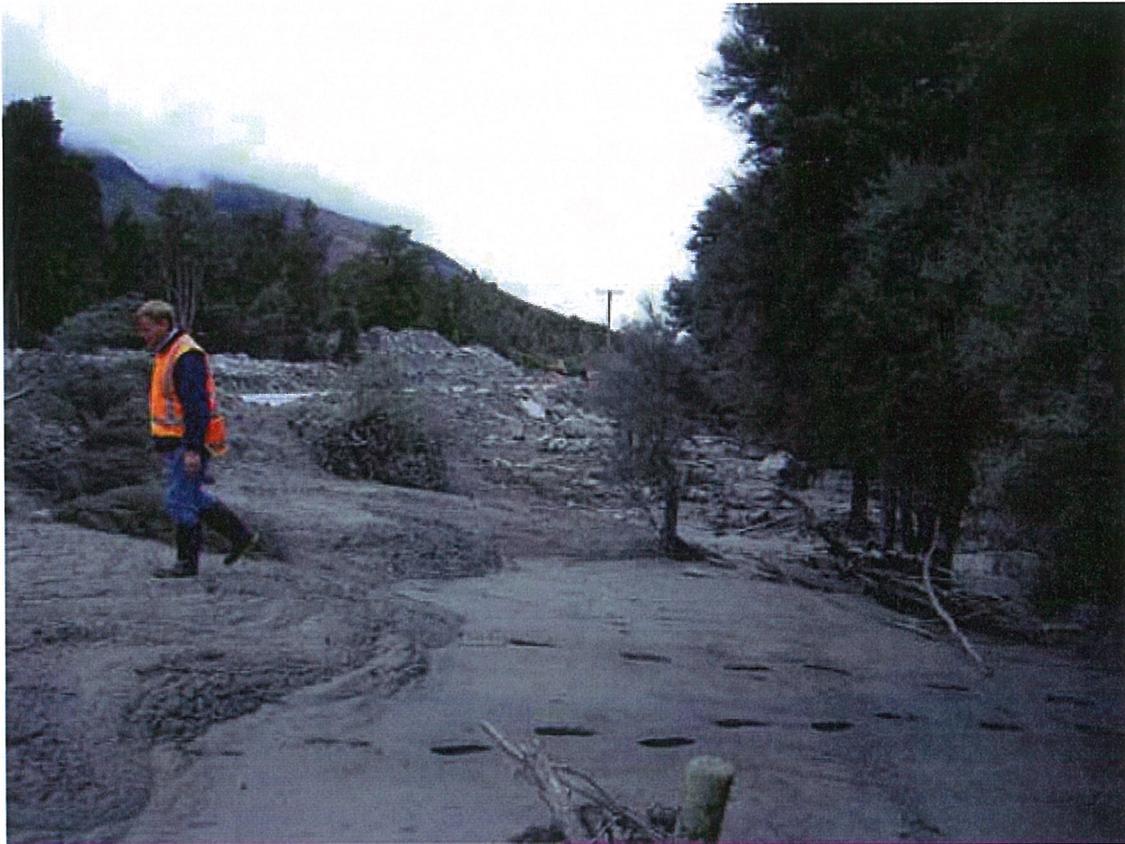
Figure 27: Debris on true right of Pipson Creek at SH6, showing depth of flows during 2006 event.

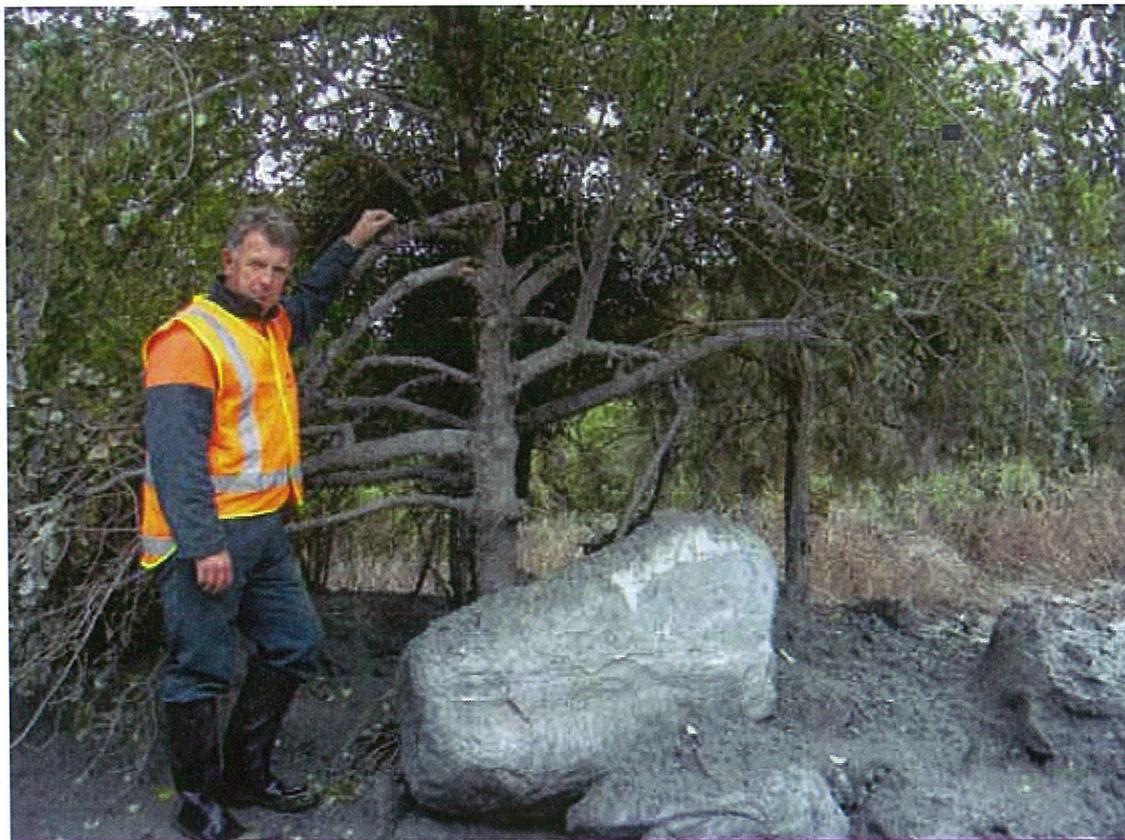
Figure 28: Pipson Creek flow depths following 2006 event. Figure's hand is at maximum depth of debris flow. Rock in foreground was deposited during flow. Approximately 150 m upstream of SH6 on true right.

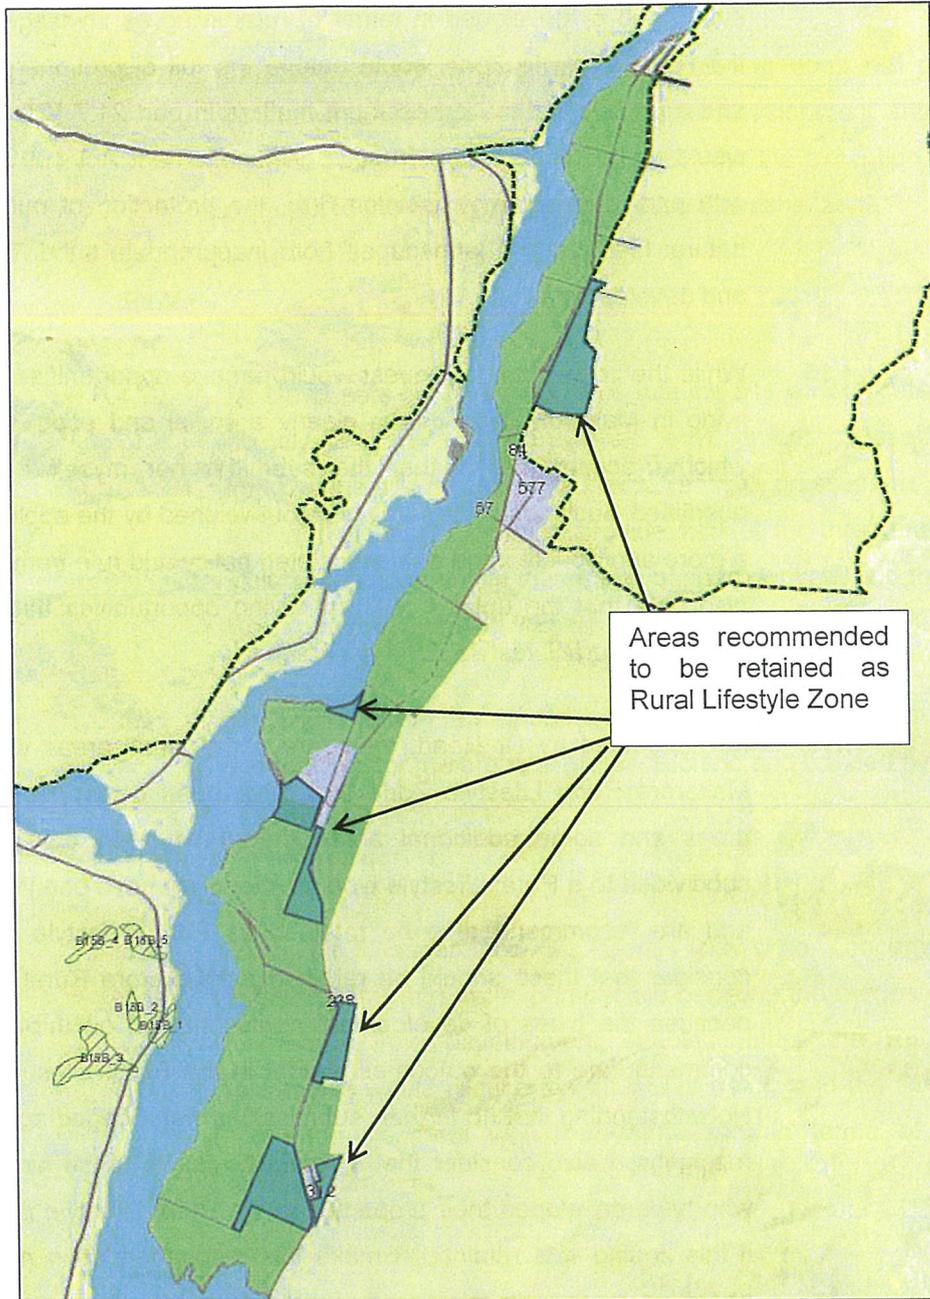
Figure 1. Areas outlined by dark green shading that are recommended to be retained Rural Lifestyle Zone. The remaining light green areas illustrate the notified PDP Rural Lifestyle Zone, all of which are recommended to be rezoned to Rural.

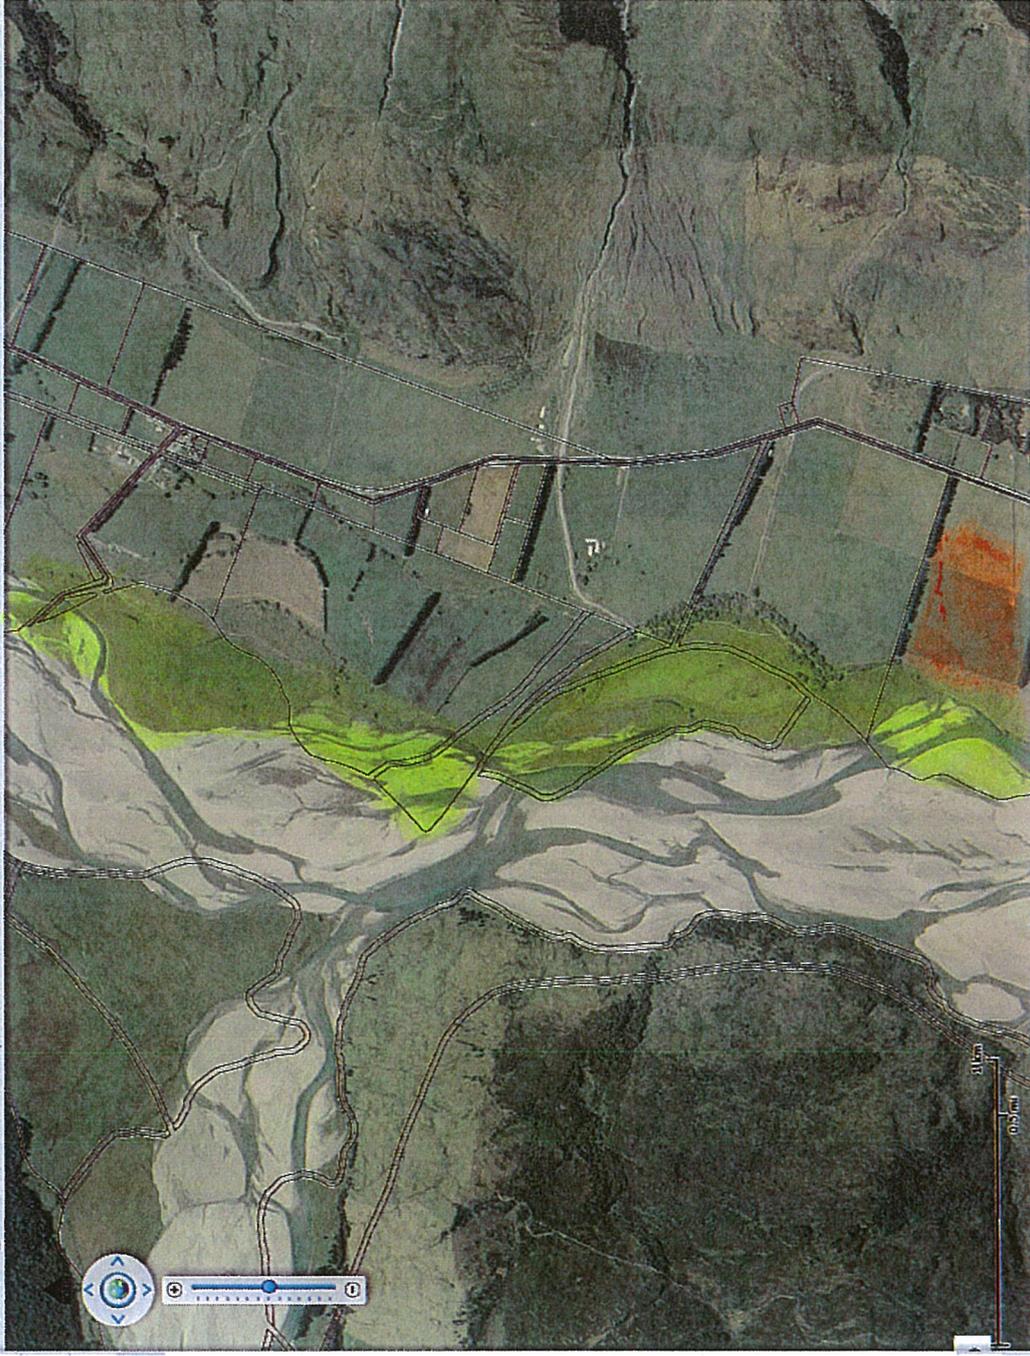
Orange area is flooded area shown in New's photo - after just 4" of rain (a fairly common event in Makarora where annual rainfall is approx. 120"/year).
