Archaeological Report
Prepared by Southern Archaeology Limited

Archæological Survey & Assessment of
Gibbston Valley Station Property
Gibbston Flat
Queenstown Lakes District

P.G. Petchey
Southern Archæology

2008

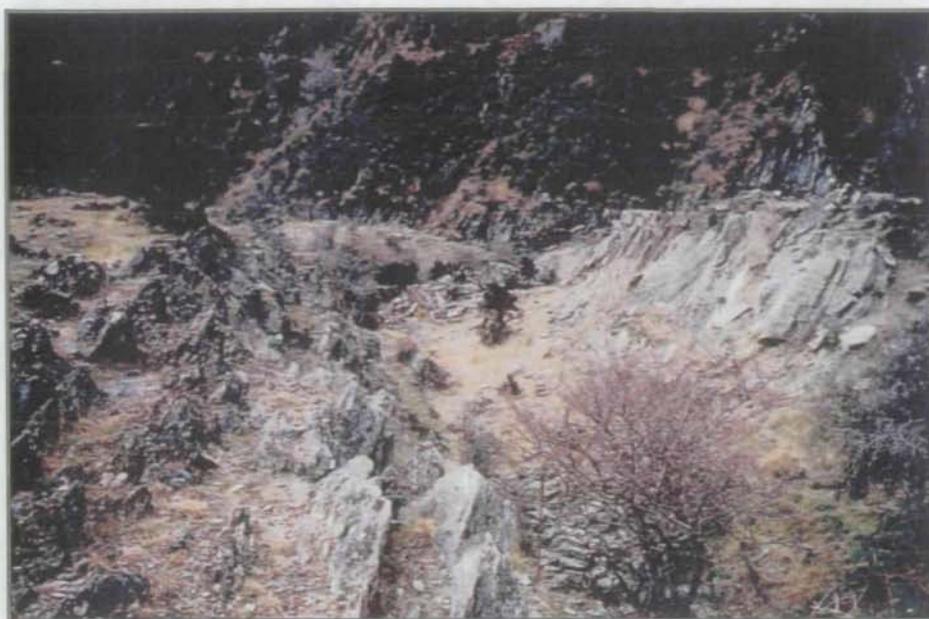
Figure 2
Exposed schist bedrock in the main area of goldworkings at site F41/274, showing the dip to the southwest.

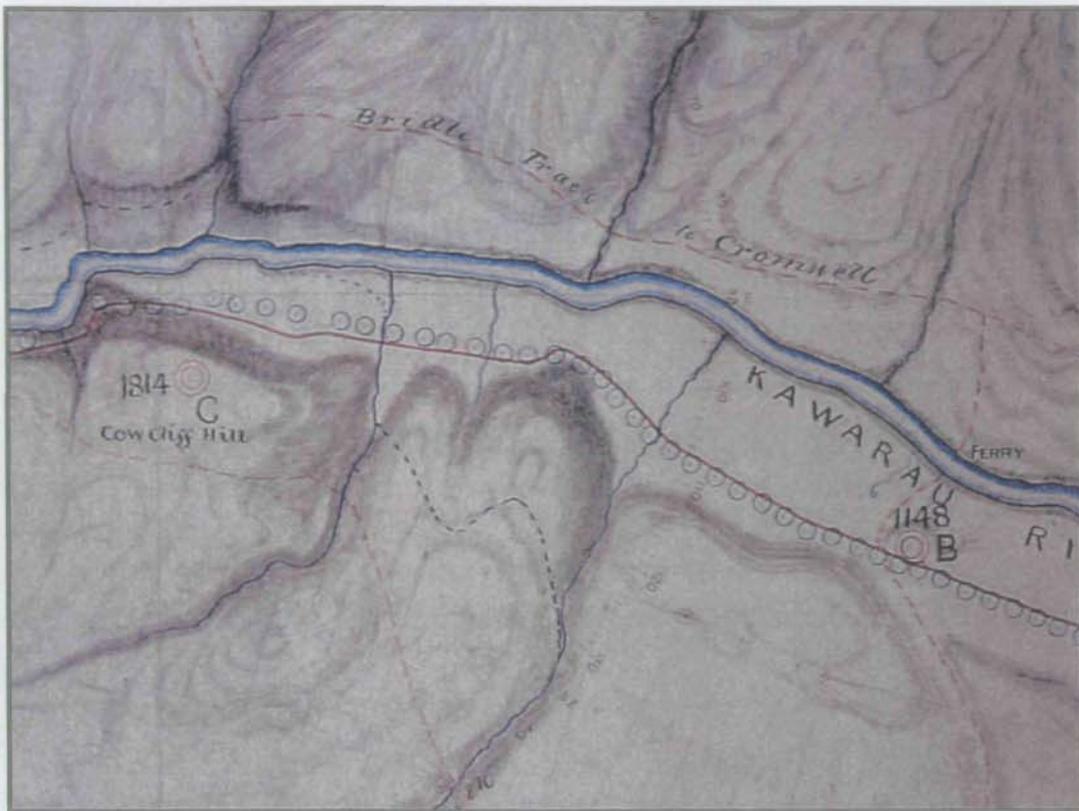
Figure 3

Part of the 1867 Sketch of Part of Kawarau District (S.O. 4630). The Gibbston Valley Station property runs approximately between Trigs C and B. Note the old track to Cromwell on the northern bank of the river, and the new road across the Gibbston Flats to the south of the river. This route is still in use as State Highway 6. Also note the ferry marked just north of Trig B, of which little trace or record survives.

The schist gable walls of the main hut site (site F41/269) are still standing, but the structure shows sign of movement, and the end walls are bulging. The hut measures 4.9 metres by 4 metres, and stands 2.5 metres high (Figure 19). It is possible that this hut was associated with the ferry or wire crossing of the Kawarau River at this point, as shown on an 1867 map (see Figure 3).

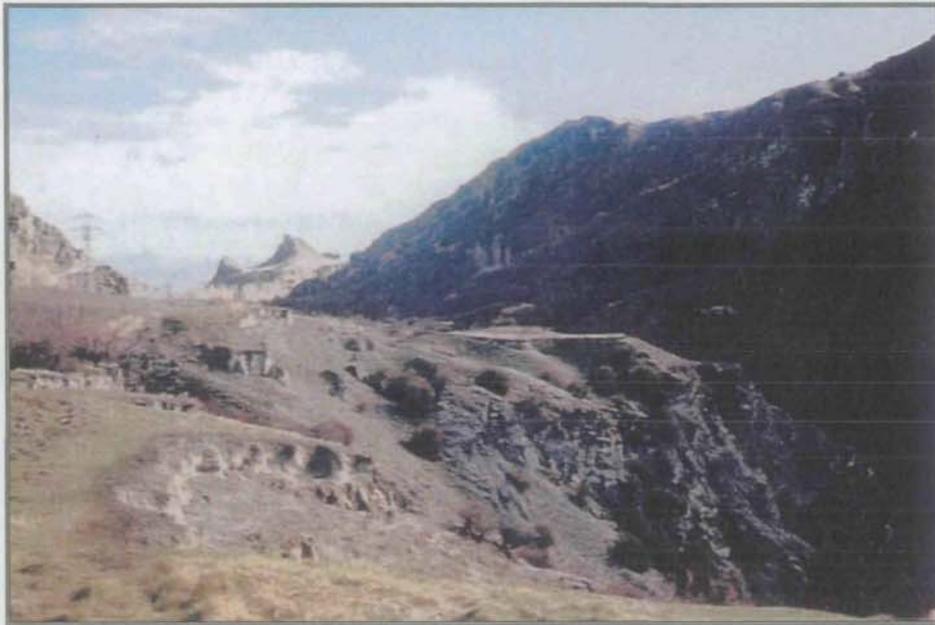
Figure 5

Looking towards the west, showing the terrace edge of the western end of the Gibbston Valley Station property. Some small scale gold prospecting or working has occurred here.

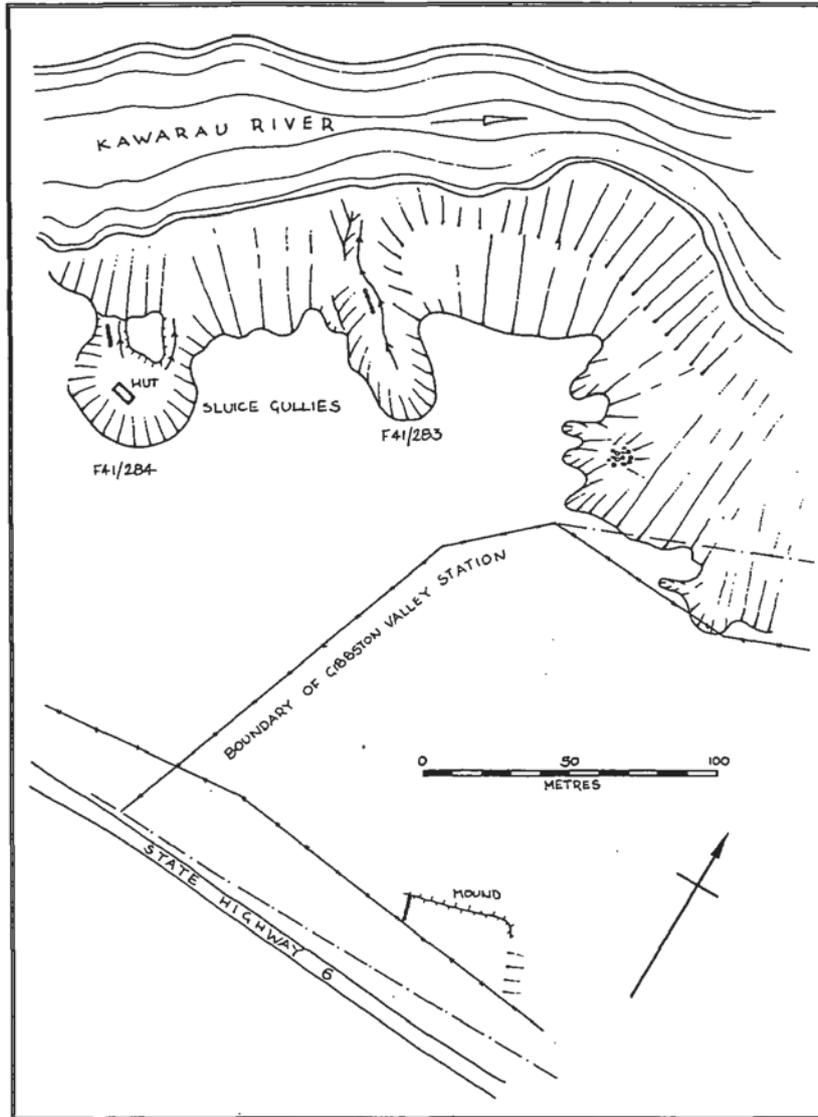
Map 1

The western end of the property, showing the two recorded archaeological sites on the neighbouring property, immediately to the west of Gibbston Valley Station. Note the small area of tailings just to the north of the curve in the boundary.

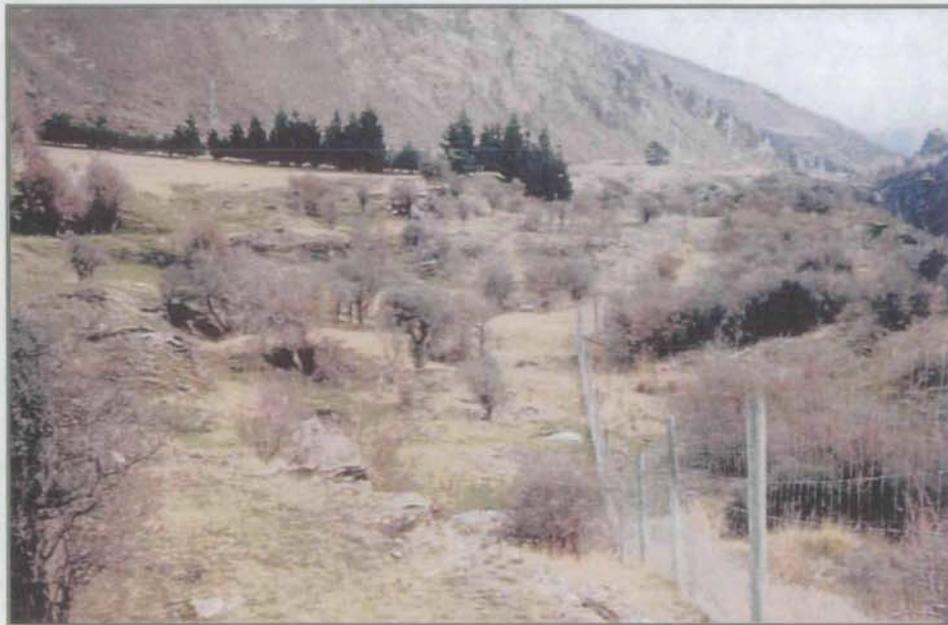
Figure 6

Shallow gold workings (site F41/607) on the east side of the creek (the creek gully is beyond the conifers in the middle distance).

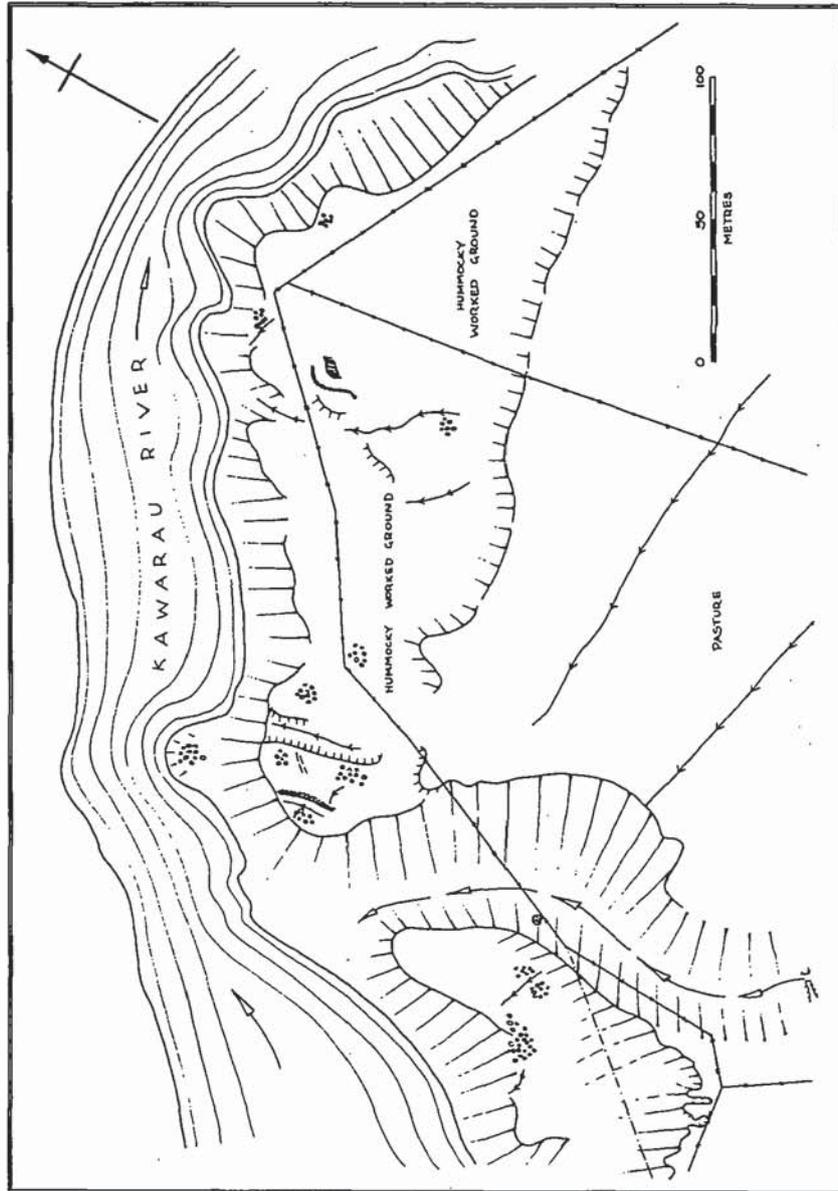
Map 2

Gold workings (sites F41/607 and 609) on the terraces on either side of the deeply incised creek. The workings on the western side (F41/609) are partially overgrown, while those on the eastern side (F41/607) are somewhat amorphous. The southern of the two water races in the pasture is probably modern, and still in occasional use.

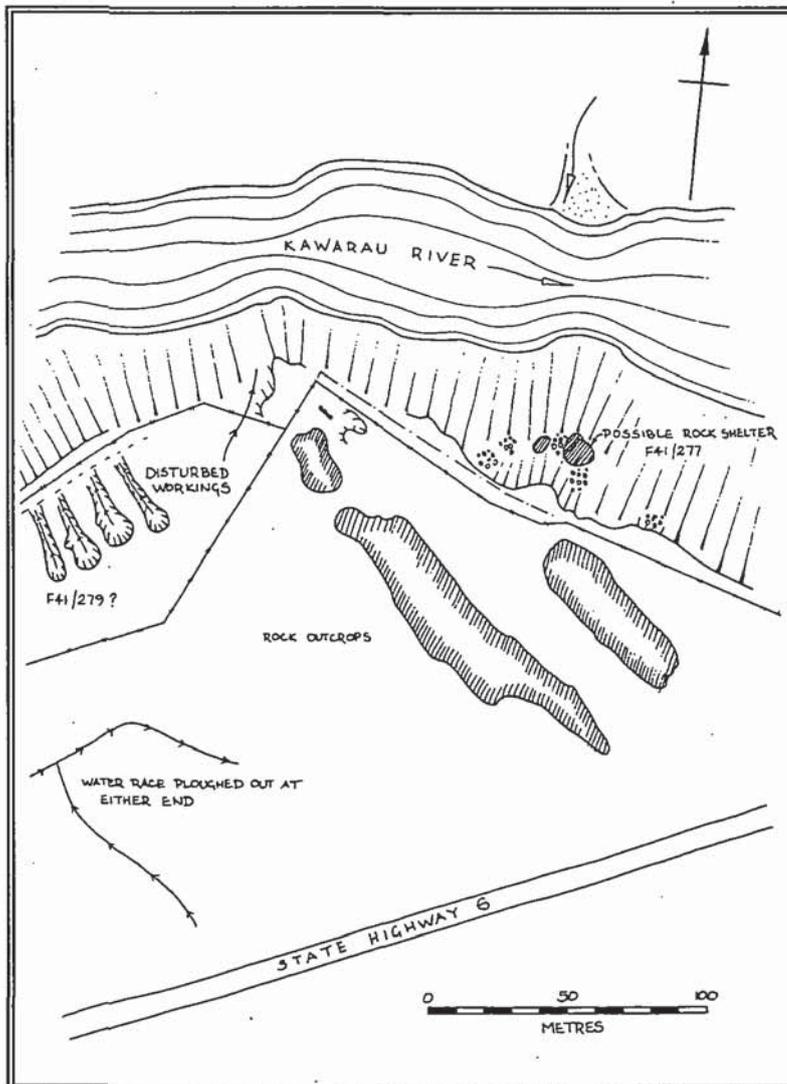
Map 3
Gold workings and
rockshelter near
large schist
outcrops.

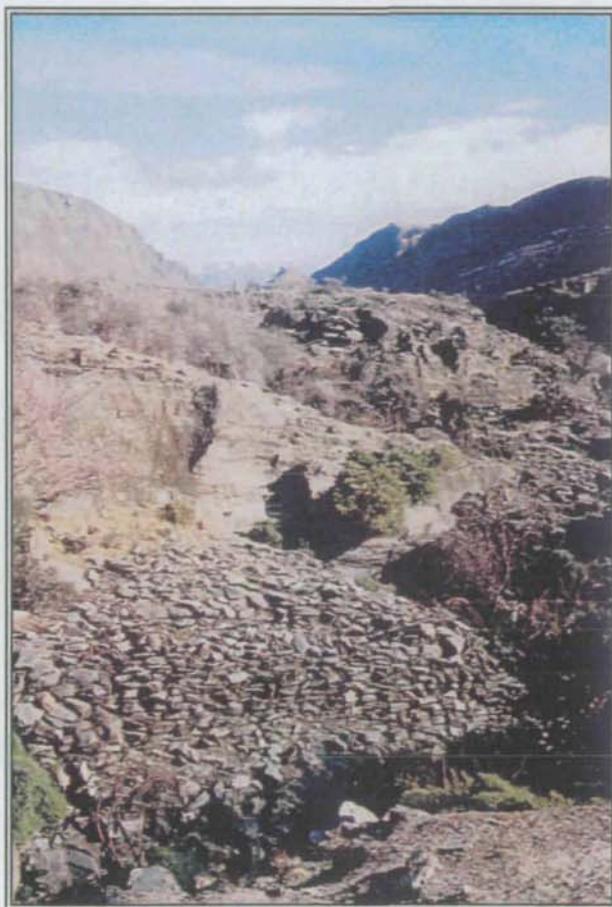
Figure 7

Large pile of tailings supported by stone revetment in the main central gully of the workings shown in Map 4 (site F41/274). View looking towards the west.

All of the tailraces from these workings have been cut through by the bulldozed line of a deer fence that has been erected around the property in the past.

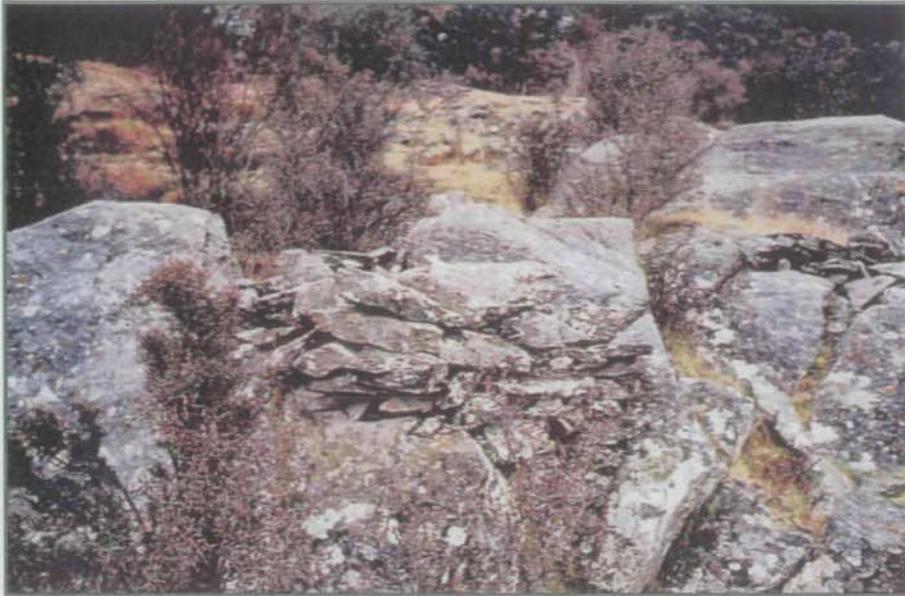
Figure 8

Small pile of tailings placed on natural schist boulders in site F42/274.

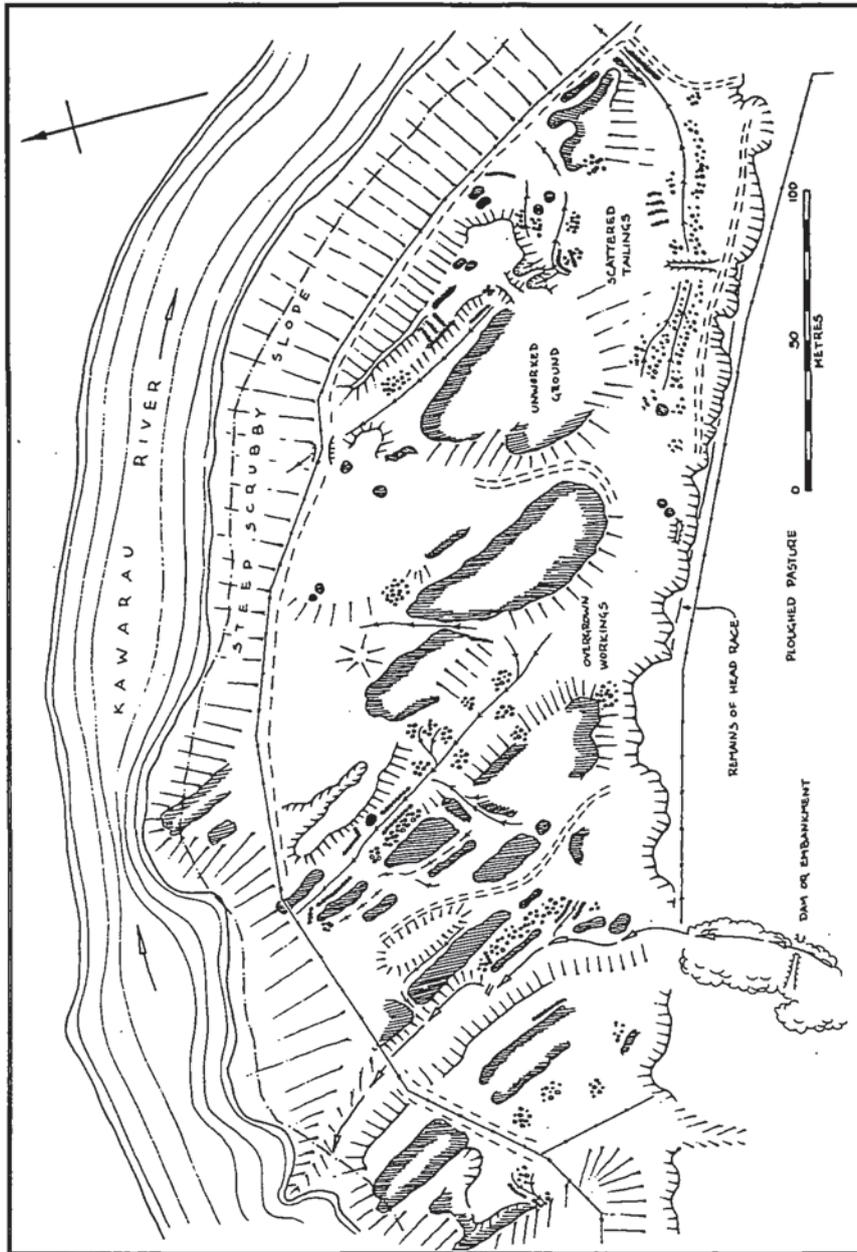
Map 4

The main area of gold workings recorded during the 2007 survey. These are recorded as site F41/274. Note the north-west/south-east trending schist outcrops, with the main tailraces running between them. The main exception to this pattern is the tailrace to the extreme east of this map, which was cut down into the bedrock. Toms Creek flows through the working on the western side.

- The gold workings shown in Maps 4 and 5 (sites F41/273 & 274) are the best examples of gold mining within the property, and contain some visually interesting areas where the natural schist ridges have been exposed and used as tail races. These sites should be carefully managed to minimise damage or modification.

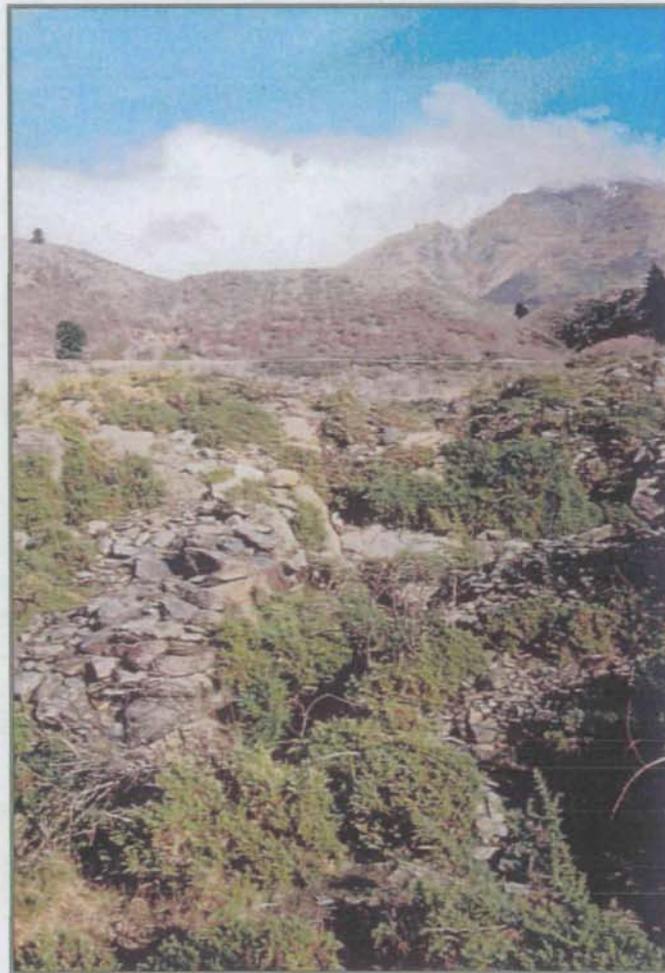
Figure 9

Part of the gold workings shown in Map 5 (site F41/273). The shallow nature of the workings can be seen, although detail is partially obscured by gorse.

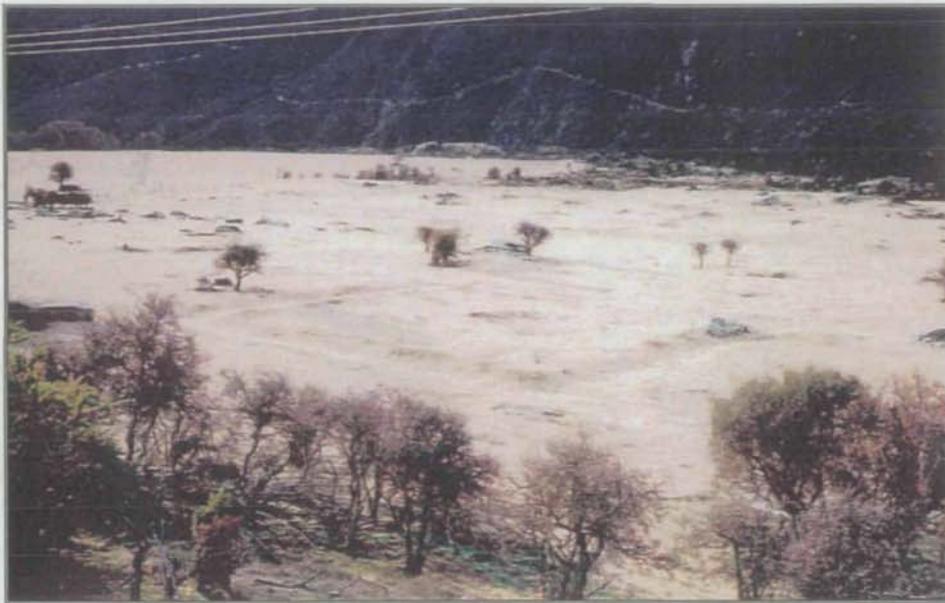
To the left of the map is a square ditch and bank enclosure and a hut site. The enclosure (Figure 10) measures 23 metres across the outside of the ditches (the ditches are on the outside of the banks). It was probably a small garden or stock enclosure, possibly associated with the nearby hut site. It has been recorded as site F41/605.

Figure 10
Ditch and bank enclosure, site F41/605.

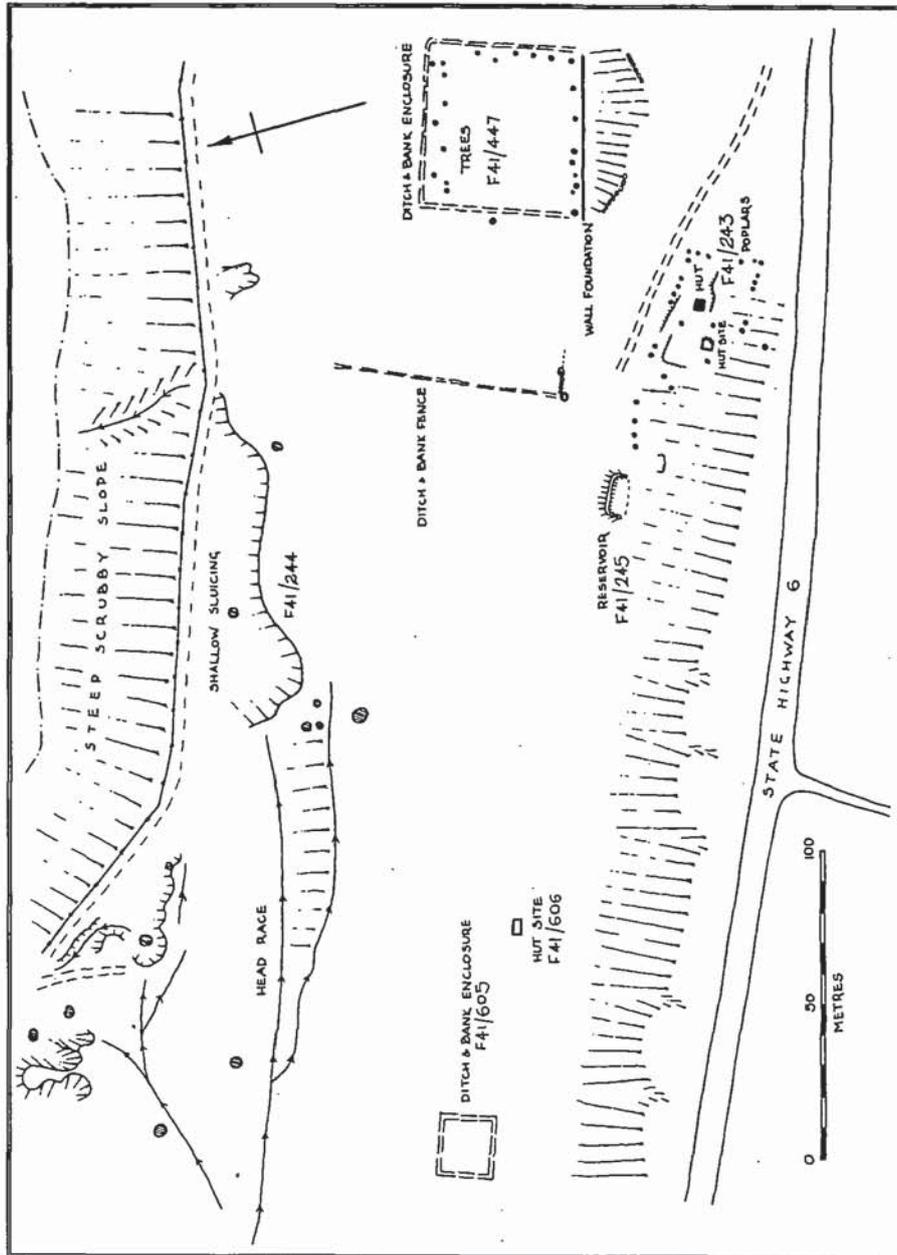
Map 6

Showing the gold workings along the river bank (site F41/244), and the complex of settlement/agricultural sites on the unworked flat ground.

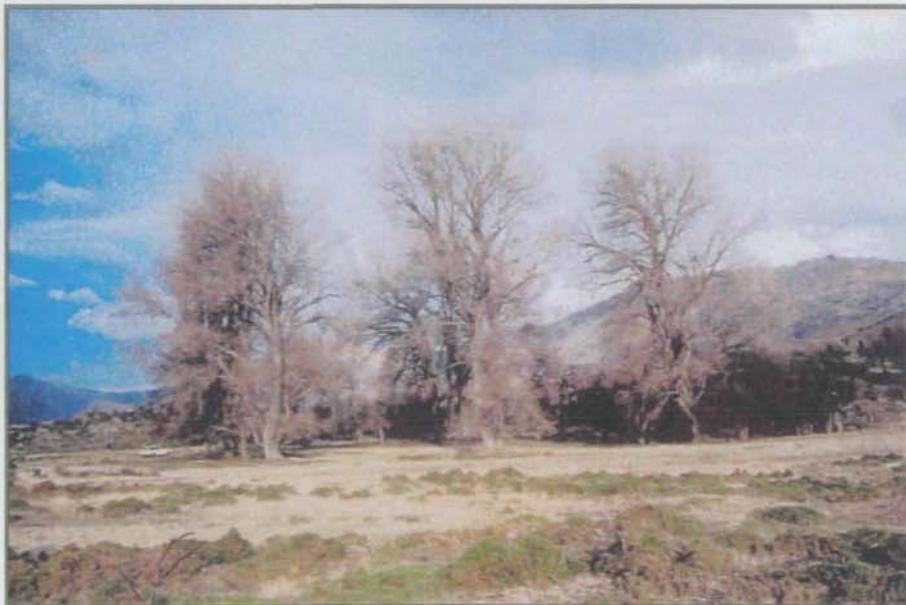
Figure 12
Willow and poplar trees within ditch and bank enclosure, site F41/447.

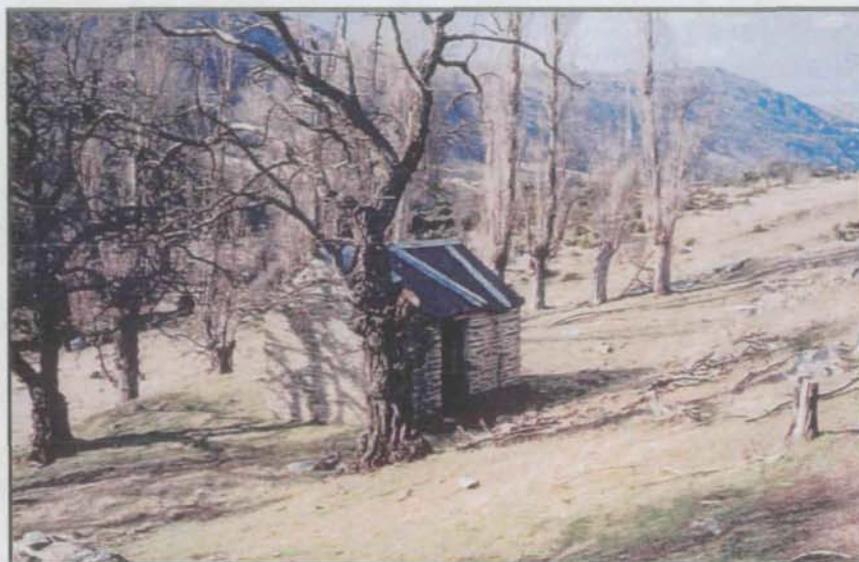
The standing hut is of schist construction with a corrugated iron roof (of which one sheet is missing). It measures 4 metres by 3.35 metres, and stands 3.1 metres to the top of the gable. It has a door in the south wall, and windows in the north and east walls. It stands within what was a fence enclosure, outline by a partial square of poplar trees. Several fruit trees are also present (they were inspected in late winter, so the variety of fruit was not determined).

Figure 13
The standing stone hut at site F41/243.

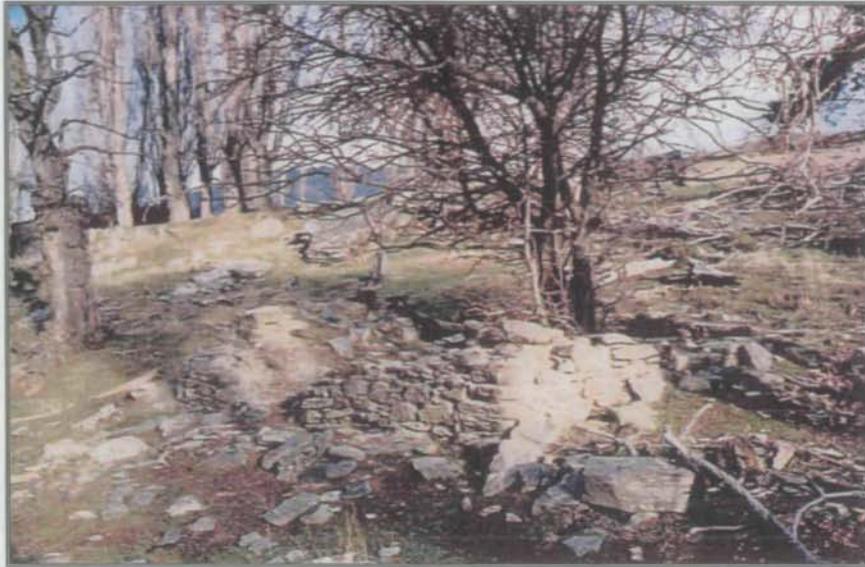
The stone hut ruin is situated 8 metres to the west of the standing hut. It measures 4.2 metres by 3.3 metres. When recorded in 1978 it had mud brick on top of the schist foundations, but by 2007 virtually all of the mud brick had eroded away. The huts were shown on a 1908 survey plan (S.O. 4726), within Section 51 Block I Kawarau Survey District, held by Robert Lyttle.

Figure 14
The stone hut ruin at site F41/243.

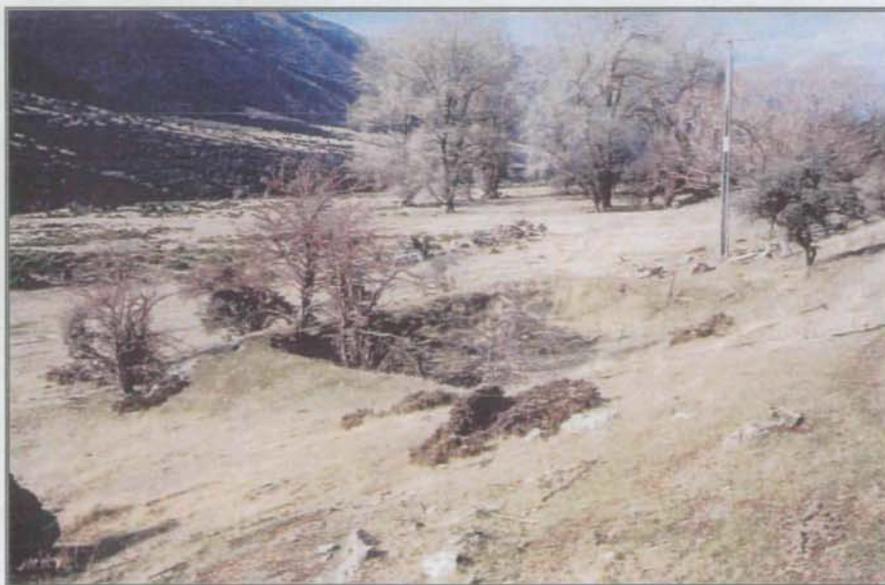
The reservoir is situated 50 metres west of the huts (Figure 15). It measures 14 metres by 7.8 metres. The front (north) wall is fronted with schist, but the internal walls are all earth. It was fed by a water race that led in from the west, but this is now becoming indistinct. The use of the reservoir is not known, but it would have been for farming, gold mining or a nearby house (possible one in the large enclosure). Its low level and limited capacity would tend to suggest that it was less likely that it was for mining.

Figure 15
The earth-walled reservoir, archaeological site F41/245.

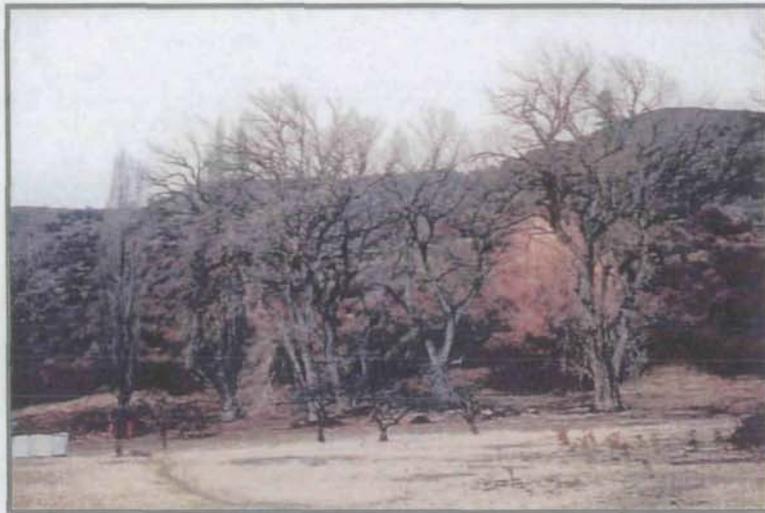
Figure 16

Historic poplar, willow and orchard trees at the original "Glenlee" property.

- The Glenlee homestead site is likely to contain sub-surface archaeological evidence. Any disturbance in this area should be subject to archaeological monitoring. Retention of the original trees is suggested if their condition is adequate.

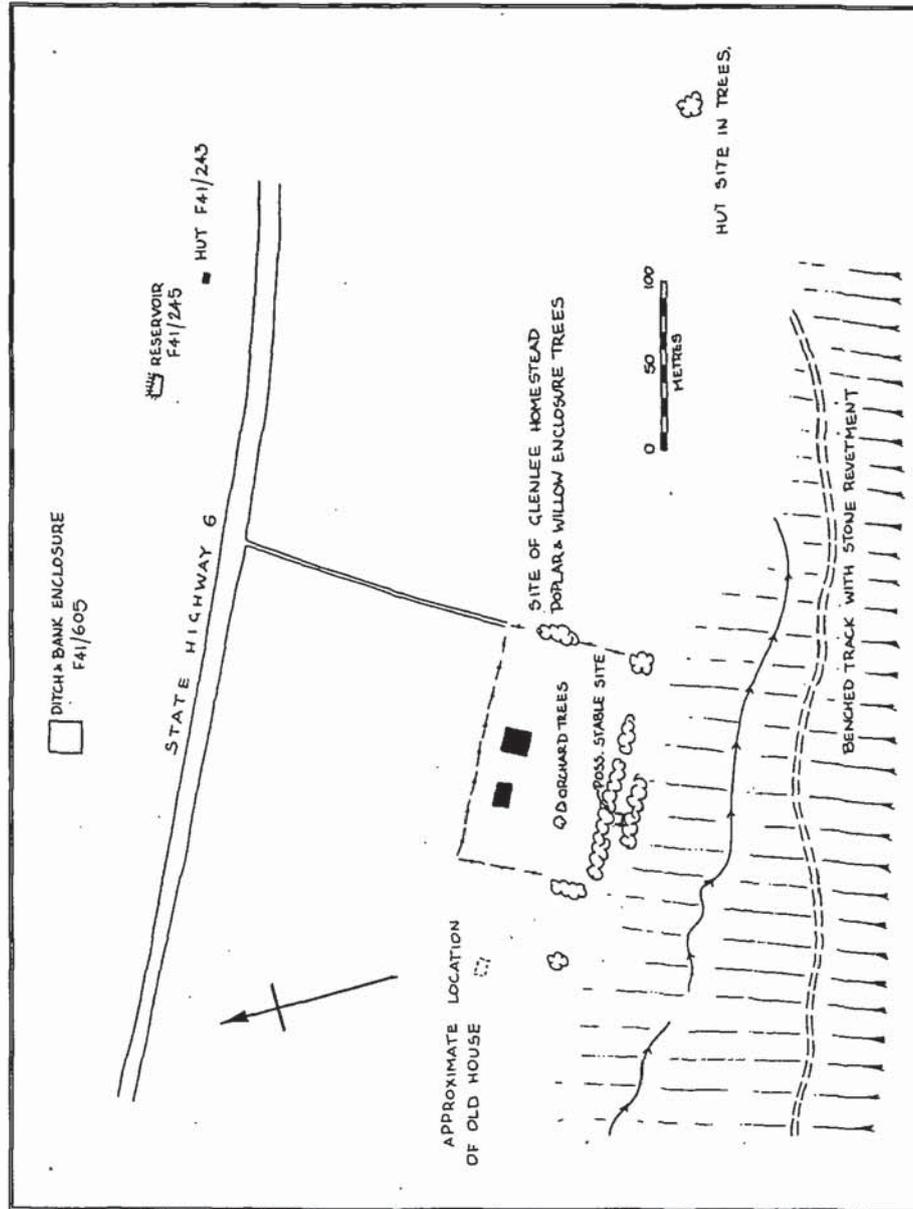
Map 7

The original location of the "Glenlee" homestead (site F41/675). The houses on the site now are of mid to late twentieth century construction, but the main enclosure trees were associated with the original house. The sites of another house and a hut as shown on historic maps are also shown.

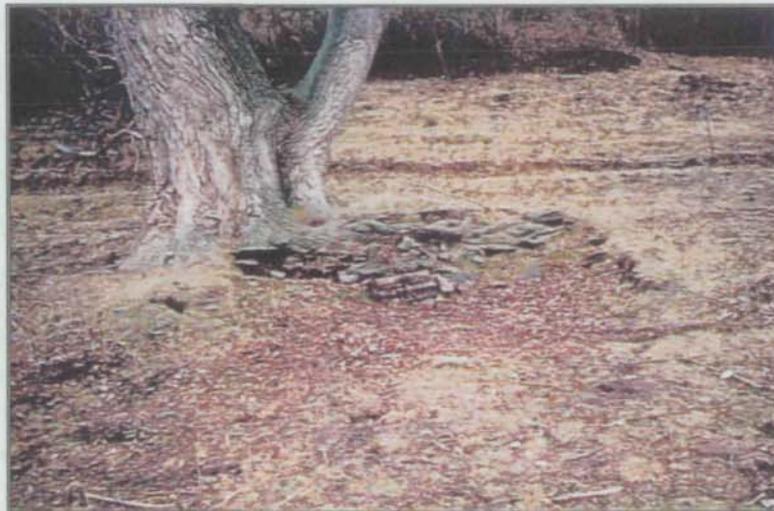
Figure 18

Building site at the base of a large willow tree at the original "Glenlee" property.

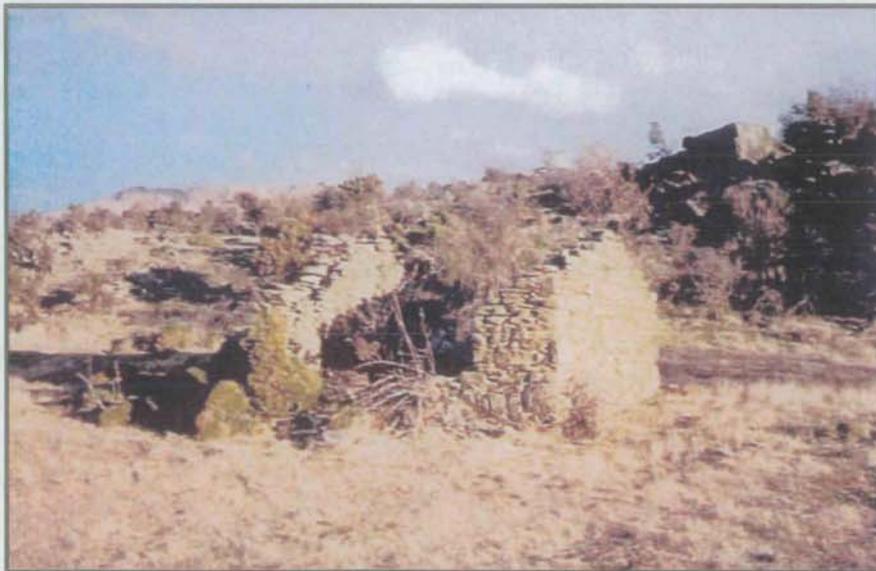
Figure 19
Ruin of stone hut, site F41/269

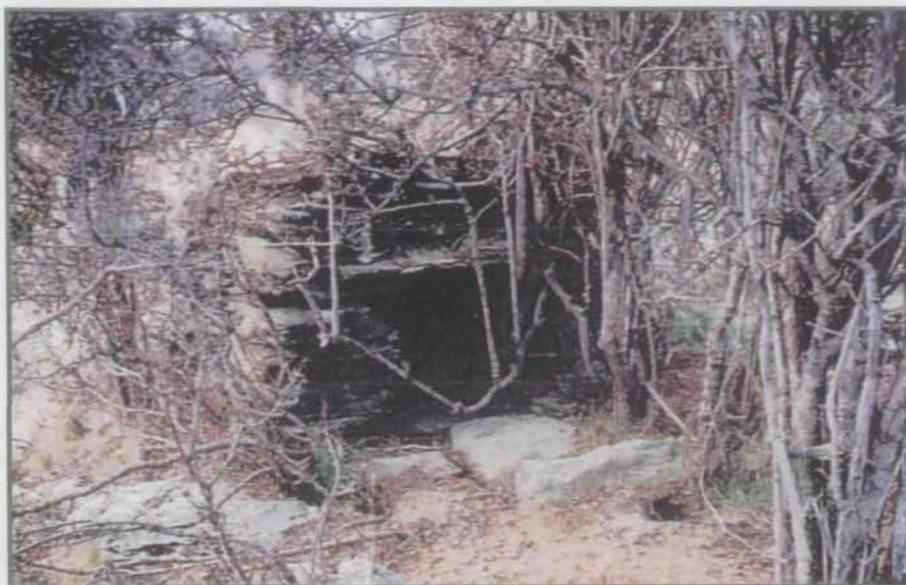
The tent site (site F41/270) consists of a stone fireplace (1.3m by 1.0m) situated 3.6 metres from a large boulder on the hillside above the hut ruin (Figure 20). A line of stones between the fireplace and boulder indicates that a tent or shelter was set up between them.

Figure 20
Stone fireplace partially hidden in scrub, site F41/270.

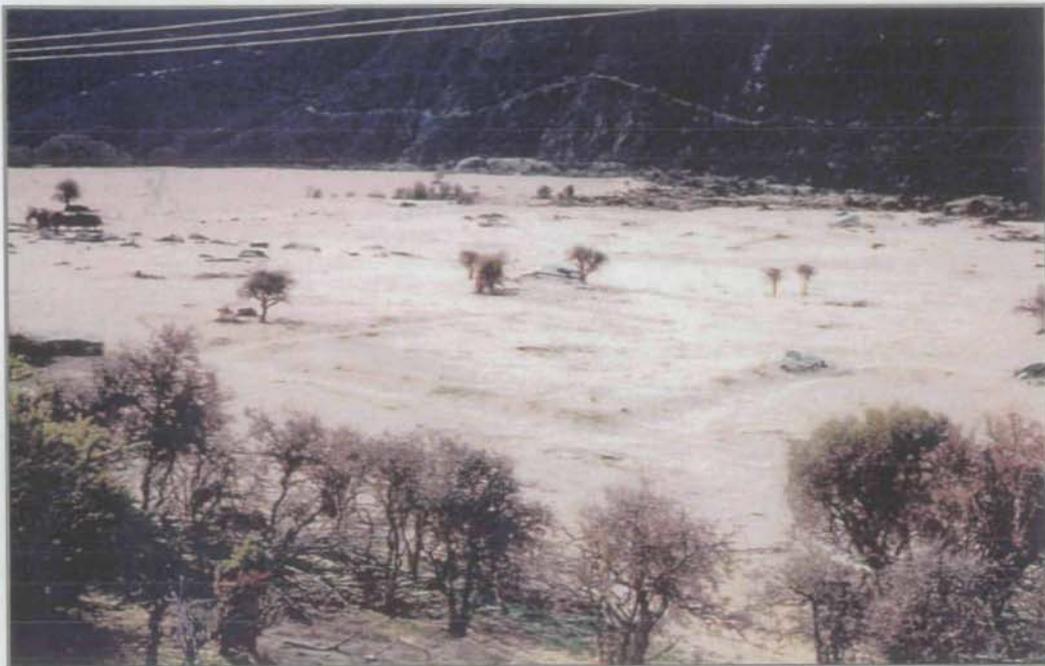
2. State of site and possible future damage
 Site is in reasonable condition, although the bank is now only a low mound. The outline is still clearly visible. Threatened by a proposed golf course and residential development.

The ditch and bank enclosure from the south.

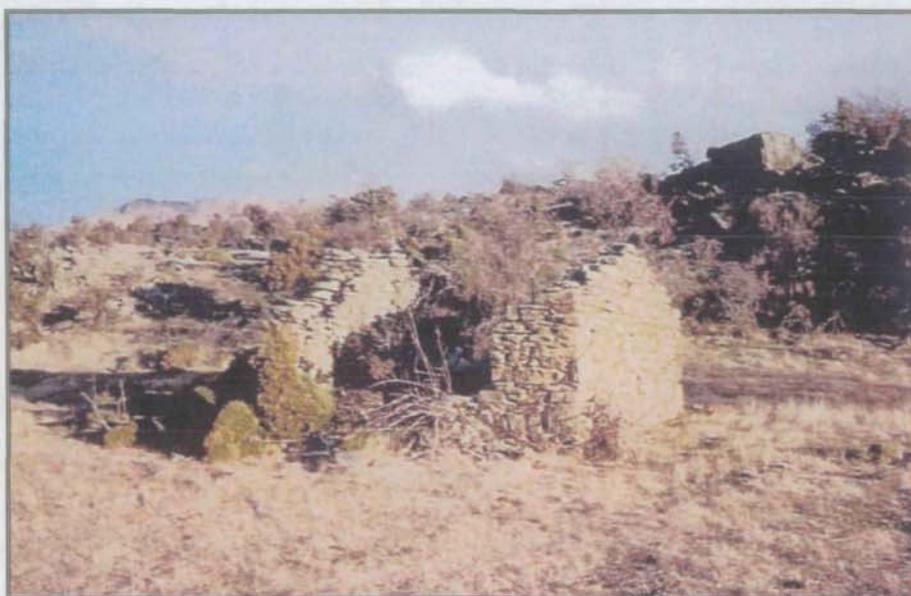
The hut ruin is slowly deteriorating. It measures 4.9 metres by 4 metres. The chimney still stands to a height of 2.5 metres. The south wall has crumbled and the east and west walls are bulging.

The hut ruin in 2007.

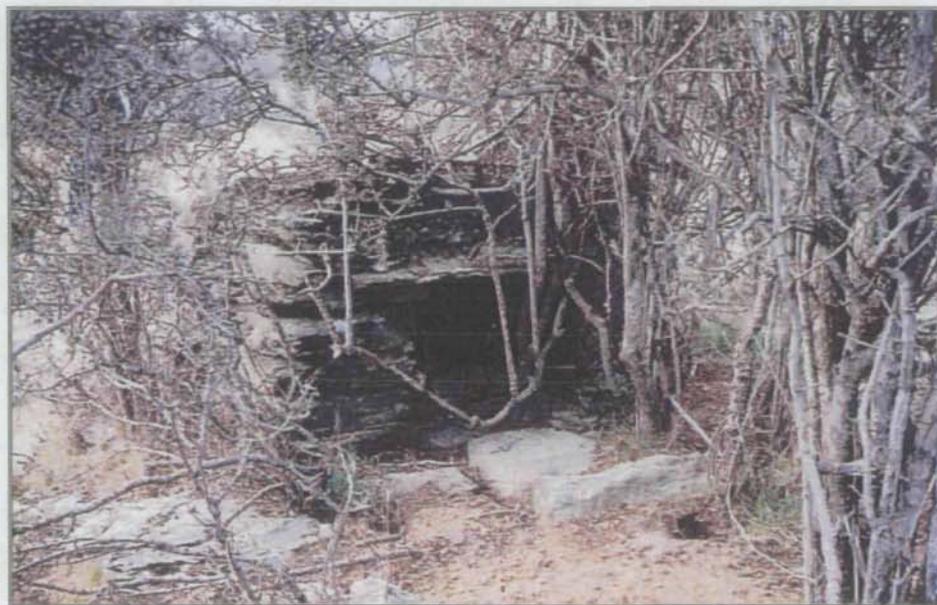
The stone chimney measures 1.3 m by 1 m and is 1 m high. It is situated 3.6 metres from a large rock, and this was probably the site of a tent or lightweight timber hut. A line of stones in the ground between the chimney and the large rock probably marks the front wall of the tent/hut. This was probably a small gold miners hut, associated with alluvial gold mining along the banks of the Kawarau River.

The stone fireplace/chimney in 2007.
