1 BENMORE PLACE, GLENORCHY

Archaeological Assessment
October 2019

Archaeological Assessment for 1 Benmore Place, Glenorchy

Archaeological Sites: E41/295

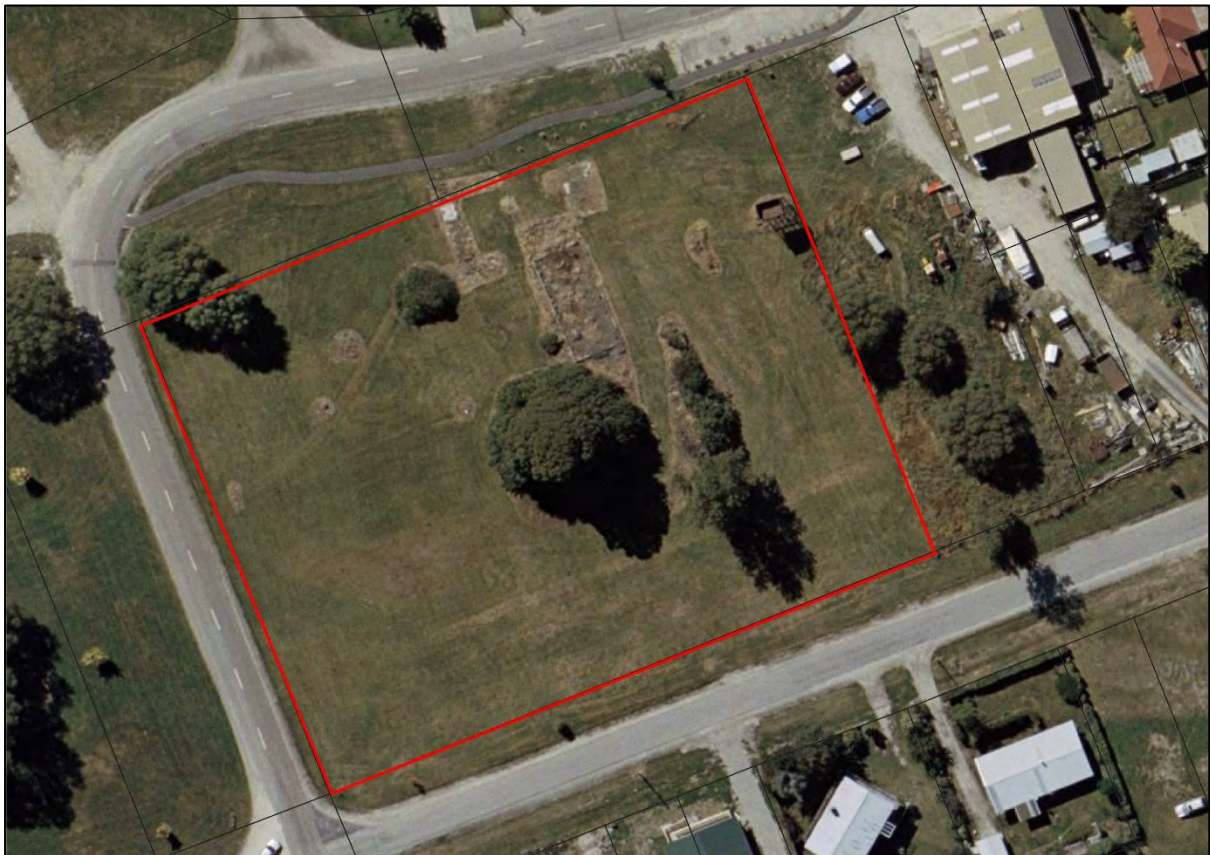
Figure 2. Site boundaries at 1 Benmore Place, Glenorchy with historic remains clearly visible (QLDC webmaps). Note extension of part of the historic site into the road reserve.

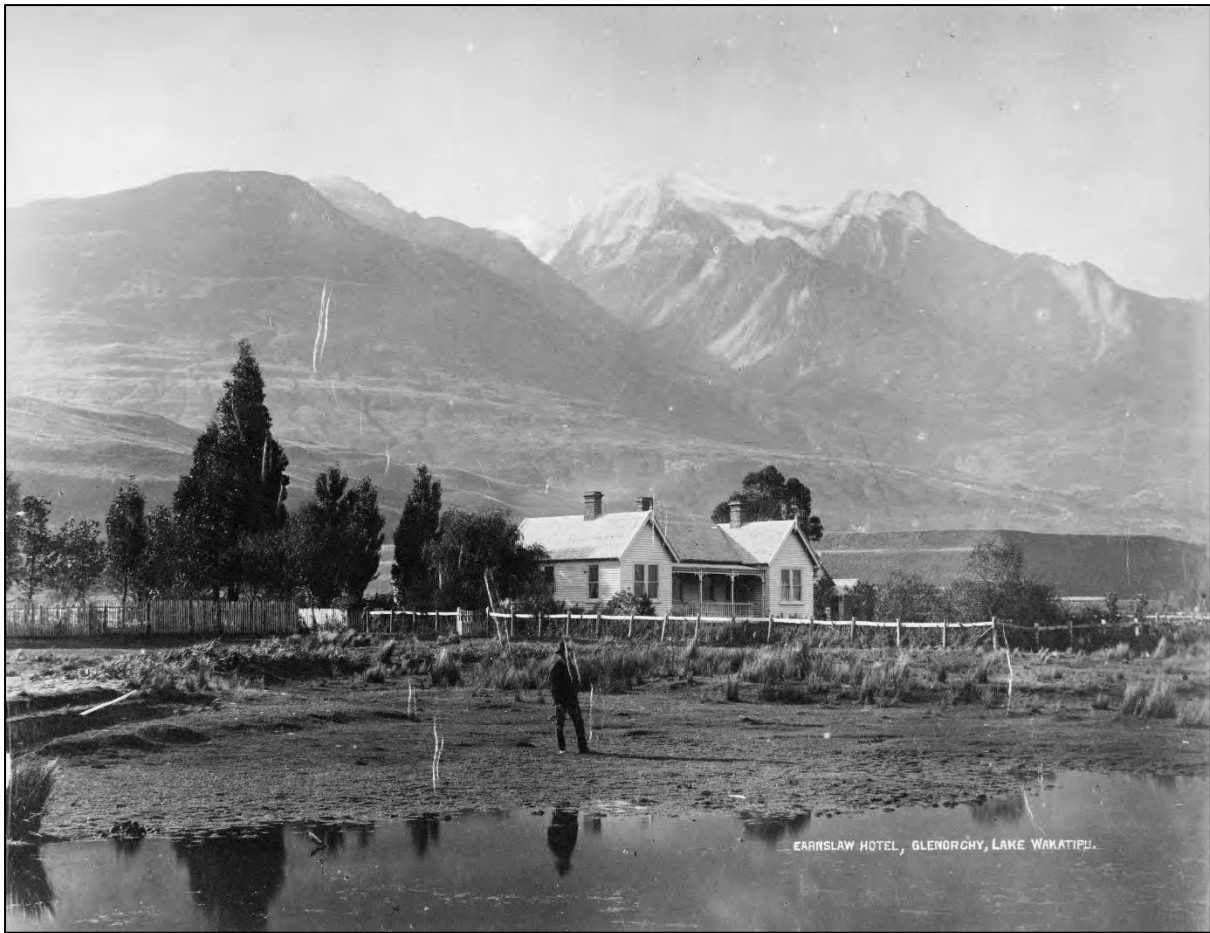
Figure 8. Mt Earnslaw Hotel in 1880 (National Library). The original hotel may have been located to the rear.

In November 1880, the hotel was officially opened (Figure 8). Birley, described as an old and respected resident, celebrated by a "house-warming" in the orthodox style. Following its opening, the head of the lake was noted as having two well-known hostelrys, one on the east side and one on the west, providing "accommodation of visitors to the grandest portions of the district" (Lake Wakatip Mail, 1880b). One year later Birley was advertising the Mount Earnslaw Hotel (Lake Wakatip Mail, 1881). An advertisement in 1882 described the hotel being established in 1863, and subsequently having extensive additions (detached) added with "commodious, well-ventilated and well-furnished Dining, Sitting, and Bed-rooms have just been made to this favorite and old-established hostelry, which now affords superior accommodation for Tourists and Families wishing to stay amongst the most attractive portion of the Lakes district" (Lake Wakatip Mail, 1882b). This coincided with his application for an accommodation license (Lake Wakatip Mail, 1882a).

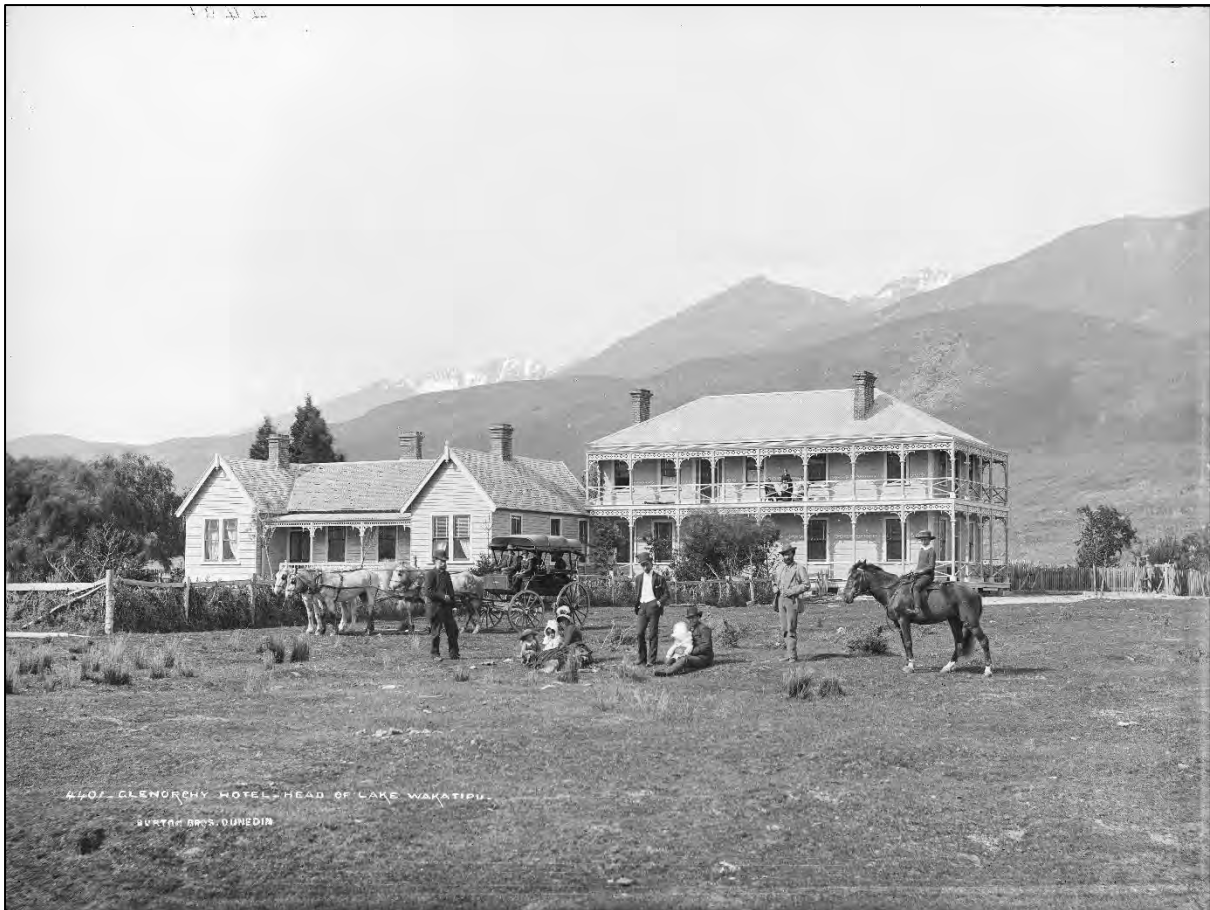
Figure 9. Mt Earnslaw Hotel in 1886 following construction of two-storey addition (Te Papa).

In 1885 Birley further extended the hotel with the construction of a two-storey addition built on a cement foundation (Figure 9). This contained 20 rooms, and was furnished with hot and cold baths, with water laid on everywhere. The total cost was estimated at £1,000 (Lake Wakatipu Mail, 1885).

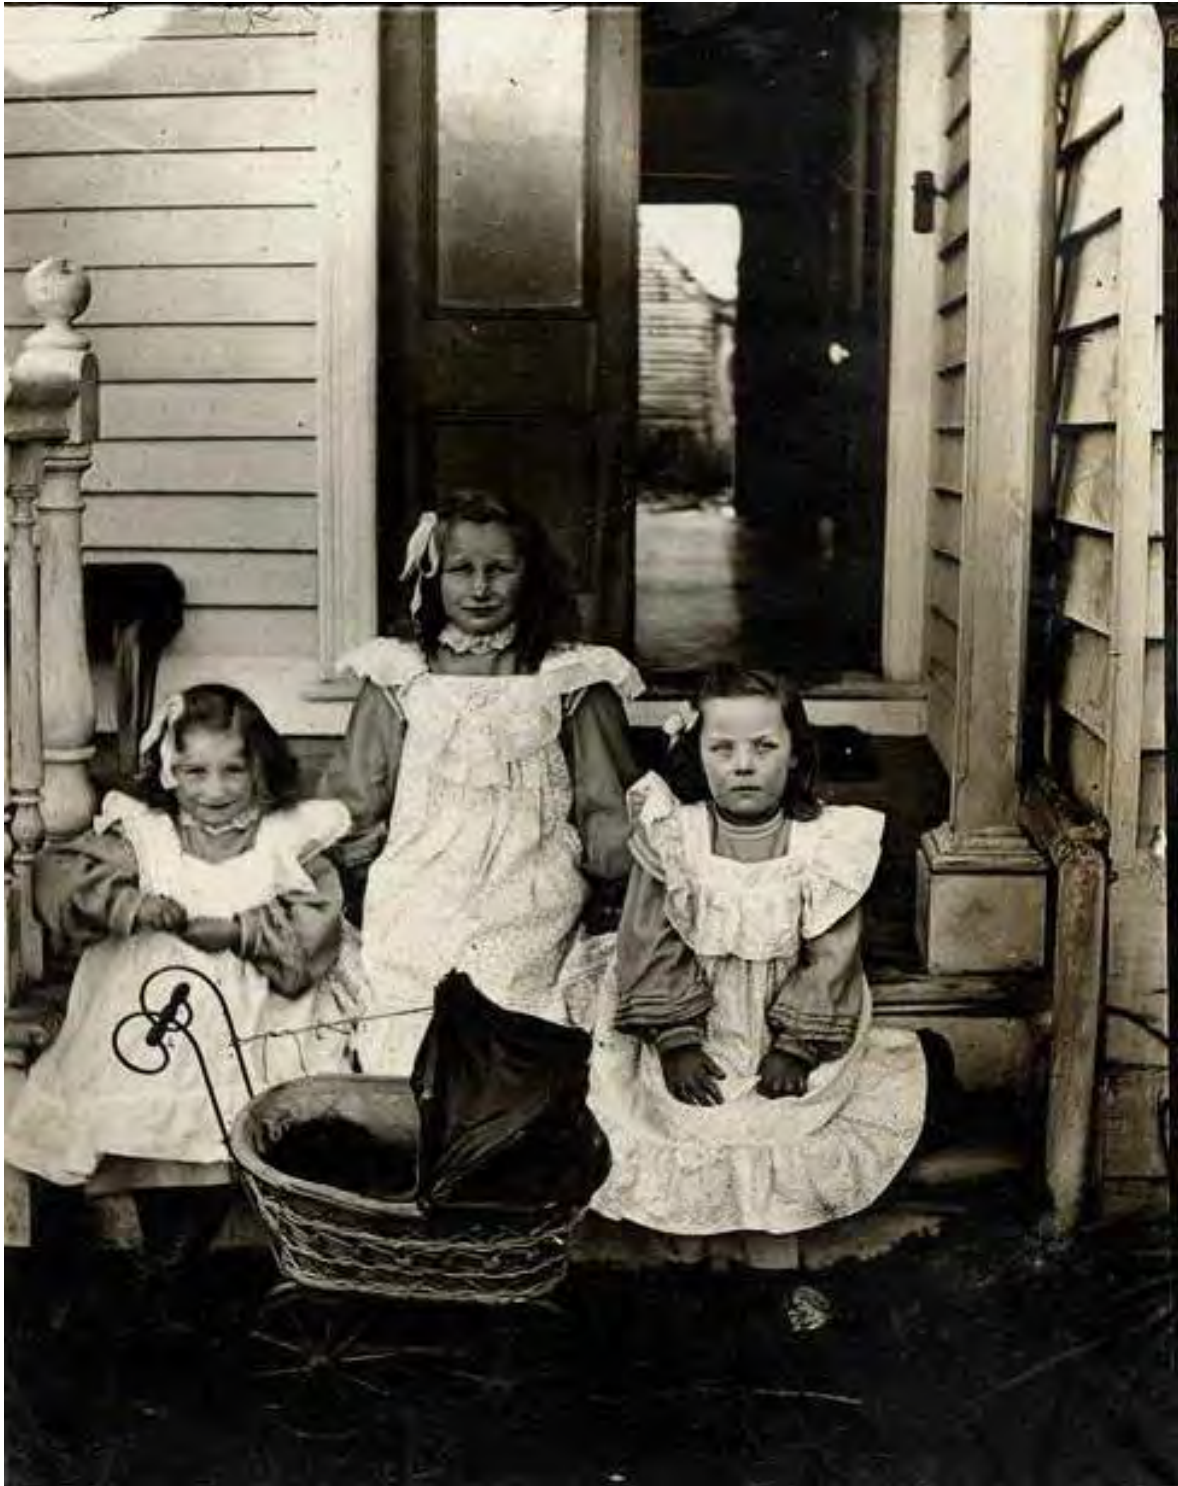
Figure 11. Photograph from c.1904 on the main verandah of the 1880 hotel, with gabled building visible through the door at the rear (Glenorchy 1 K1350 c1904).

Adjacent to the two-storey addition and behind the original cottage is the remains of another building foundation (Figure 25). Its original purpose and age are uncertain. However, it is visible in Figure 11 from c.1904. Its size and form suggest it may have been the stable.

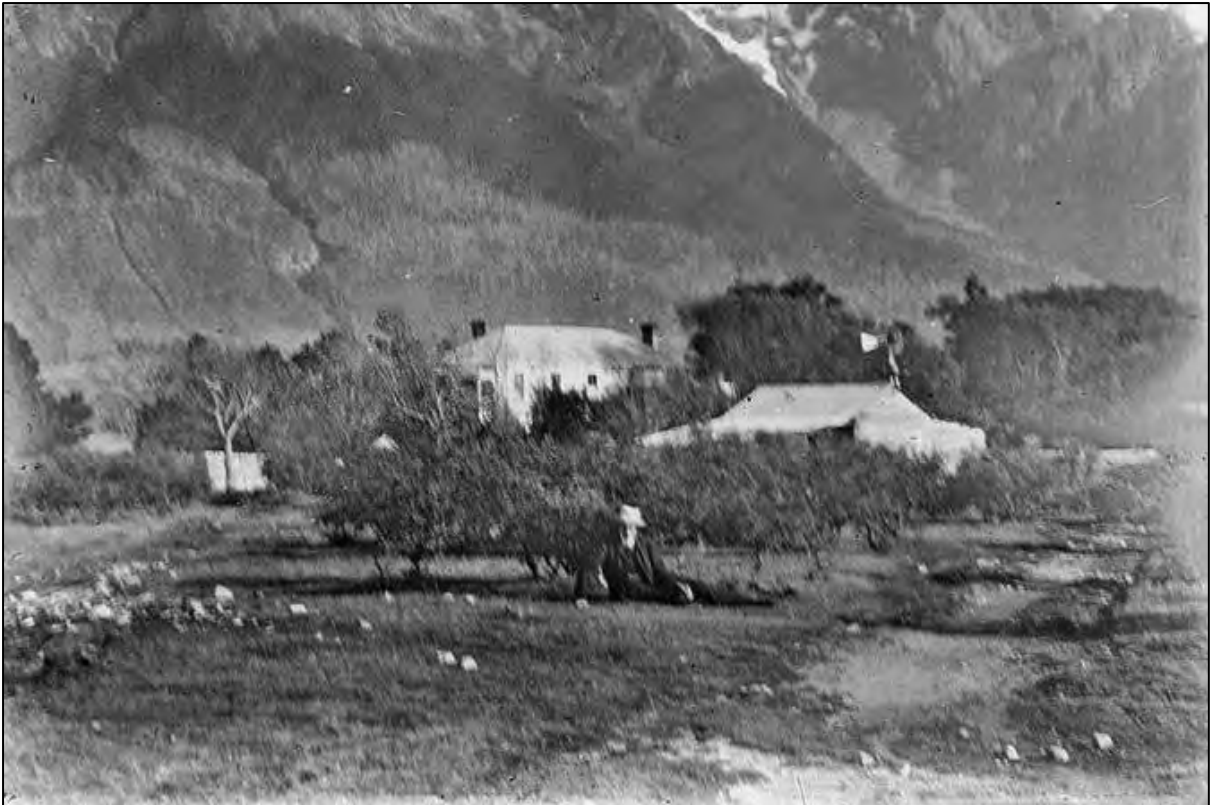
Figure 12. Photograph showing the rear of the hotel addition and timber building out the back towards the eastern edge of the site, c. 1908 ('Glenorchy (1)' K2272 c.1908). This building may be the original pre-1880 hotel.

There are additional areas of discoloured grass and places with mature vegetation suggesting the possibility of additional ancillary buildings or the original hotel being located behind the main accommodation block (Figure 26-Figure 27). Figure 12 shows a timber building with a lean-to located somewhere behind the two-storey addition. However, its exact location is uncertain. The operation of a hotel would have also required a number

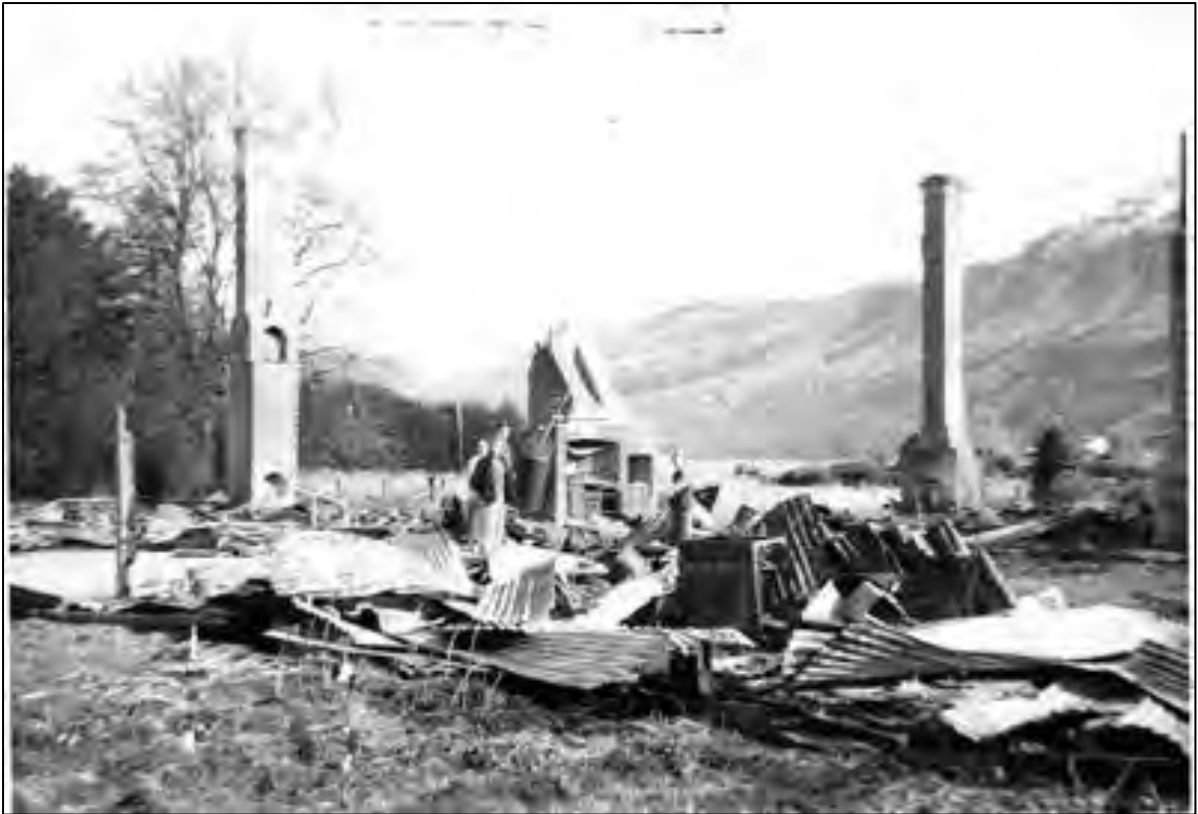
Figure 14. After the Mt Earnslaw Hotel Fire (Eric Livingstone; July 1959 - eHive).

The Birley family sold the hotel in 1907 to Mr Alfred Groves (Figure 12)(Southland Times, 1907a). He sold it in 1911 to Mr W. Holland and at the time it comprised 26 rooms (Southland Times, 1911). Fourteen different owners took on the Mt. Earnslaw Hotel between Alfred Groves in 1911 and Joe Hussey, who would be its last owner in 1959 when it burnt to the ground (Figure 13, Figure 14)(Glenorchy Historical Society).

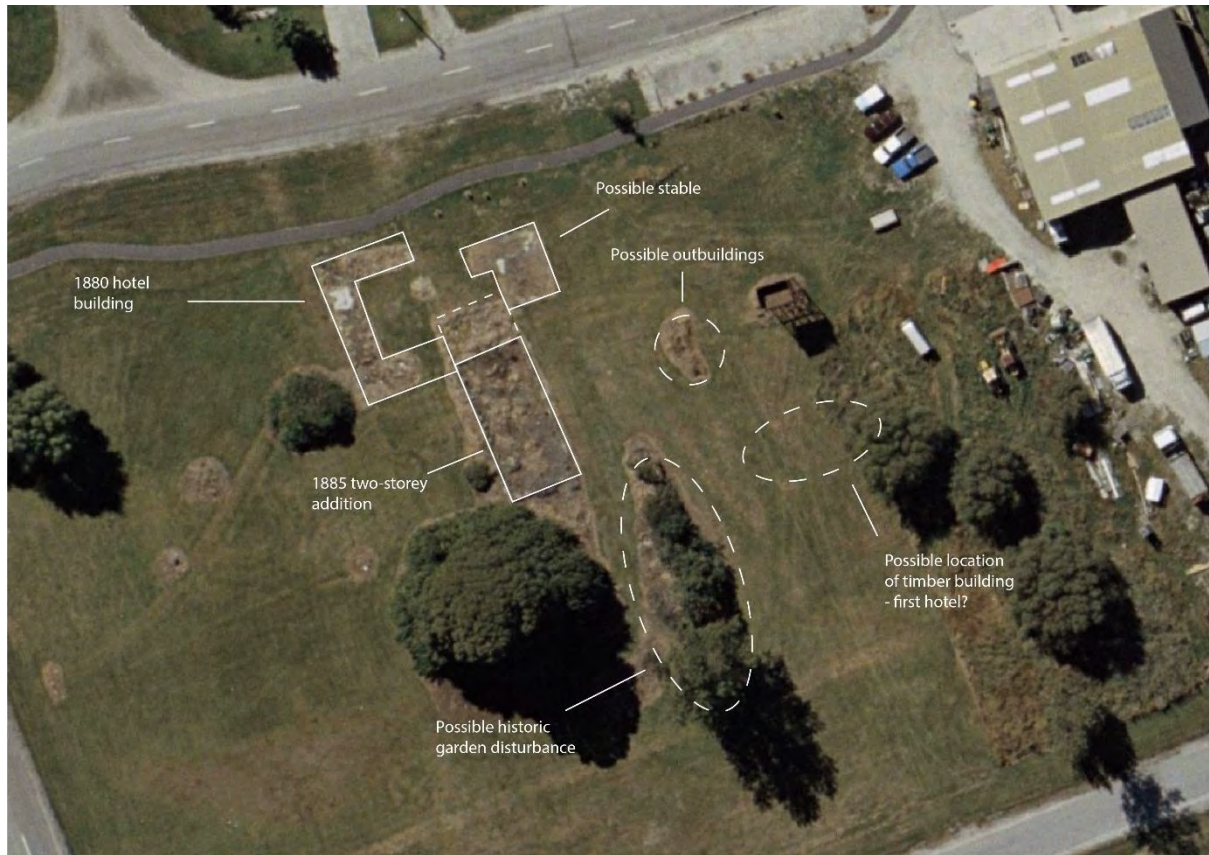
On-site observations show a number of visible features associated with historic building foundations and possible locations of ancillary buildings (Figure 15). The site is part of a flat terrace just above lake level. It is mostly in grass with some mature trees and shrubs (Figure 16-Figure 18). This allows for good visibility of any surface features and these can be clearly seen in high resolution aerial photography.

Figure 15. Aerial imagery overlain with projected and possible building locations.

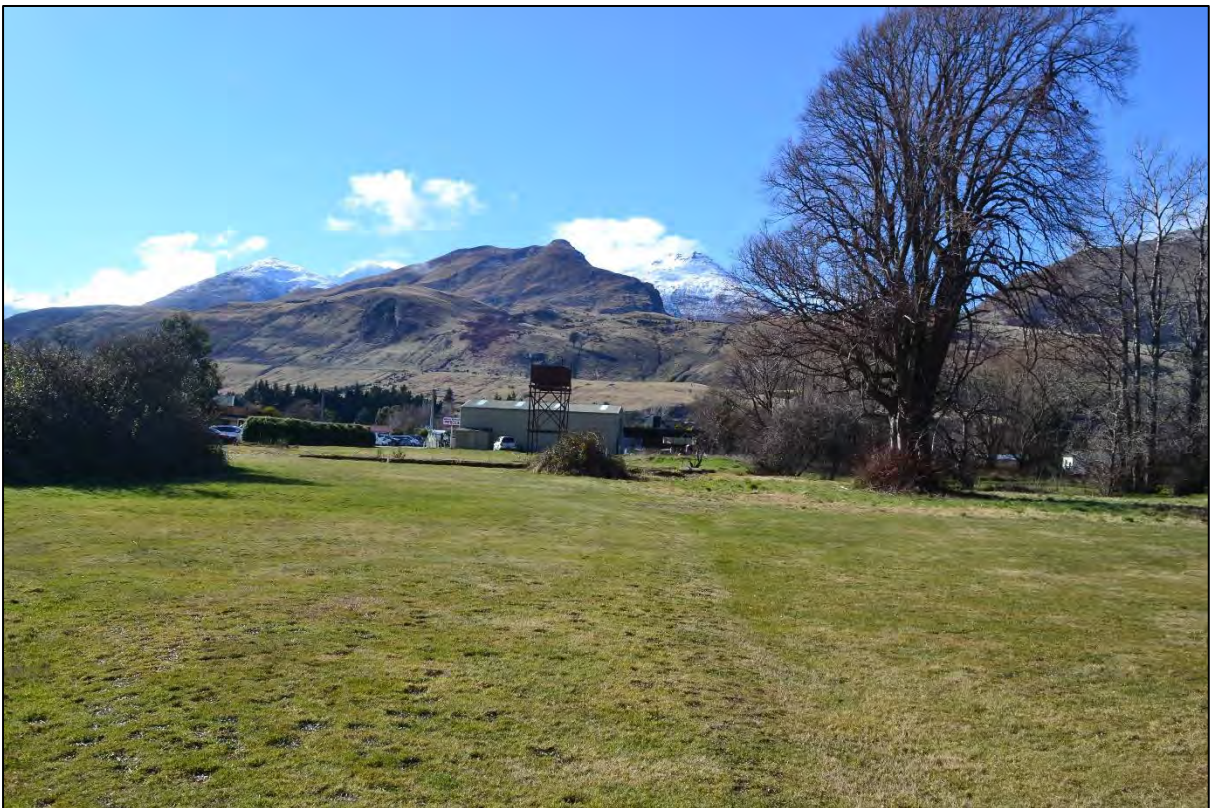
Figure 17. View of site looking east across towards where the two-storey hotel extension would have been.

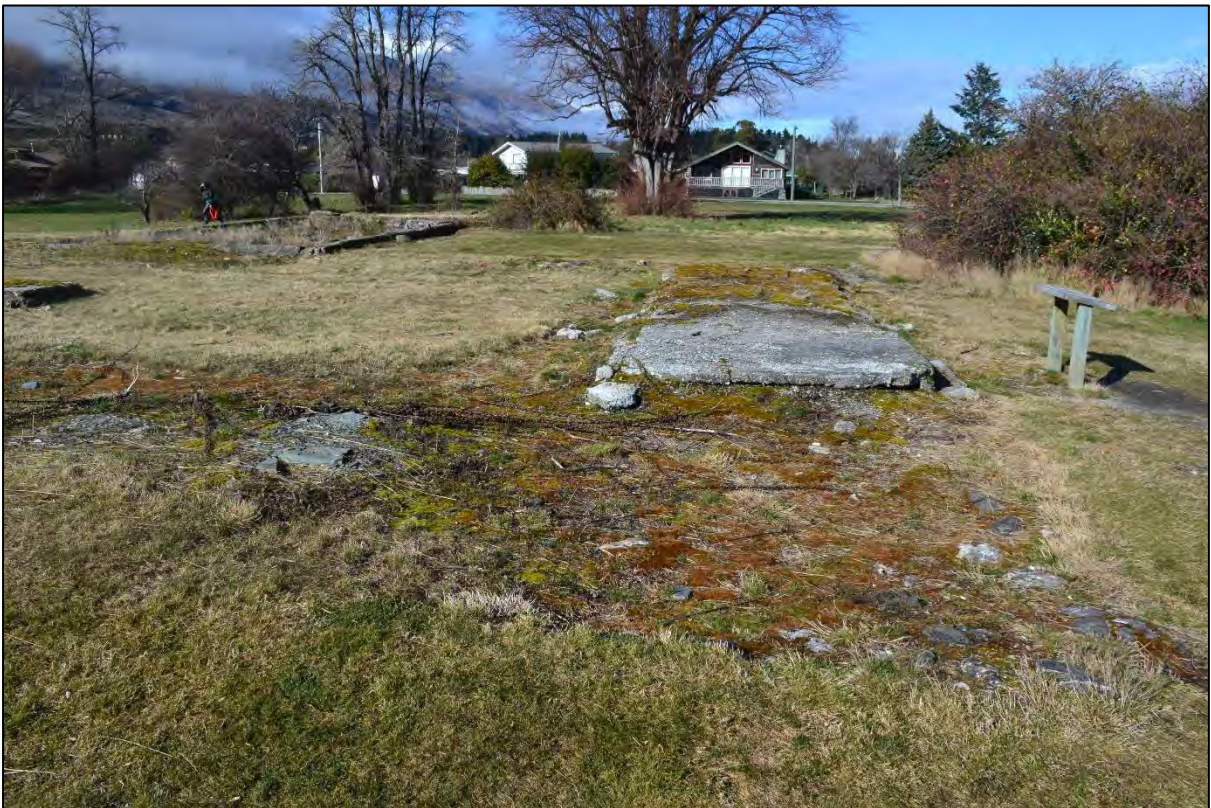
The visible historic features are clustered in the northern portion of the site. This includes the remains of the U-shaped 1880 hotel building (Figure 19-Figure 21). The central portion appears to have been built with schist pavers acting as 'bearer's for the sub-floor above and are commonly found in mid-19th century buildings. The two wings on either side are defined by the remains of concrete foundations.

Figure 19. View of the U-shaped foundations that remain of the 1880 hotel building.

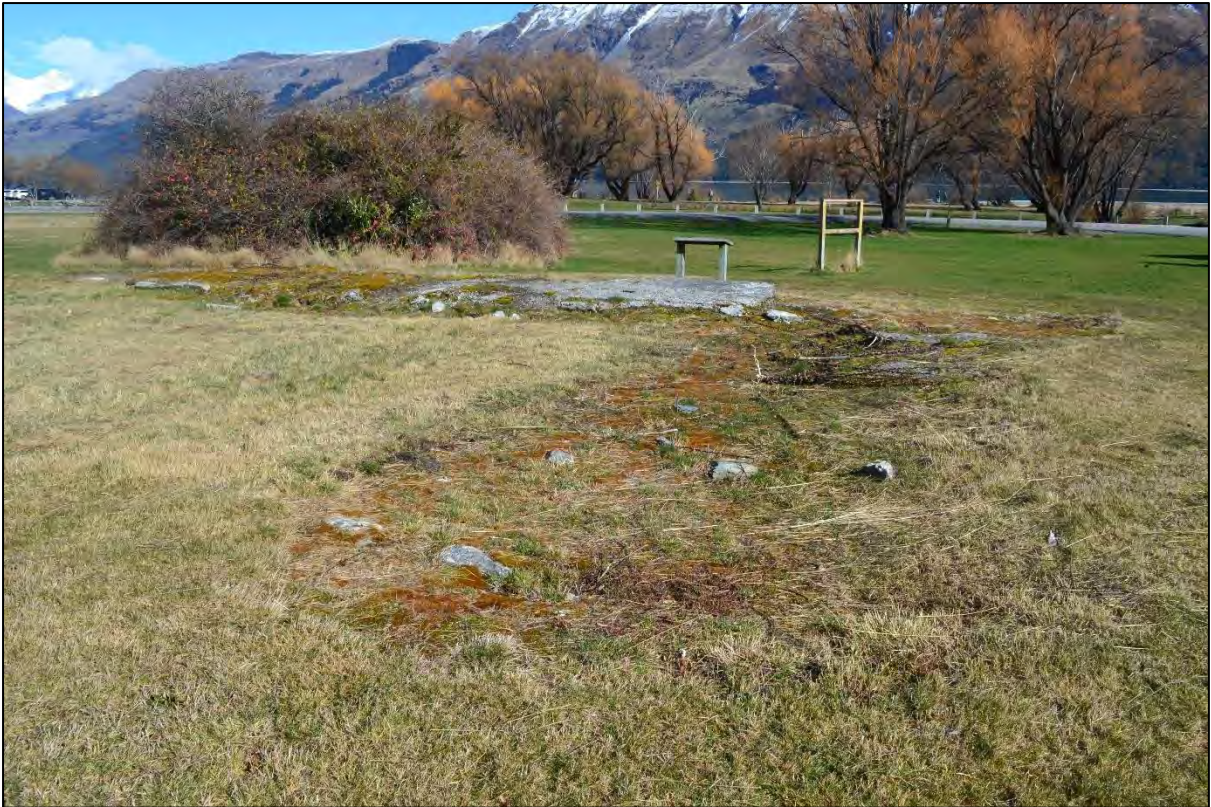
Figure 20. View looking at what would have been the rear extension of the U-shaped foundations.

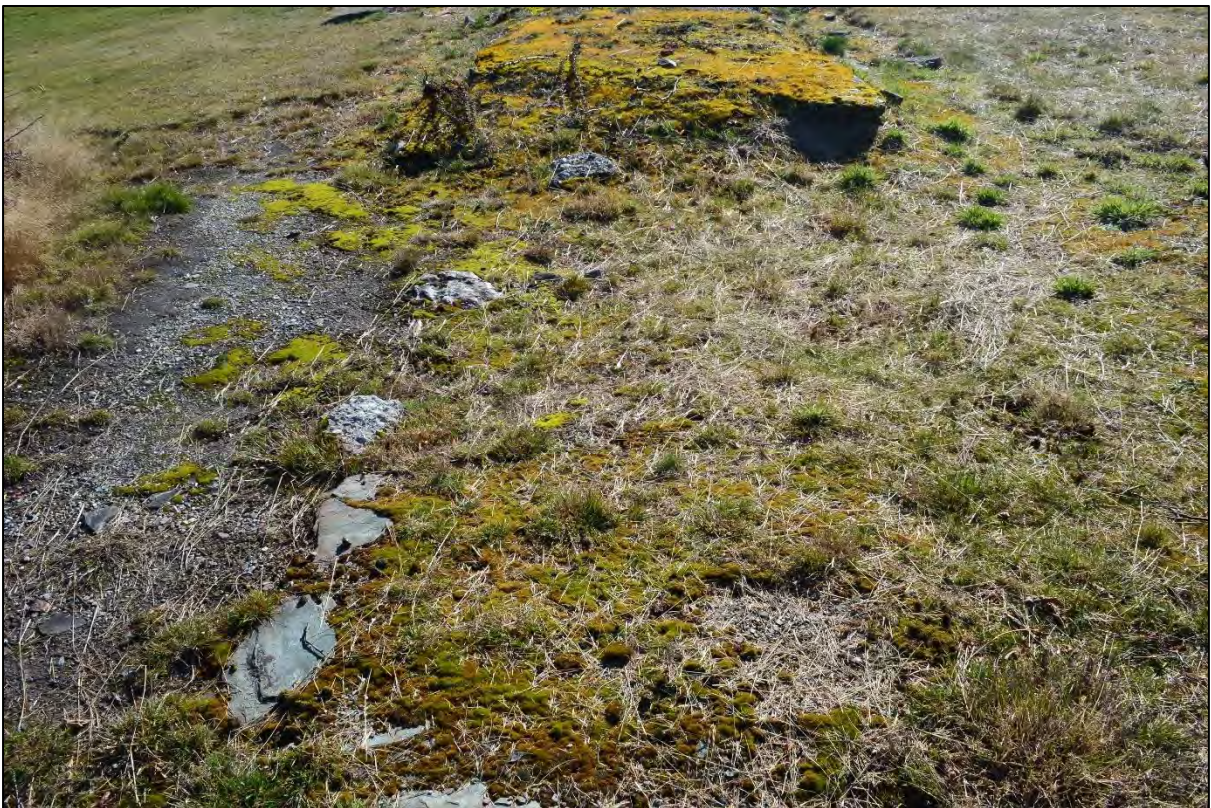
Figure 21. Detail of foundations for U-shaped foundation showing mix of schist pavers and cement.

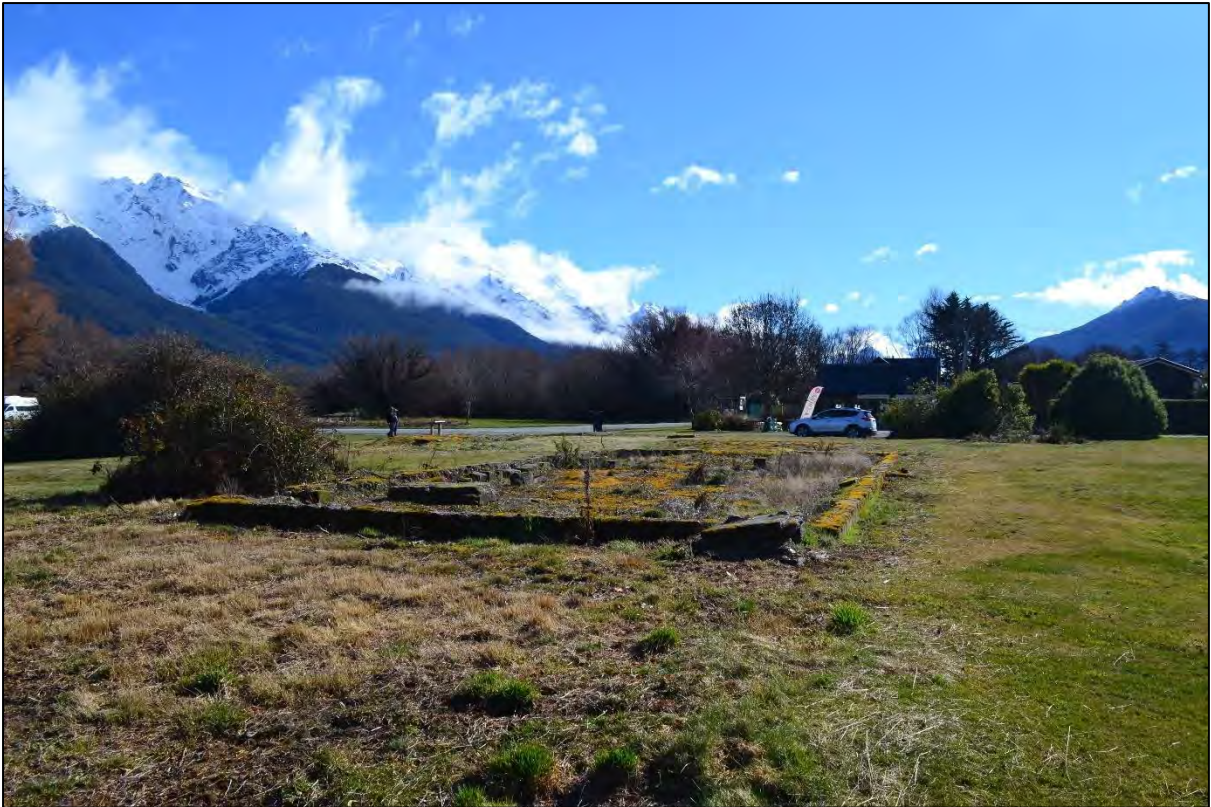
The two-storey addition from 1885 is clearly defined by a concrete ring-beam foundation and internal concrete piles (Figure 22-Figure 24). The northern end contains the foundation for a large chimney. It appears there may have been a smaller addition added to the northern end of this building at some stage, but without the concrete foundation. This suggests a smaller single-storey timber addition, possibly used as an outhouse.

Figure 22. View looking north of rectangular foundation which formed the large two-storey addition to the hotel.

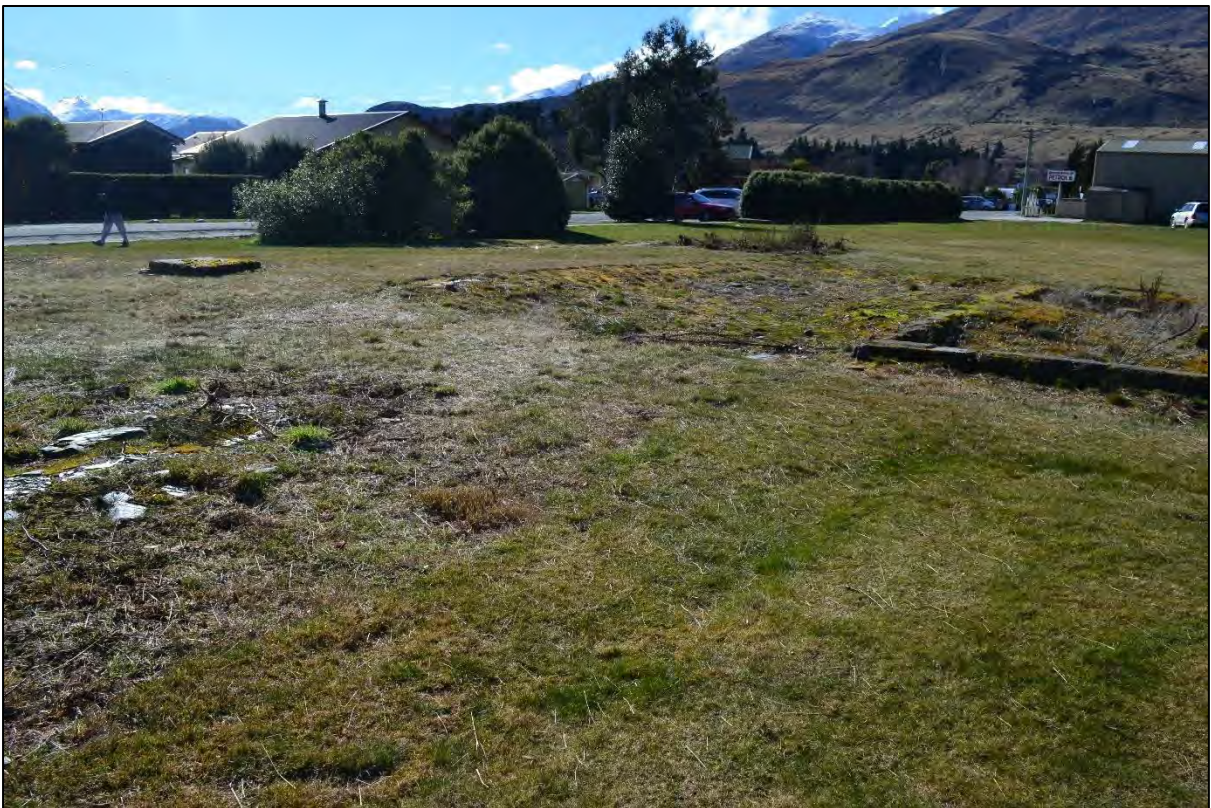
Figure 23. Detail between the U-shaped original building and the two-storey addition set behind and slightly to the side. Note the discoloured grass on the northern edge the rectangular foundations suggesting the building was larger than the existing cement foundation.

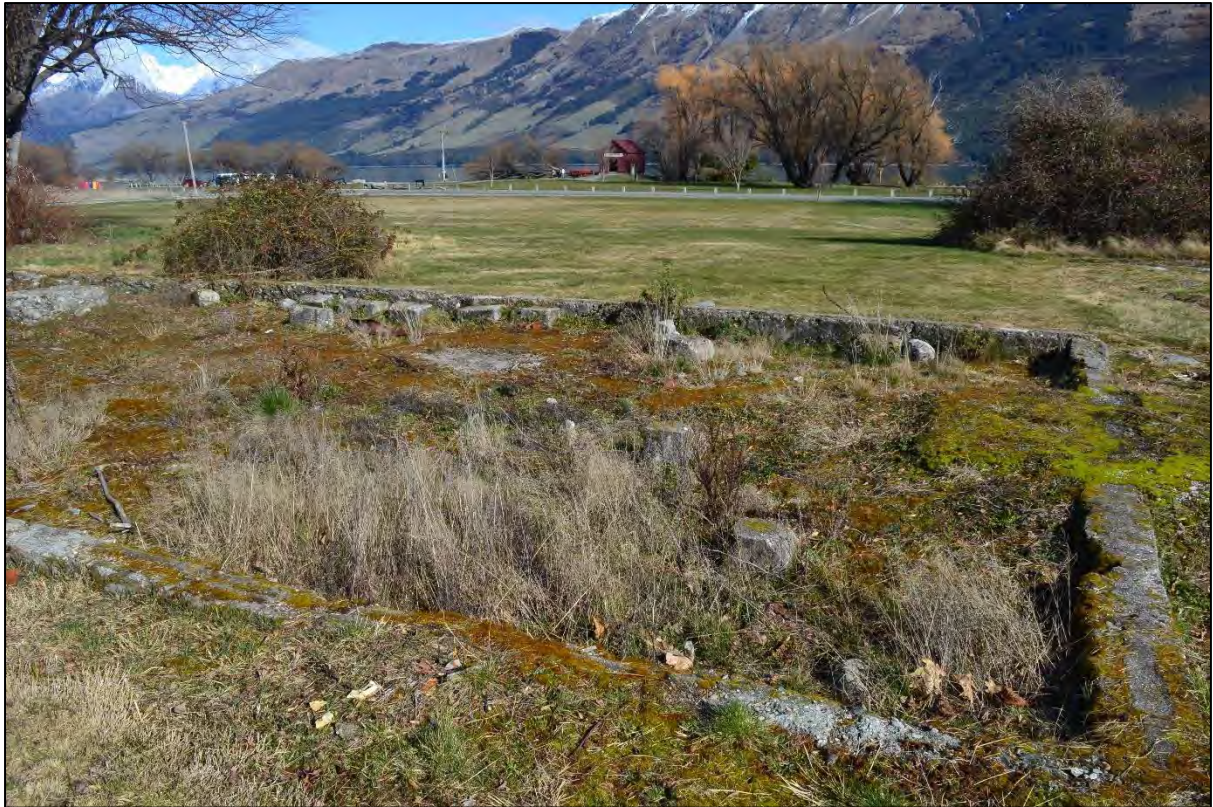
Figure 24. Detail of concrete ring foundation with internal concrete piles and foundation of large chimney on northern edge.

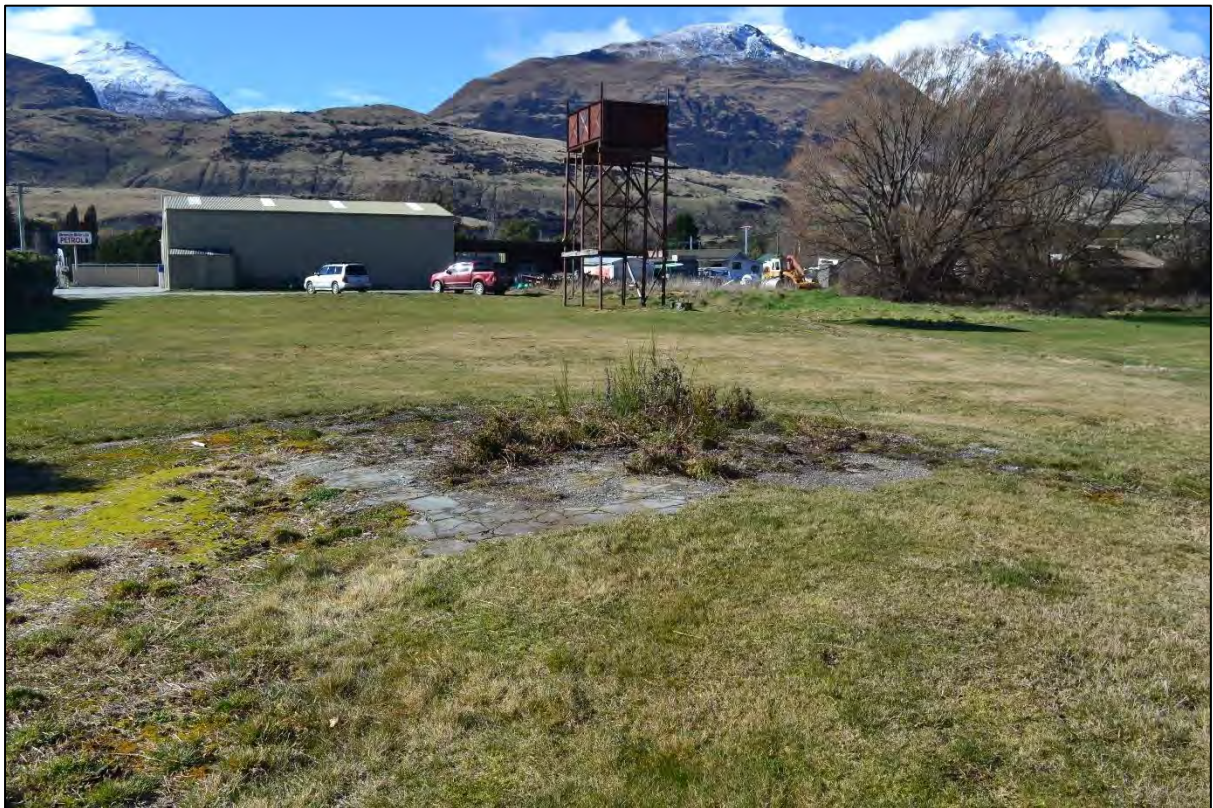
Figure 25. Remains of smaller building foundation located behind U-shaped building. Its original purpose is unclear but may have been a stable.

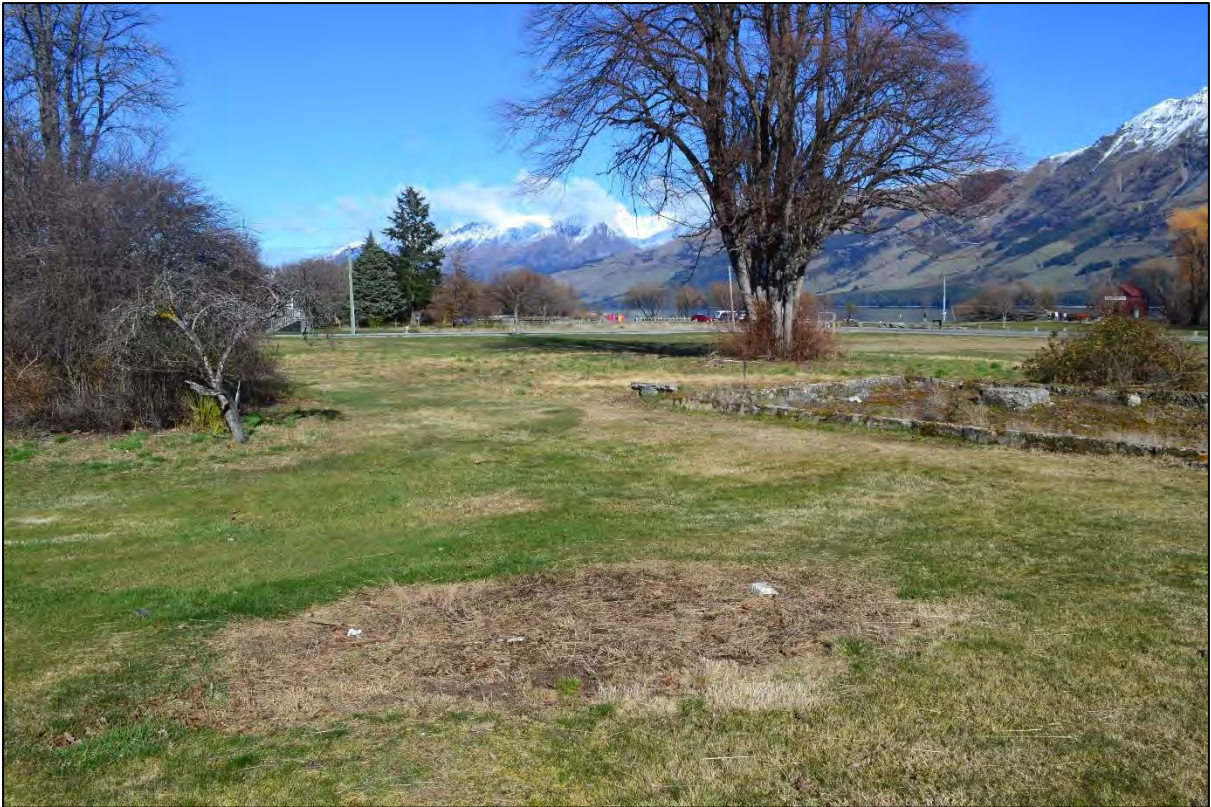
Figure 26. View looking across the rear of the site towards the south with small area of discoloured grass.

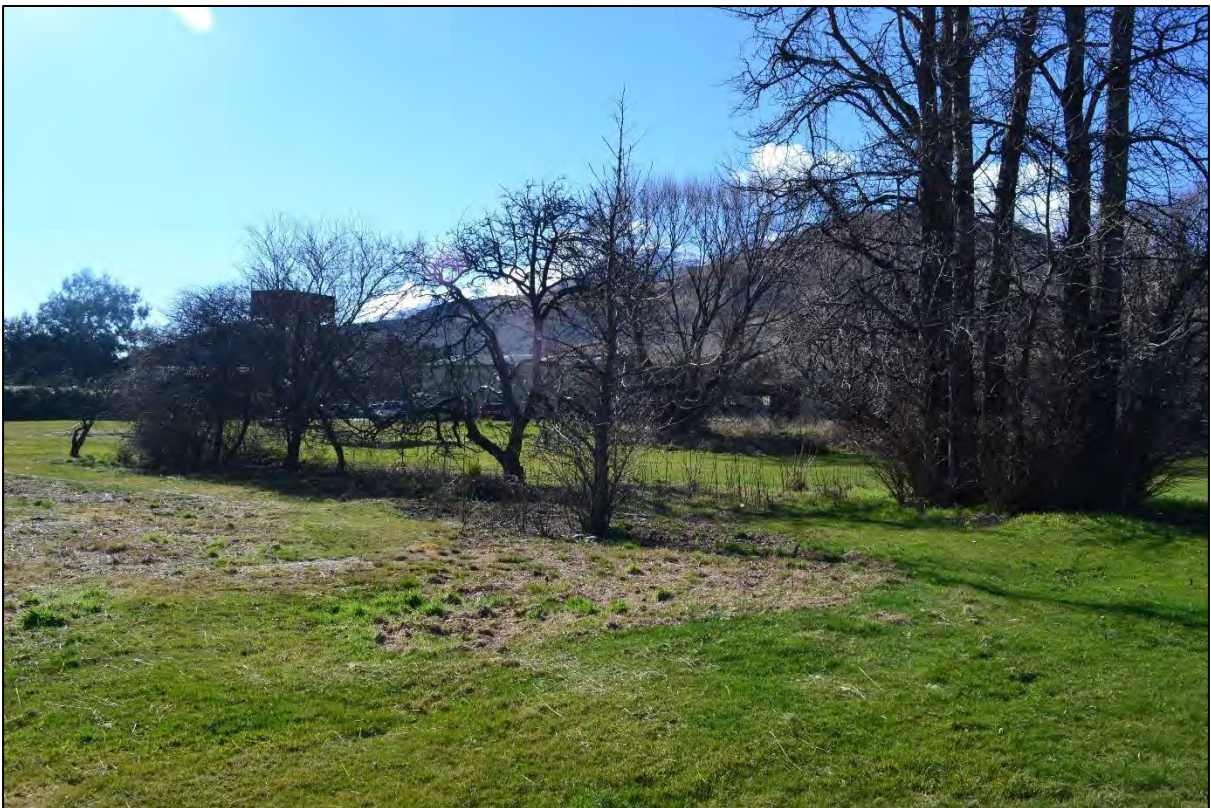
Figure 27. Area of site located in the southeast corner showing trees and various areas of grass growth possibly affected by subsurface material.

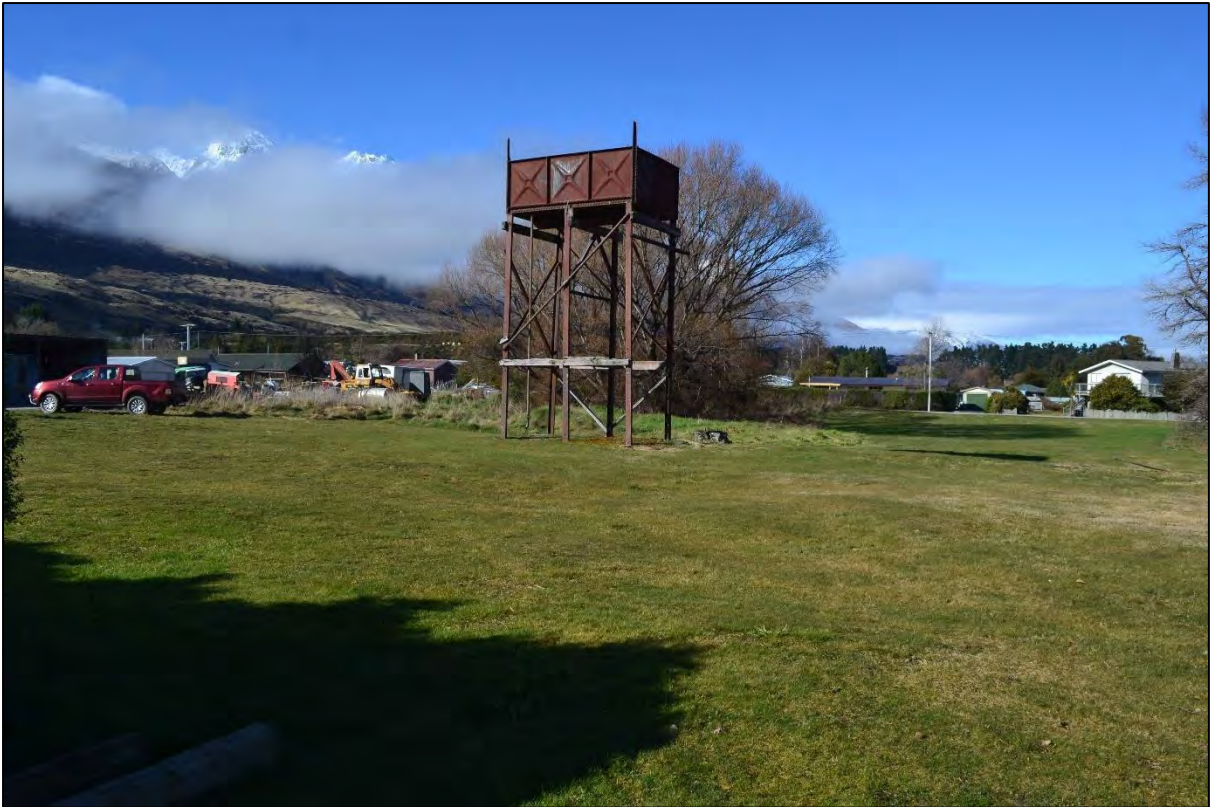
of service elements, which may have been housed in separate outbuildings. A steel water tower is located on the eastern edge of the site (Figure 28).

Figure 28. Historic steel water tank at rear of site.

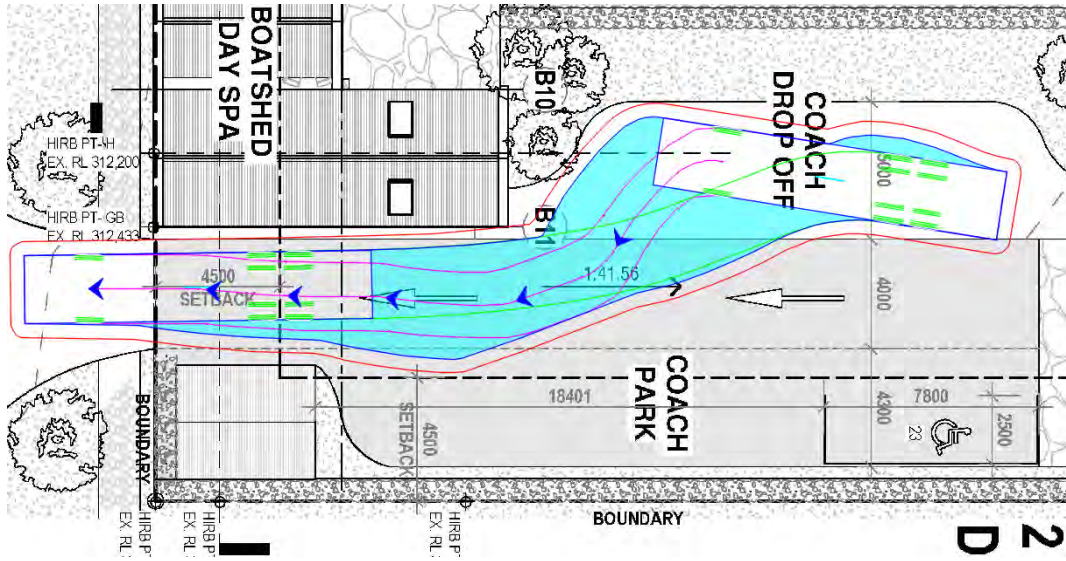
Figure 5: Coach Exiting Drop-Off Area

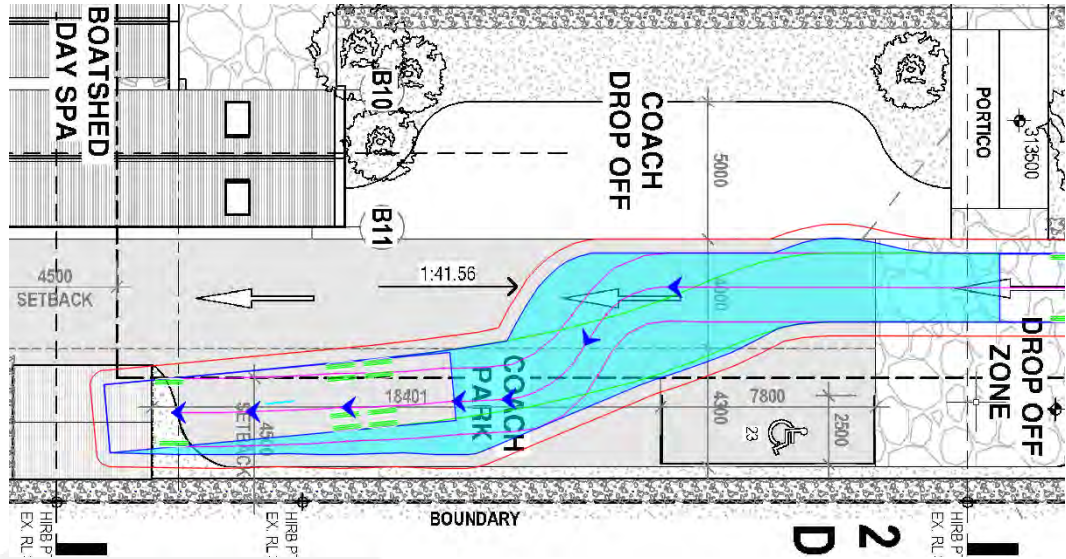
Figure 6: Coach Entering Parking Area Avoiding Mobility Parking Space

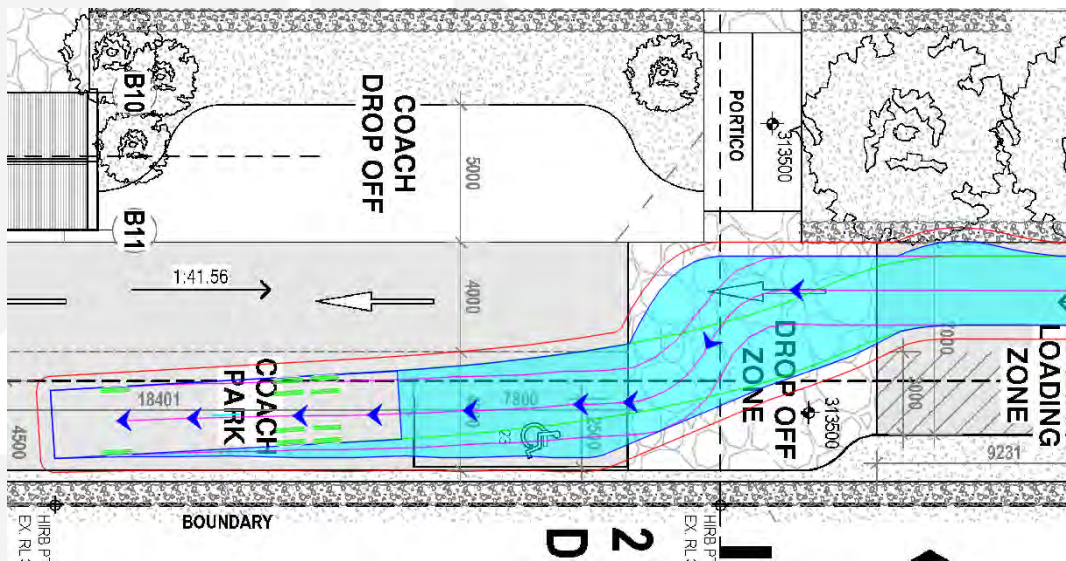
Figure 7: Coach Entering Parking Area Driving Through Mobility Parking Space
