19 January 2015

**MILLBROOK MACAULEY LAND: APPRAISAL OF KNOWN AND INFERRED HAZARDS
AND POTENTIALLY ADVERSE GEOTECHNICAL FEATURES AT SITE**

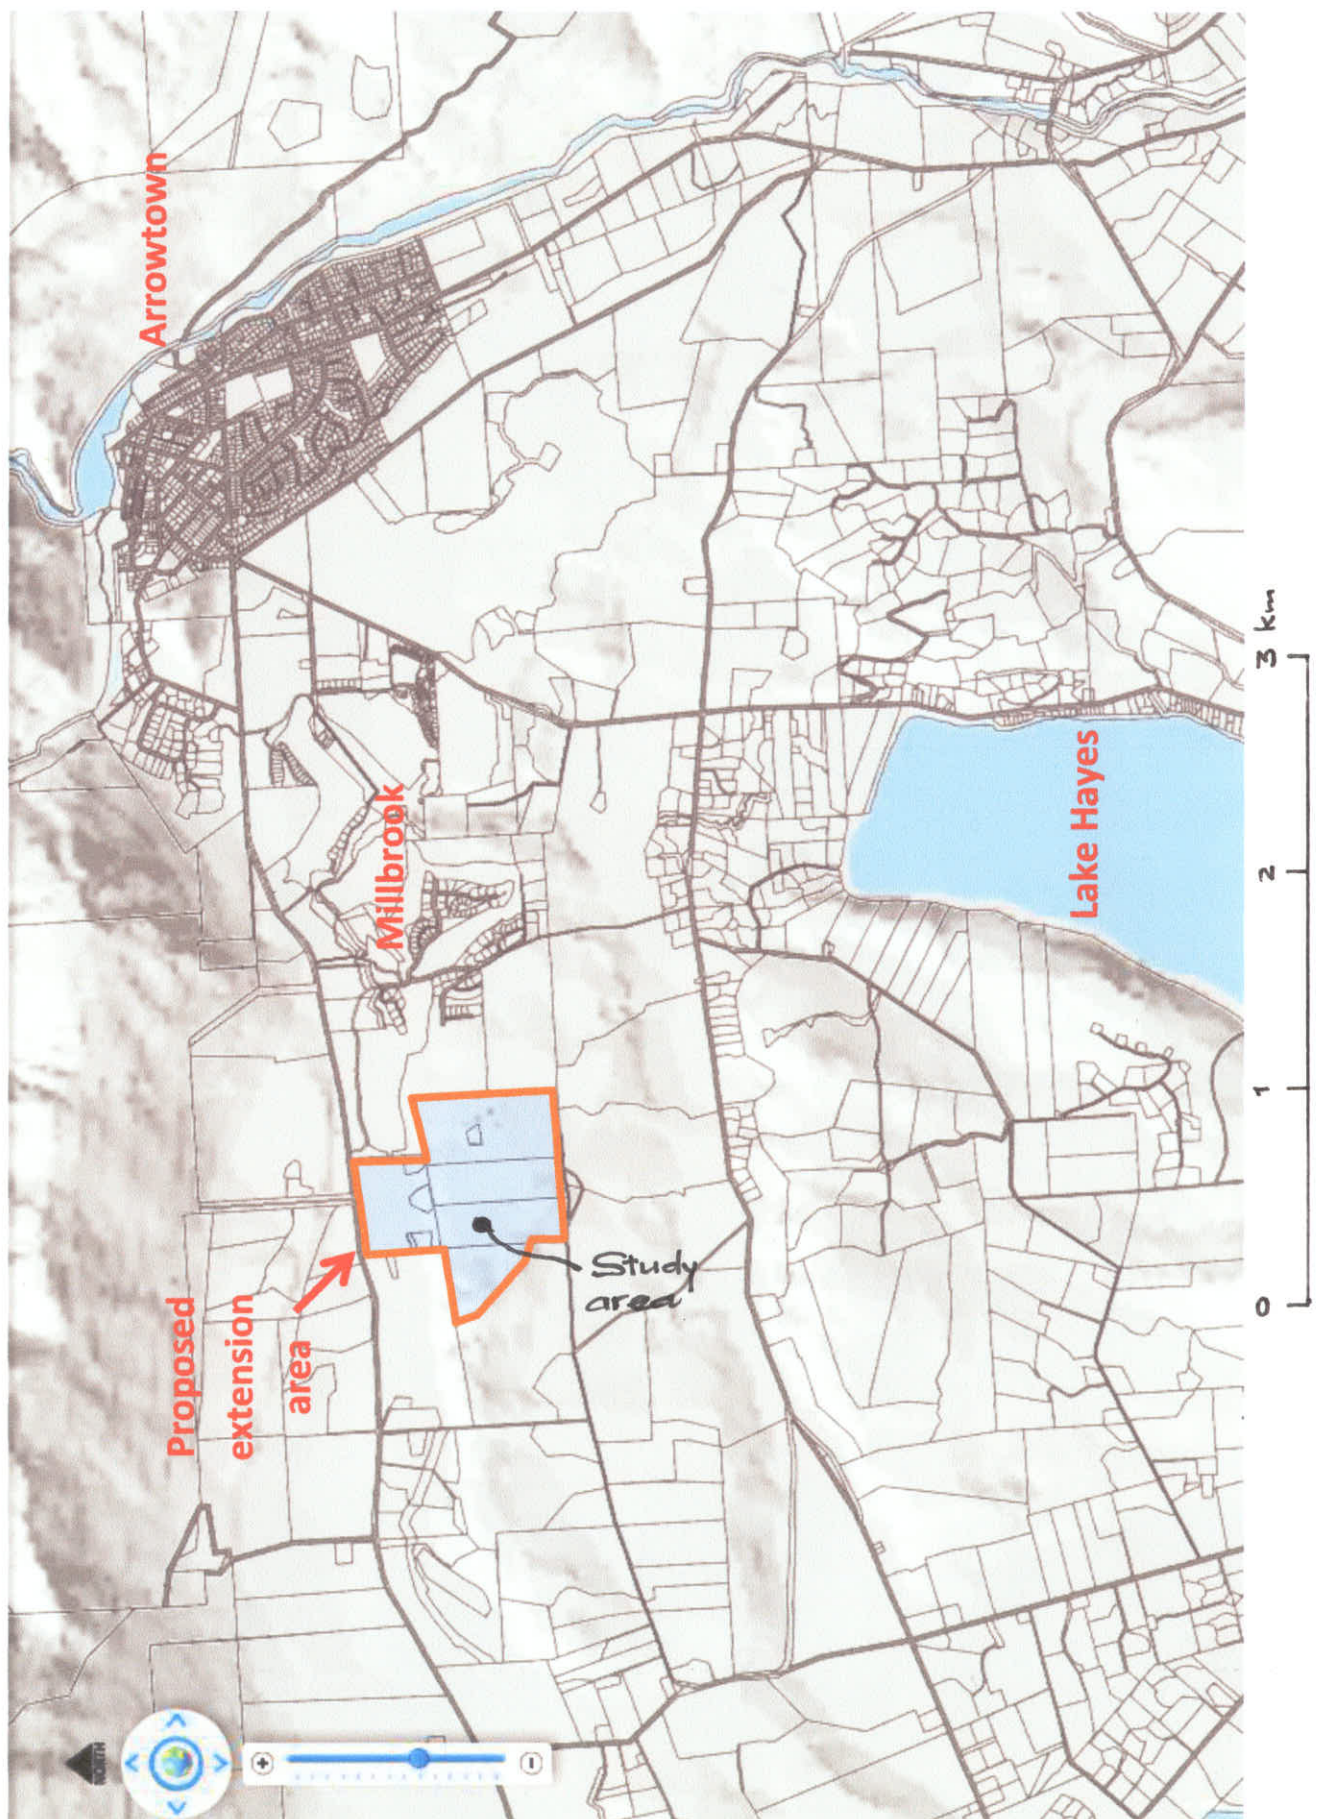
Fig.1 Location of Millbrook site

The site occupies part of an east-west-trending, glacially sculptured, valley and ridge complex just west of Arrowtown (Fig. 1). Mill Creek, and its associated floodplain, traverse the northerly lobe of the property as a variable width band (Fig. 2a) that is flanked by low to moderate gradient slopes. These, in part, are mantled by fans constructed by ephemeral, tributary streams. As indicated by Cross Sections AA' to CC' on Figure 2b, the elevated southern half of the property effectively forms an irregular platform approximately 75 – 100m above Mill Creek, this being a region within which there are substantial proposed developments (Attachment 1).

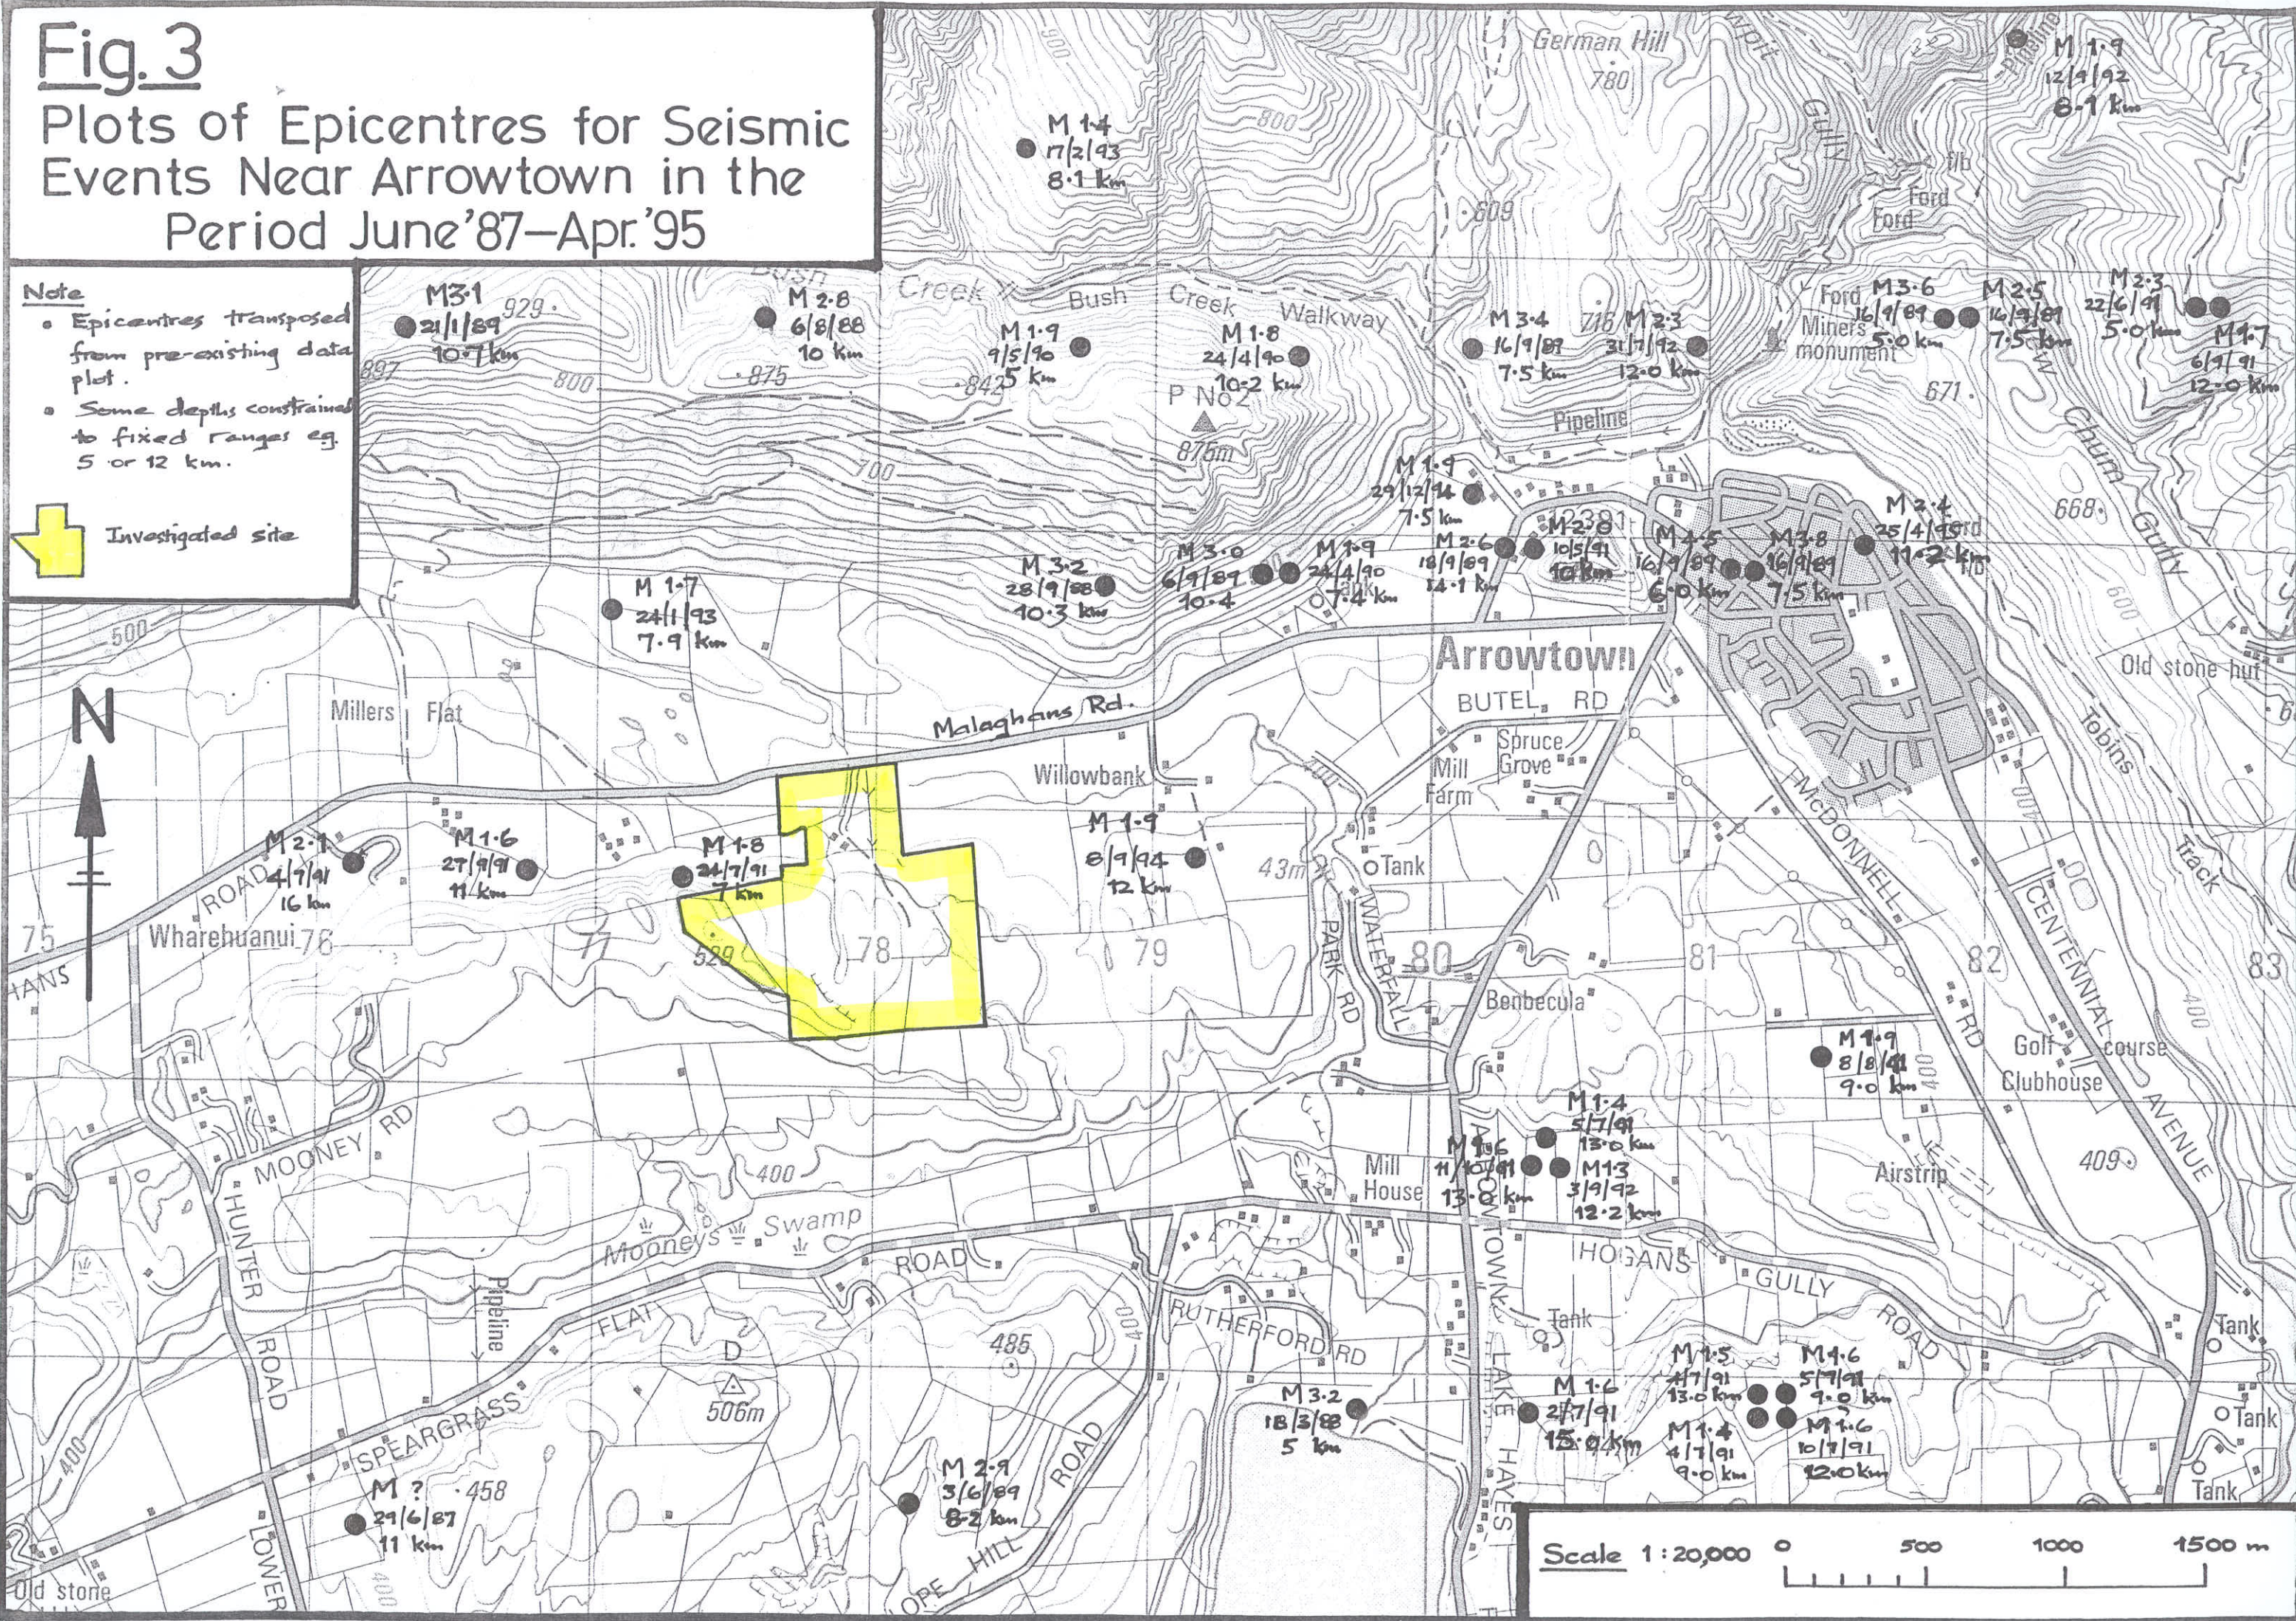
Attachment 1

- (d) Several dwelling clusters are proposed on the north-facing slopes south of the valley axis. Apart from some wet conditions, deemed to be sourced in a leaking race, there are no obvious adverse conditions, providing schist dip slope issues are recognised.

- (e) The lowermost cluster of dwellings is sited variously on fans and a floodplain to the south of Mill Creek. This zone is characterised by QLDC as a low risk area for potential liquefaction, and flooding, and/or erosion, are prospective hazards on both the floodplain and fans during storm events.

- (f) The terrain to the north of Mill Creek is designed as a golfing facility. Issues of flooding on both the floodplain and the central fan are clearly subjective at this stage, although hazard mitigations by earthworks are optional in this area.

- (a) Review the flooding risk for proposed platforms extending onto the right bank floodplain. If the hazard is acceptable, undertake appropriate subsurface investigations to:
 - Assess subfoundation material types.
 - Address the QLDC-defined liquefaction issue.
- (b) Where dwellings are to be sited on right bank fans at lower elevations, adjust platform locations in association with engineering solutions to the relevant flooding and erosion hazards.
