Davis Consulting Group: Preliminary Site Investigation (PSI) Report
and Addendum

Proposed Rezoning of Lakeview Queenstown Preliminary Site Investigation

Queenstown Lakes District Council

July 2014

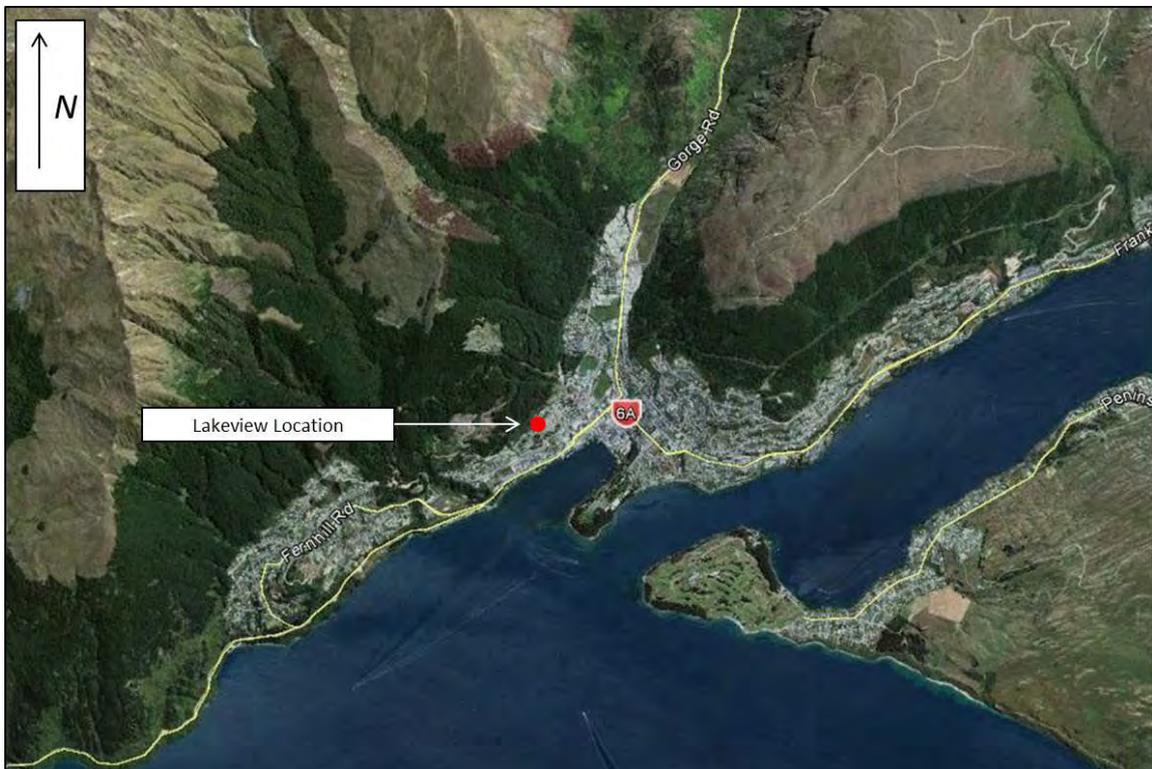
Figure 1: Site Location Plan

The site under investigation is located to west of Queenstown's Central Business District and lies to the north of Man and Brunswick Streets (Figure 1). The legal descriptions of the parcels of land within the Lakeview Sub-Zone are listed below:

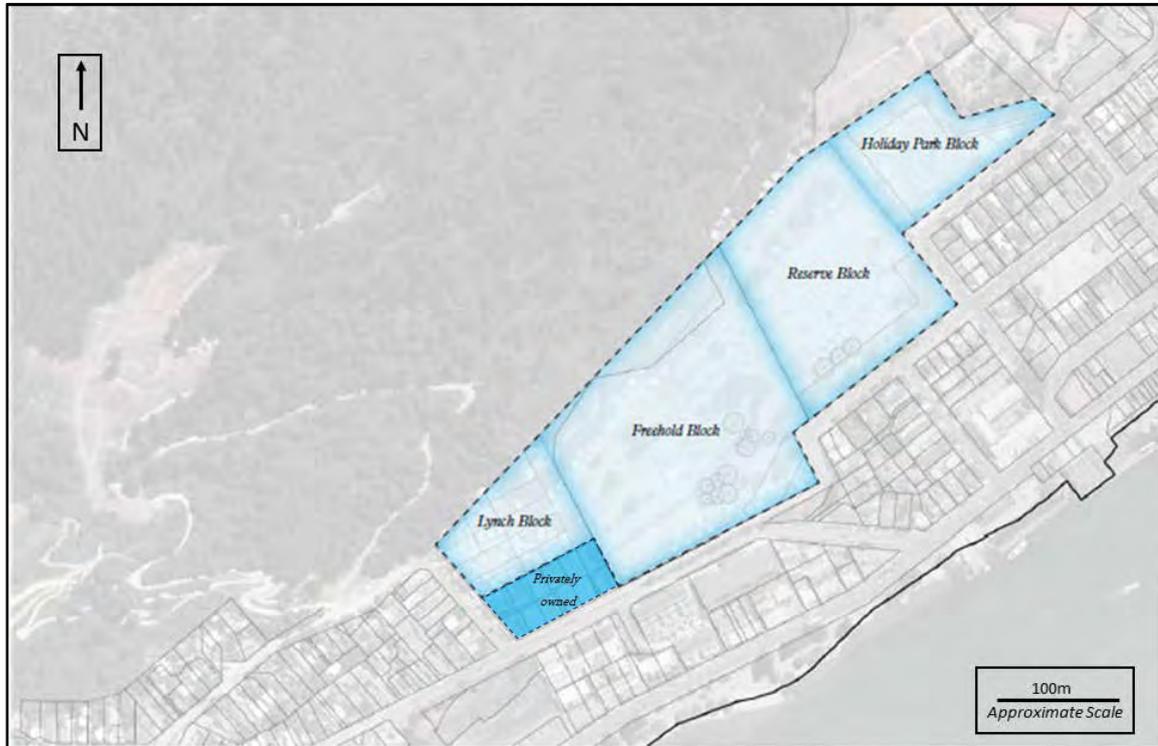
Figure 2: Proposed Lakeview Sub-Zone. Council owned sub-blocks and privately owned land.

Site investigation took place within the Lynch, Freehold, Reserve and Holiday Park Blocks of the Lakeview Sub-Zone. These four sub-blocks are shown in Figure 2, shaded light blue. The section of privately owned land in the south-west corner of the Lakeview Sub-Zone was excluded from investigation. This is shaded blue in Figure 2.

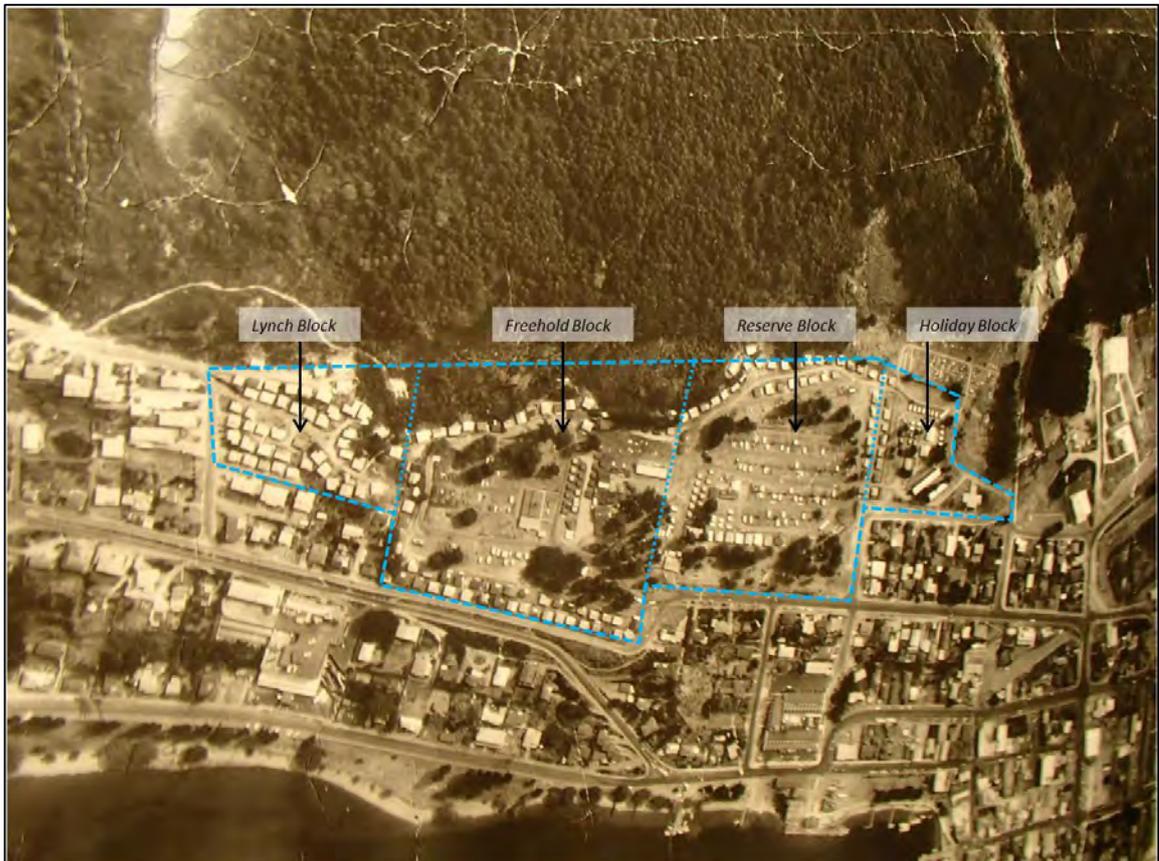
Figure 4: 1970 Aerial Photograph

Plans submitted to the council in 1959 propose a camp ground, cribs, ablution block and power transmission lines within the site (QLDC E Docs, 2014) (Appendix B). These proposed facilities were established by 1970 as observed aerial photography (Figure 4) showing maintained lawn areas for camping, cribs and associated facilities. Between 1999 and 2004, the ablution blocks in the south western corner of reserve block were removed and replaced by present day ablutions located in the south eastern corner, as seen in historical park plans (Appendix B) and aerial photographs.

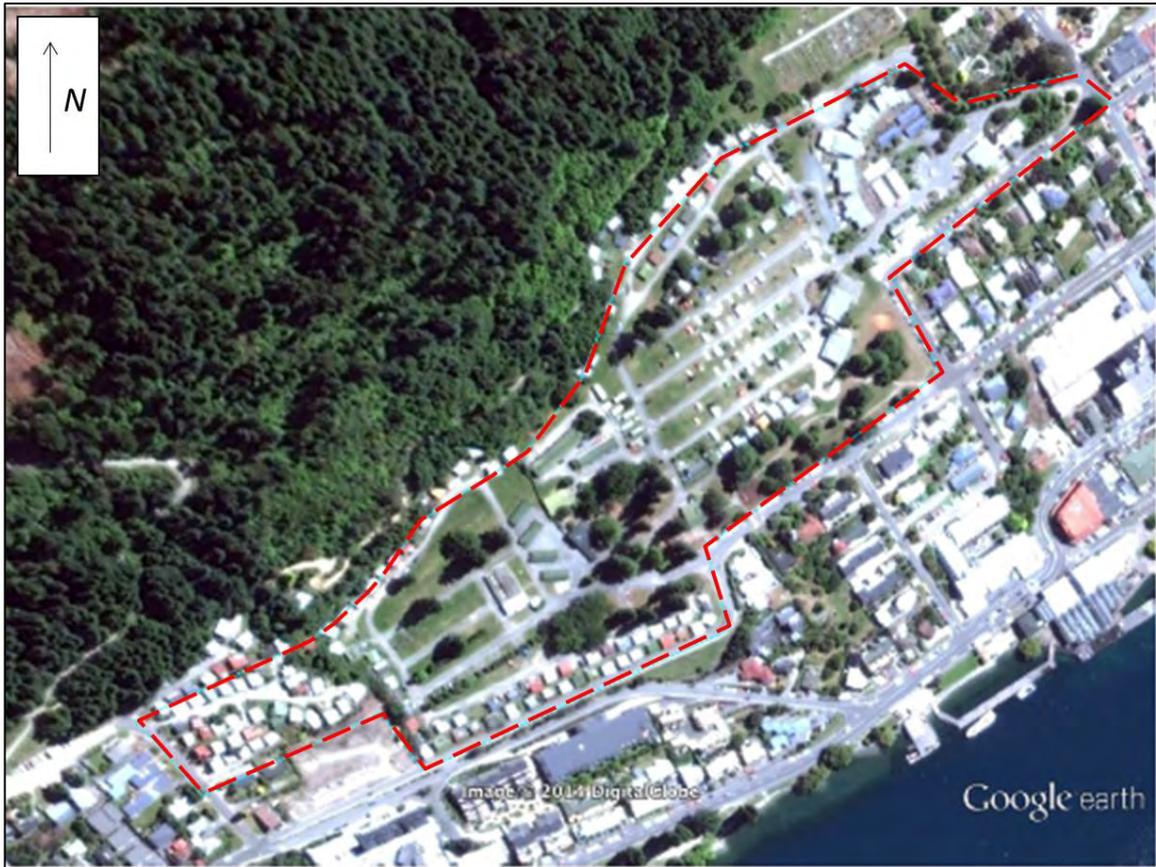
Figure 5: 2013 Aerial Photograph

The existing holiday park is shown in the 2013 aerial photograph (see Figure 5). Current facilities include a public waste water dump station, ablution block, motel units and holiday park reception (Plate 1). A plan of the holiday park is included in Appendix B. Waste water from the ablutions and waste water dump stations is reticulated to the main town waste water system, as

Existing buildings and facilities are shown in the 2013 aerial photograph (see Figure 5).
