Geotechnical Hazards – Preliminary Assessment Proposed Mt Cardrona Station Private Plan Change

October 2016

GeoSolve Ref: 160677

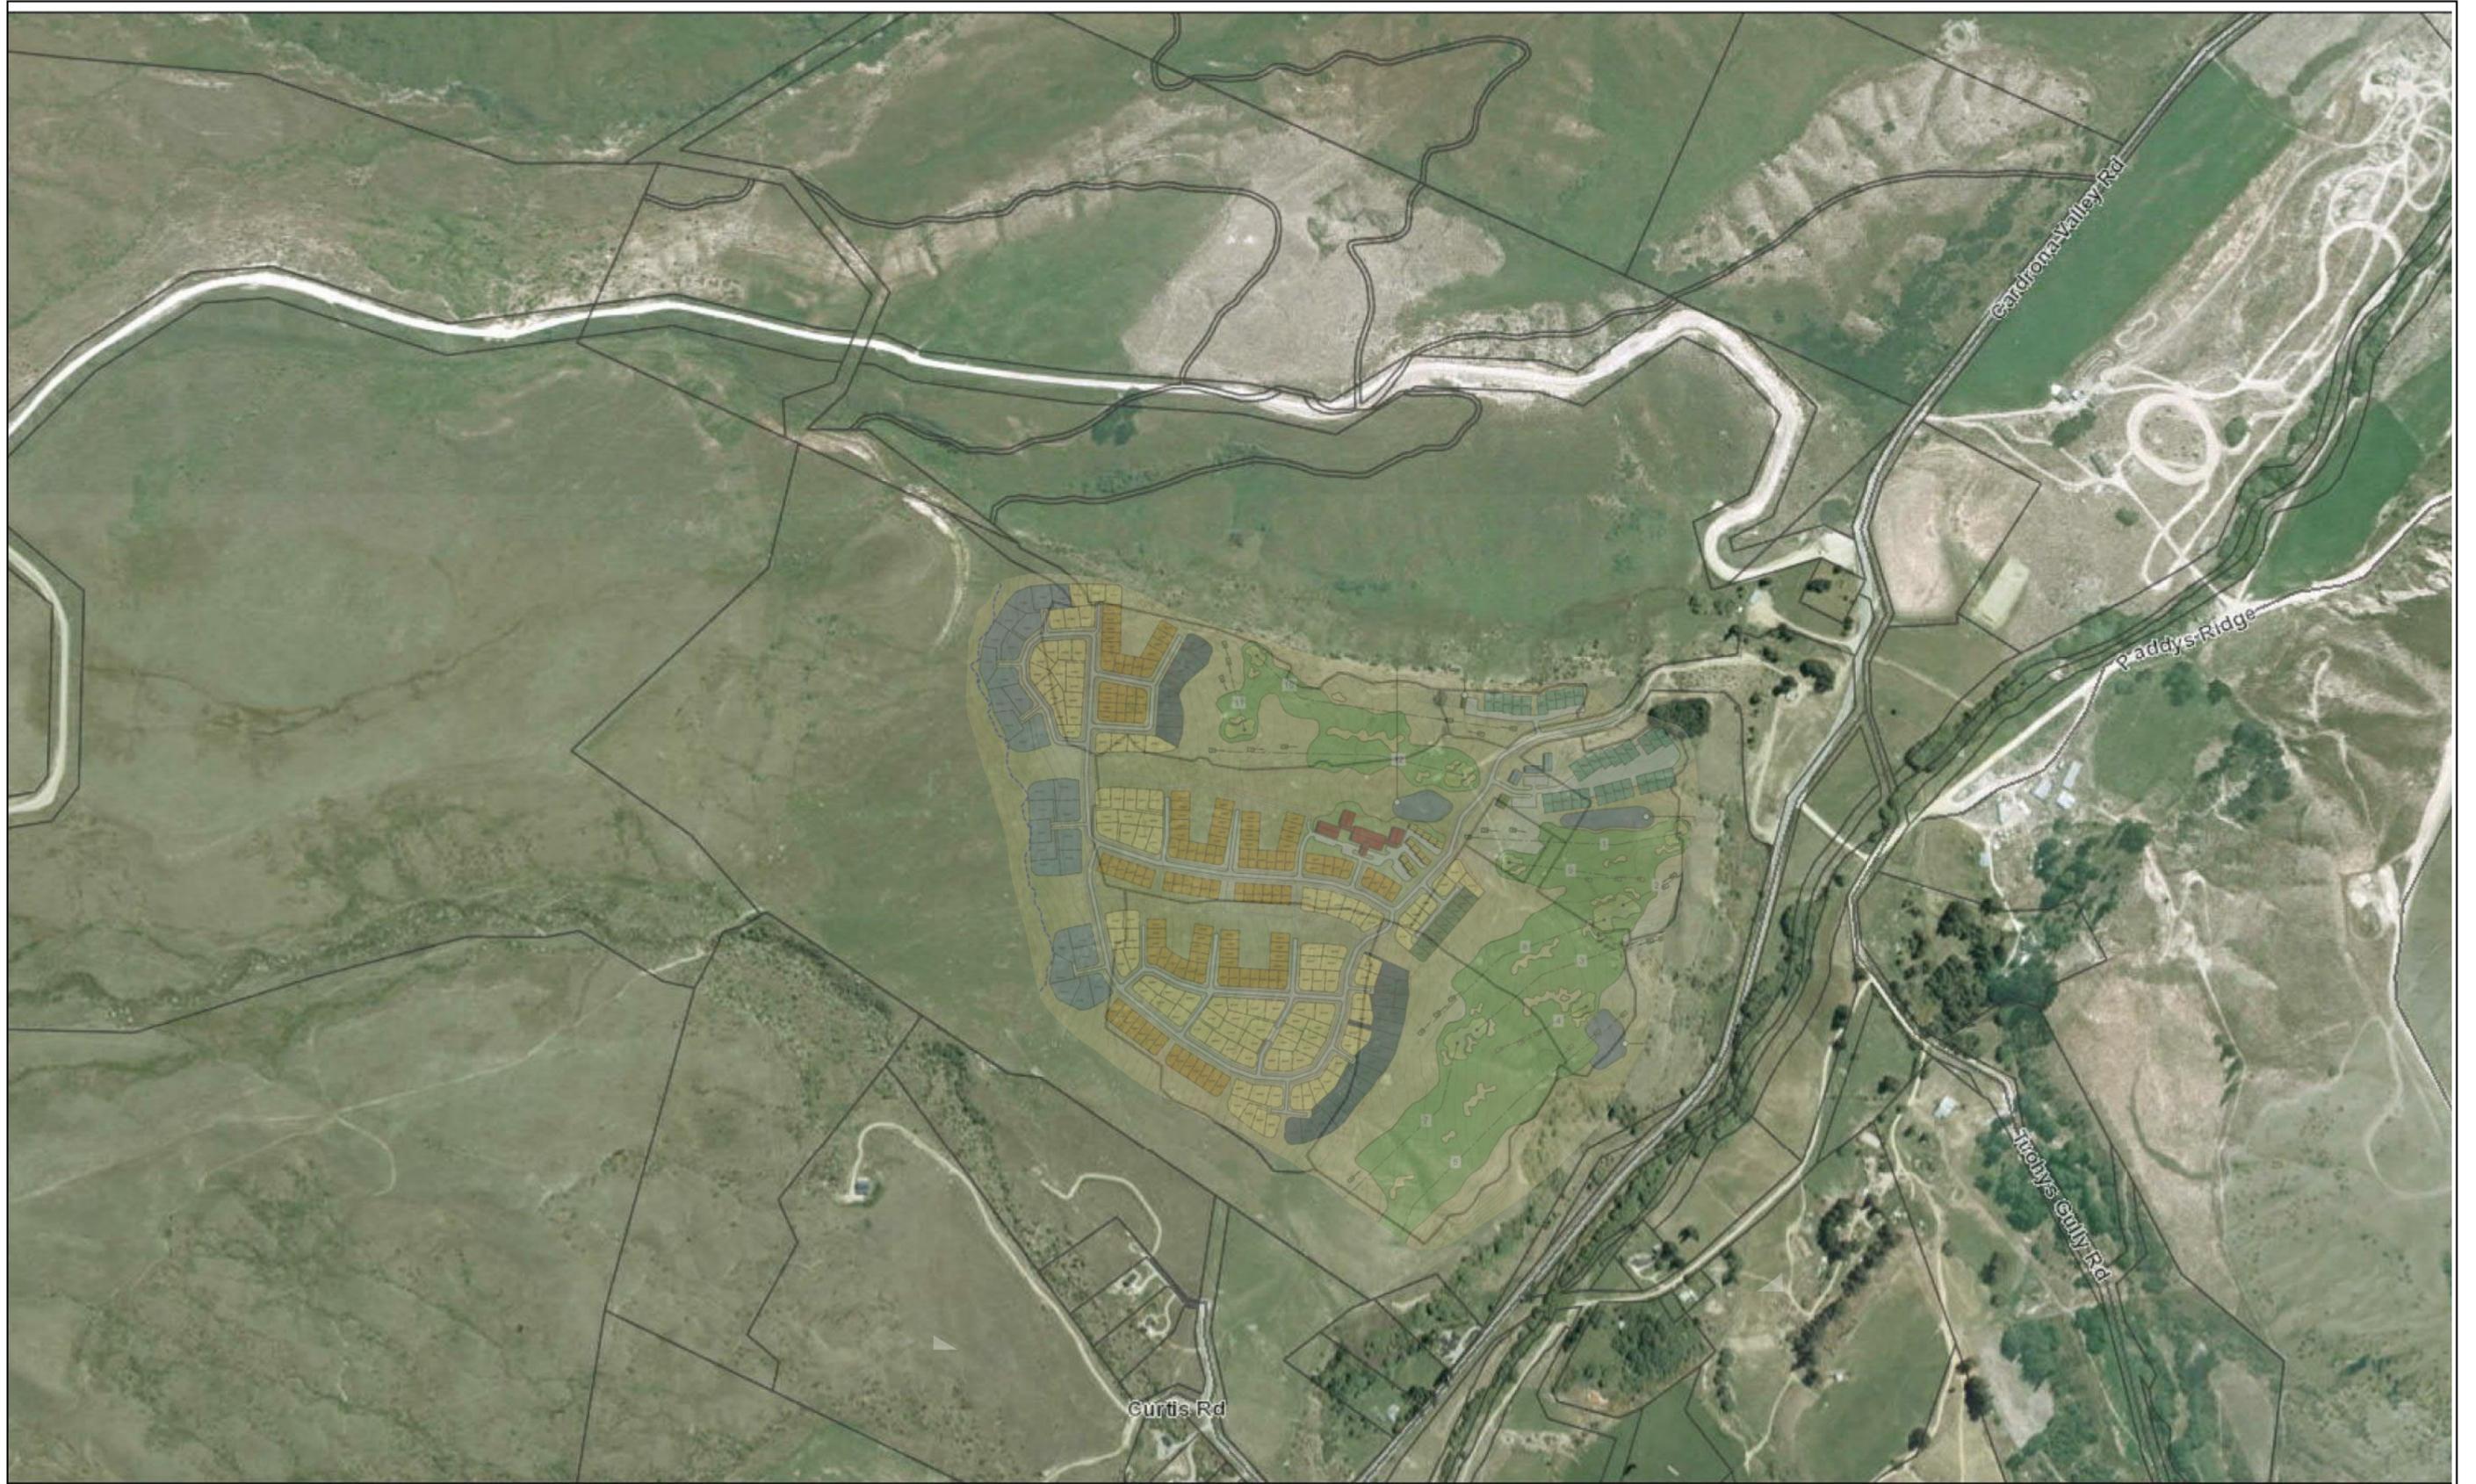
FIG No. Appendix A- Figure 3

Current QLDC and ORC mapping identifies alluvial fan hazard and active faulting hazards within and near the proposed site area (Figure 3, Appendix A). Detailed geological mapping has also identified shallow landslide and mining hazards in the site area (Figure 2, Appendix A).
