NATURAL HAZARDS ASSESSMENT REPORT

JOB TITLE	HOMESTEAD TRUSTEES HAZARDS GEOTECH
ADDRESS	HOMESTEAD BAY, JACKS POINT
JOB NUMBER	50504
	9 June 17

Client: Homestead Bay Trustees Limited  
Private Bag 39534,  
Takapuna  
Auckland

50504 Homestead GeoHazard Report

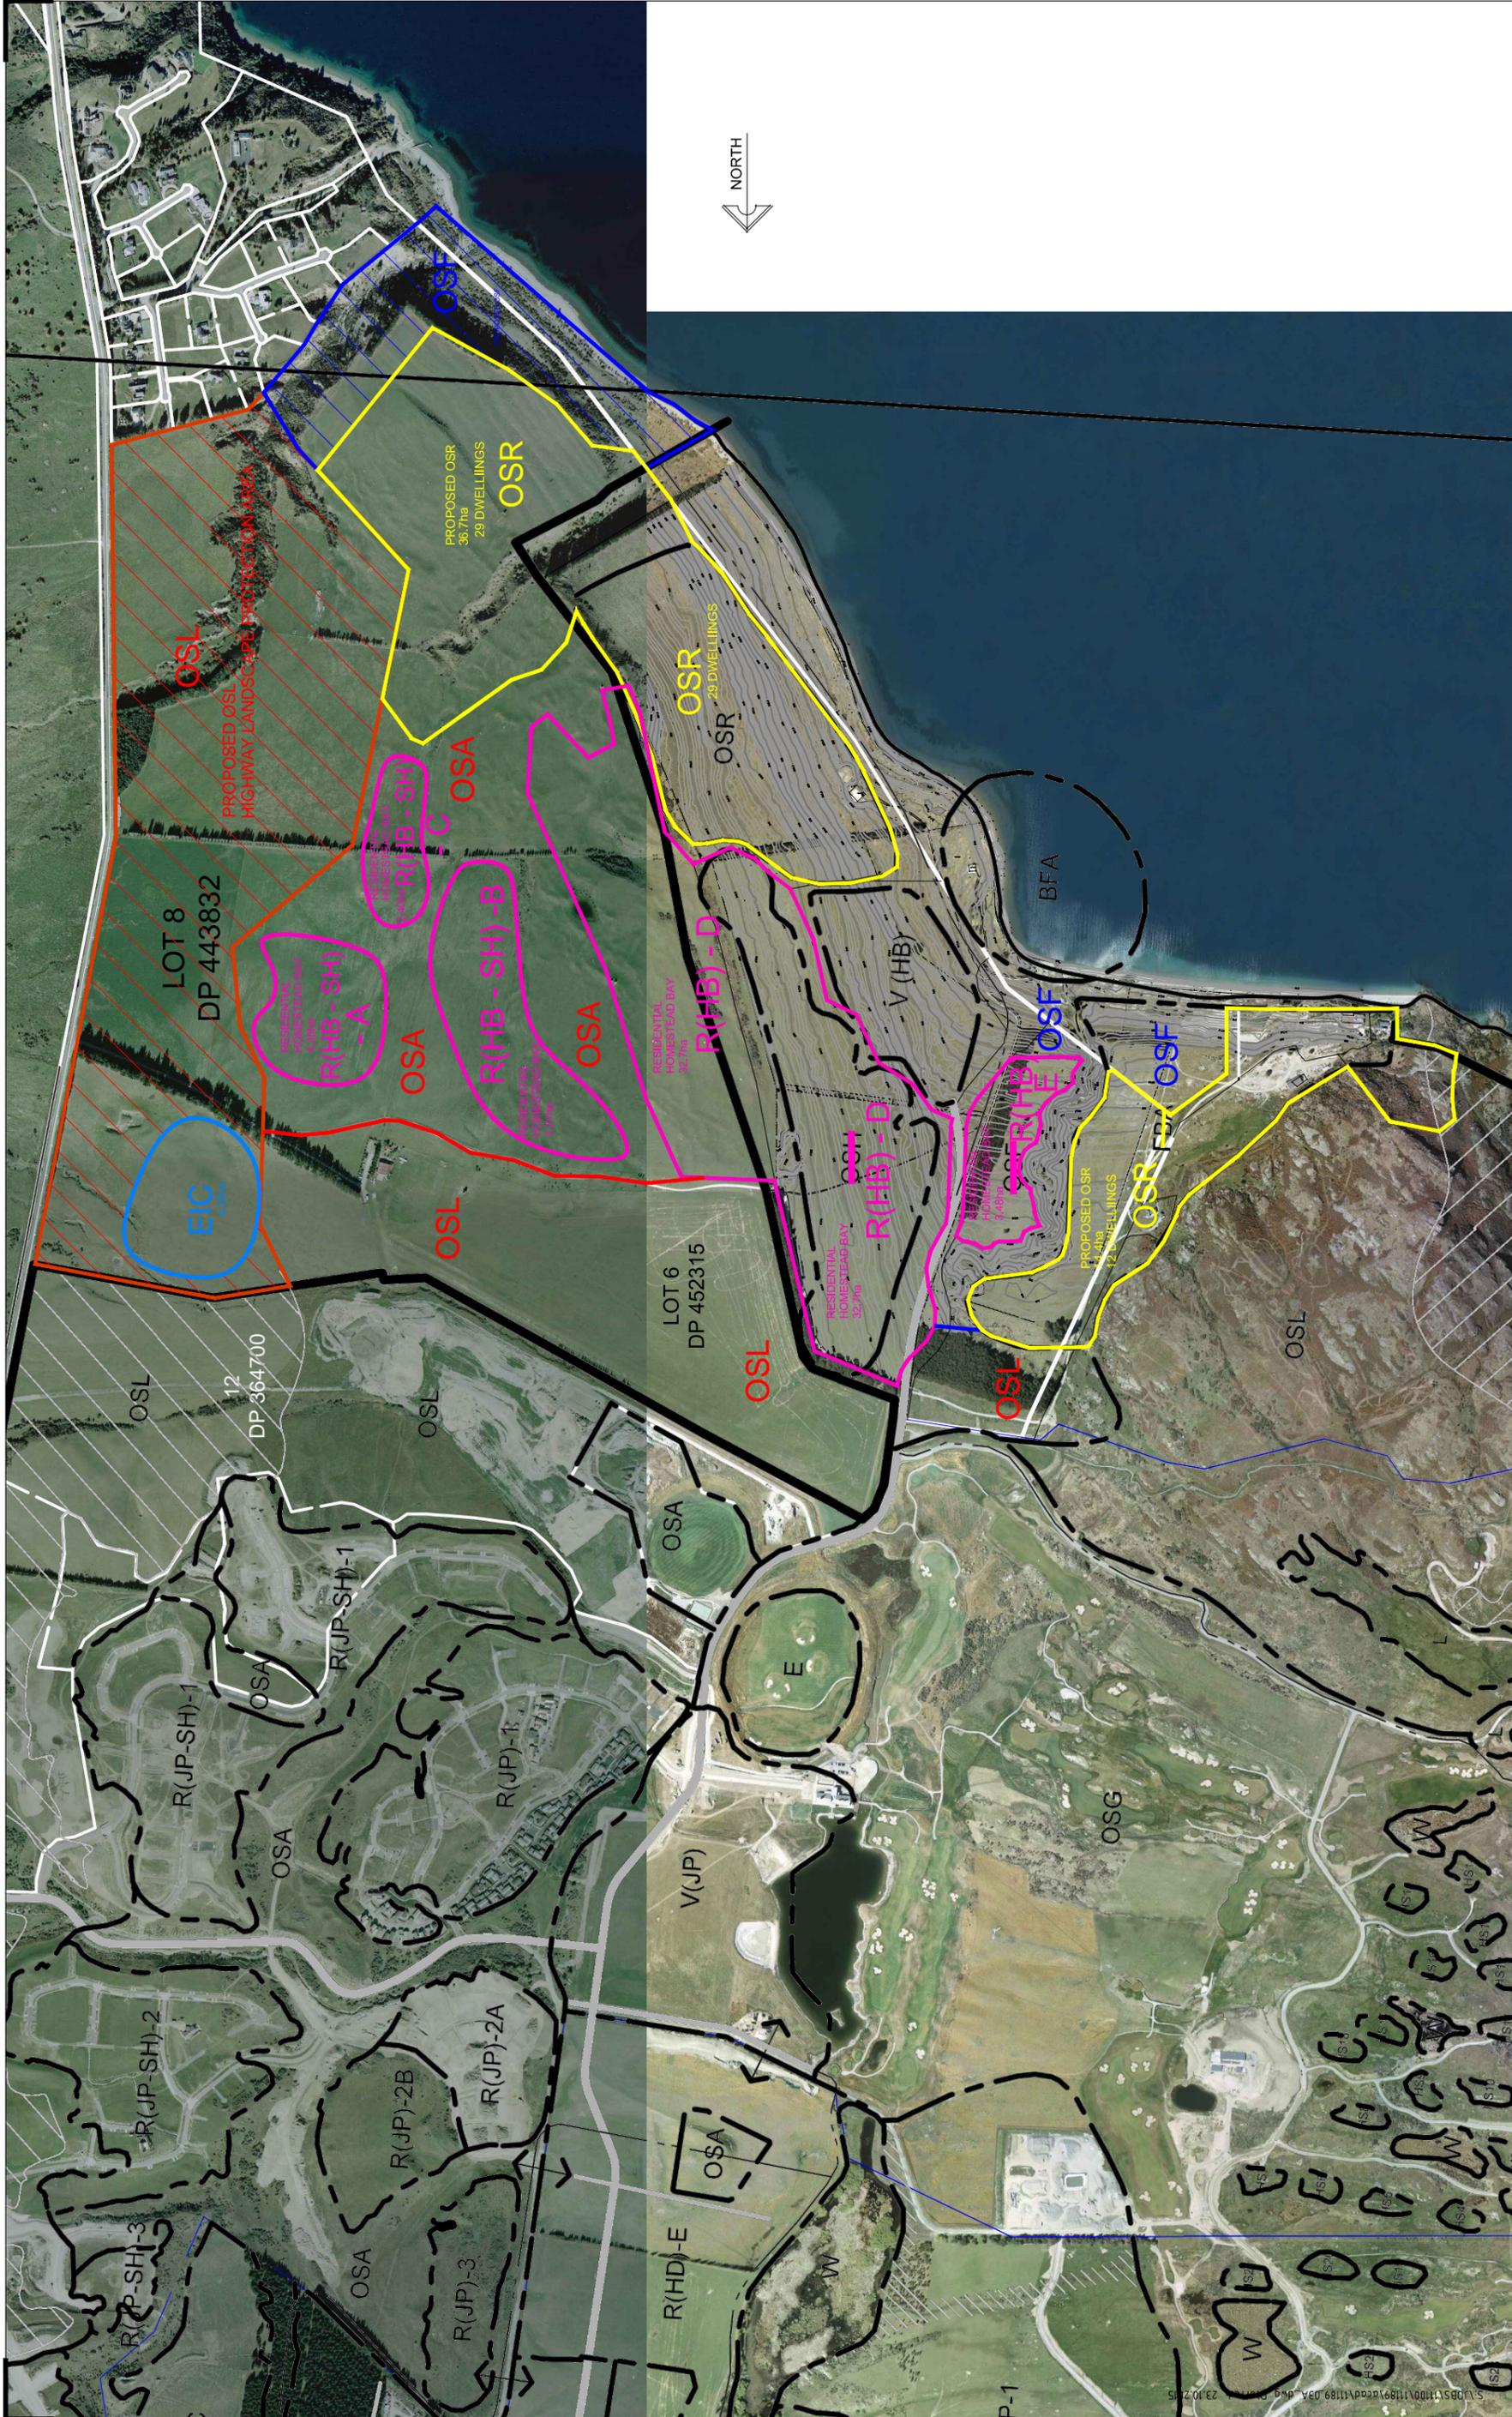
**PROPOSED STRUCTURE PLAN AND EXTENSION TO JACKS POINT ZONE  
HOMESTEAD BAY  
OVER LOTS 1 TO 8 DP 443832**

The only potential areas of the development that may be subject to specific liquefaction engineering and designed foundations for structures is likely to be a small area in the western most portion of LOT6 DP 452315 (OSL)

We have sketched the approximate extent of area that could be subject to this hazard on the plan "Hazard Areas" in Appendix A. It must be noted that standard investigation and design would be expected to mitigate this potential hazard hence this area is not precluded from development.

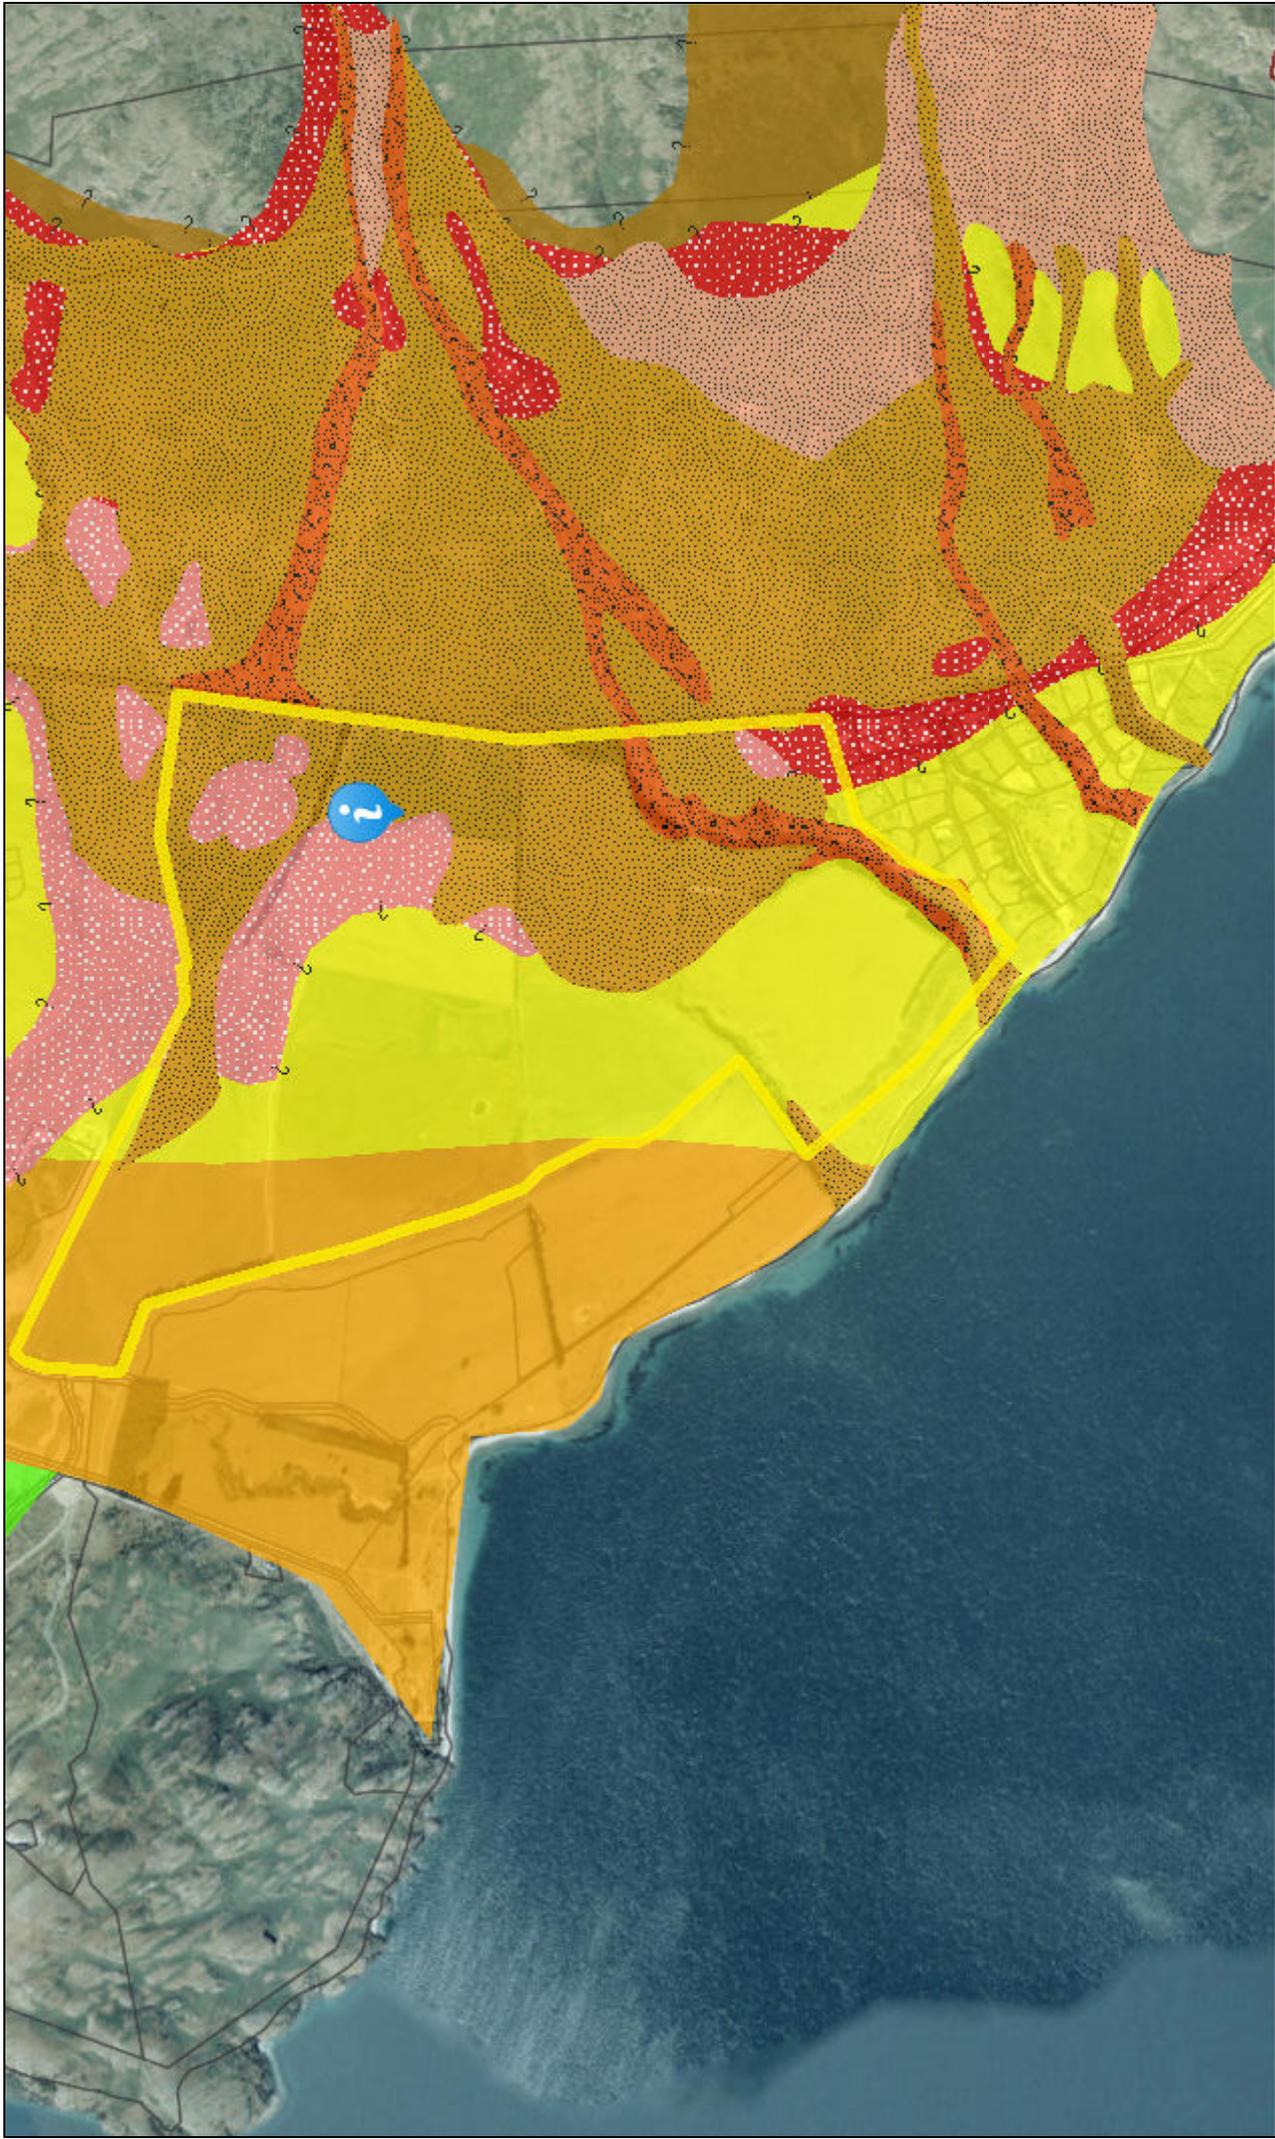
Queenstown Lakes District Council

From the QLDC hazard maps the following natural hazards are mapped across the sites extent.
