Wanaka Water Supply Water Safety Plan

Final
November 2015

Project	Water Safety Plan (formally Public Health Risk Management Plan)				
Report	Wanaka Water Supply Water Safety Plan				
Date	November 2015				
Document Reference:					
Version	Author	Reviewed	Signature	Date	Distribution
Wanaka Water Supply PHRMP	MWH	June 2010		June 2010	QLDC, PHS
Wanaka Water Supply Water Safety Plan 2015 v1.3	M. Heather – QLDC	J. Rozitis, D Lind, J. Thorburn		13 October 2015	J. Thorburn, J. Rozitis (Veolia) R. Darby, U. Glasner, D Lind(QLDC)
Wanaka Water Supply Water Safety Plan 2015 v1.4	M. Heather – QLDC				Draft submitted to Public Health South. Presented to Wanaka Community Board workshop.
					Submitted to Public Health South for Adequacy Assessment, QLDC, Veolia

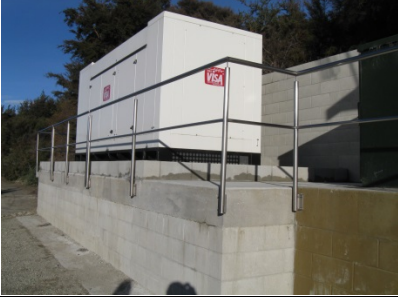
Beacon Point Intake mesh screen	Beacon Point Intake Pump Station generator	Beacon Point Intake pump and valve chambers

The Beacon Point Intake draws water via a 630mm OD MDPE pipe. A new Kleenscreen inlet screen was installed in 2009 with a 0.9mm stainless steel mesh designed to prevent debris and large particulate matter from being drawn into the intake. This mesh was replaced in 2011 with a 20mm mesh due to irreparable damage to the screen.

A 500 kVa back-up diesel generator was installed on-site in 2013 in the event of a power failure. The generator is sized to start one pump under emergency conditions using the existing switchgear at the site.

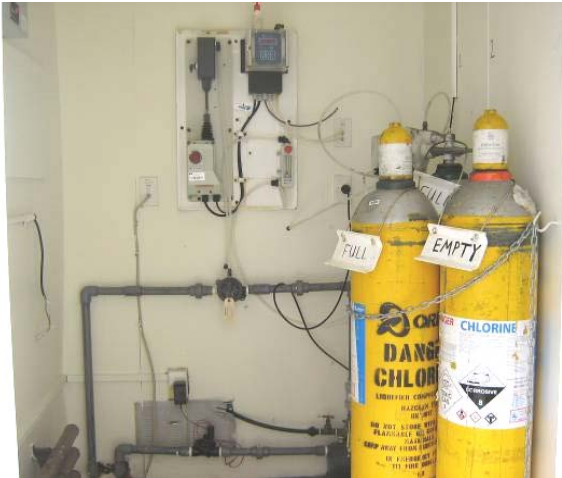
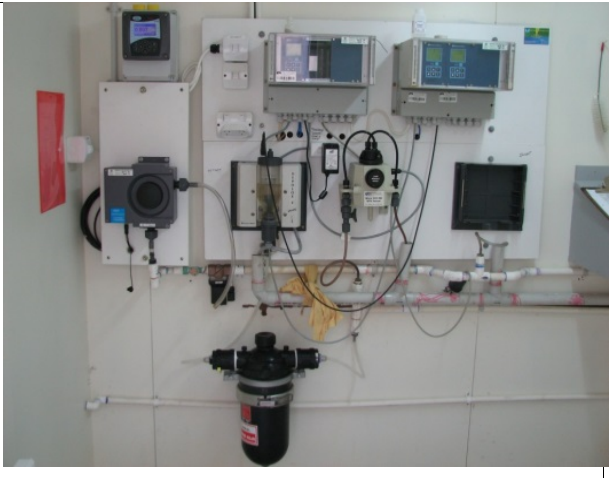
Gas bottle and W&T chlorine dosing equipment with gas bottle auto change over	Depolox and turbidity meters

Western Chlorination: The chlorination at Western Reservoir is a gaseous chlorine system that injects chlorine into the water as it is pumped from the intake into the reservoir. The dosing pumps, equipment, and chlorine bottles are stored in a small and secure concrete building adjacent to the reservoir. The building is away from any residential properties and well locked with appropriate hazard signs.

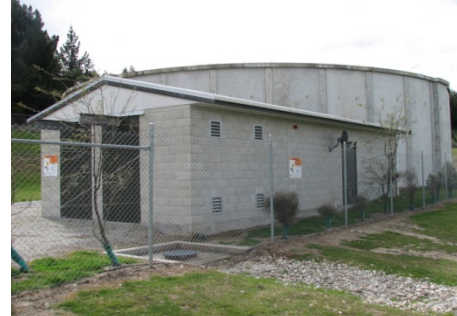
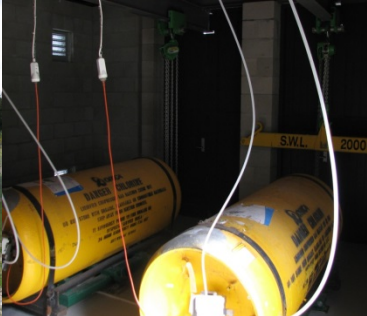
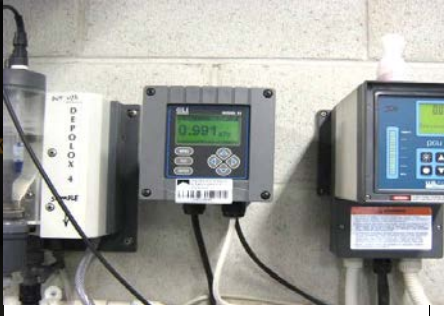
Beacon Point reservoir and treatment building securely fenced	Chlorine drums	Typical Depolox 4 set up for pH and FAC on the reservoir inlet and outlet stream

The dosing pumps, analysers and two 1 tonne chlorine cylinders are stored in a concrete building adjacent to the reservoir. The building is securely locked, displays the appropriate hazard signs and is away from any residential properties.

There is a pH meter, turbidimeter and chlorine analyser in the building. pH and FAC are measured pre and post reservoir using dual instruments. They all have high and low set points (which for chlorine are 0.6 and 2mg/L) and if the treated water is outside these limits an alarm is sent to the operators who can respond within 20 minutes. The UVT analysers are turned off in summer due to the algae clogging the analysers. Compressed air is used to remove algae from the analysers.

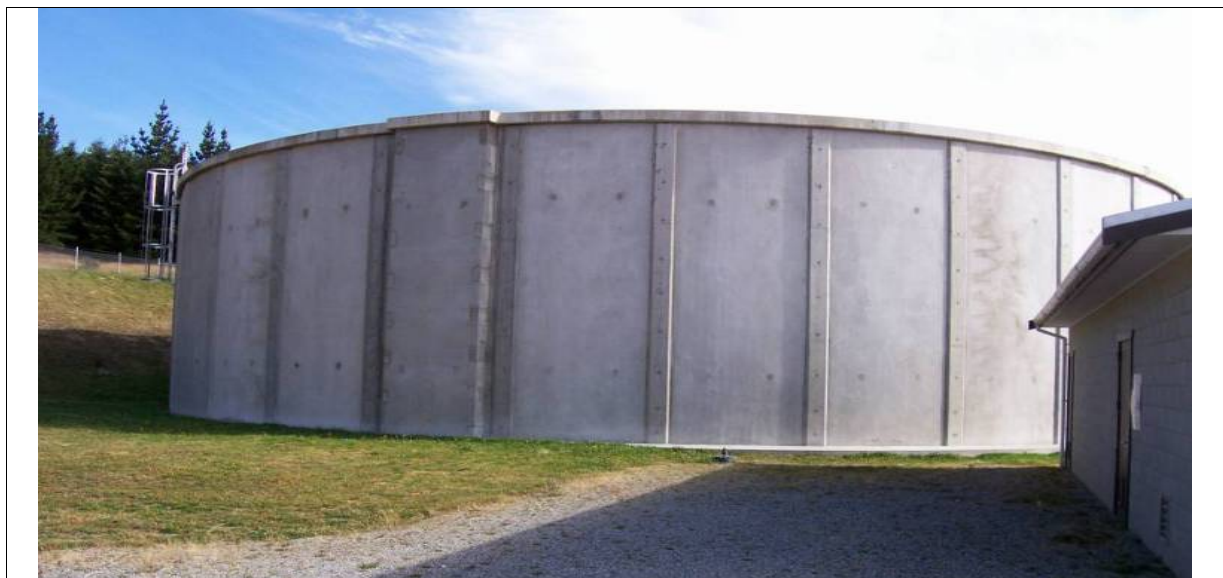
The building to the right of the reservoir houses the chlorine cylinders.

Beacon Point Reservoir: The existing storage capacity of Beacon Point reservoir is 3,500m³. This reservoir is the largest of all the reservoirs on the Wanaka water supply and can supply water to all other reservoirs in the Wanaka area.

The reservoir is in good condition with no signs of water ingress on the roof surface. The access manhole lids are all raised and the vents are sealed against animal ingress. The reservoir and associated facilities are fenced and locked. The fence has barbed wire on top. There is no light to light the site in the dark however the entire system is automated and therefore it is considered lighting is not required.
