Wanaka Airport Water Supply Water Safety Plan

Final
September 2015

Project	Water Safety Plan (formally Public Health Risk Management Plan)				
Report	Wanaka Airport Water Safety Plan				
Date	September 2015				
Document Reference:					
Version	Author	Reviewed	Signature	Date	Distribution
Wanaka Airport 2011 PHRMP v2 - Draft	B. Goldman - Alpine Environmental			2011	
Draft Wanaka Airport Water Safety Plan 2015 v1.2	M. Heather – QLDC	R. Darby, U. Glasner, R. Fegan, J. Thorburn		19/6/2015	J. Thorburn (VW) R. Darby, U. Glasner (QLDC) F. Fegan (Wanaka Airport)
Draft Wanaka Airport Water Safety Plan 2015 v2.0	M. Heather – QLDC	R. Darby U. Glasner	R. Darby	2/9/2015	Draft submitted to Public Health South. Presented to Wanaka Community Board workshop.
Final Wanaka Airport Water Safety Plan 2015 v2.1	M. Heather – QLDC			21/10/2015	Presented to Wanaka Community Board.

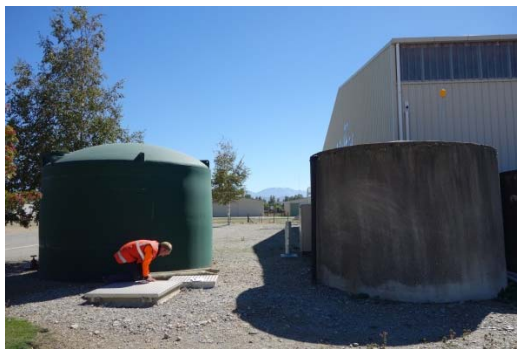
Borehead under steel lid, plastic firefighting storage tank & concrete storage tank (reservoir)

Water is pumped from the bore into a 25,000L covered concrete storage tank (reservoir) located directly adjacent to the bore. The bore and bore pump are considered to be in good condition.

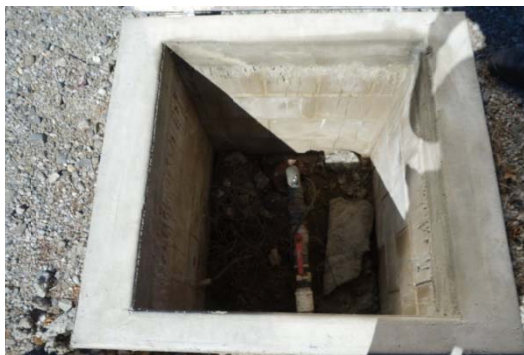
Borehead within concrete chamber. Borehead itself not sealed.

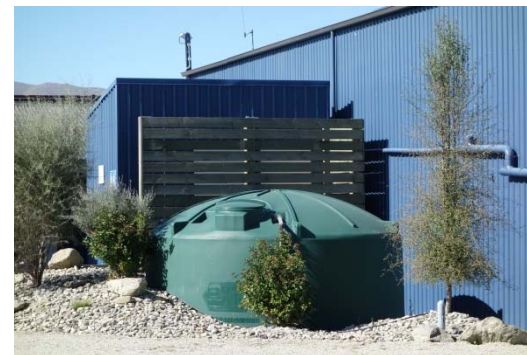
Plastic storage tanks like this one are located on each property for storage & firefighting.

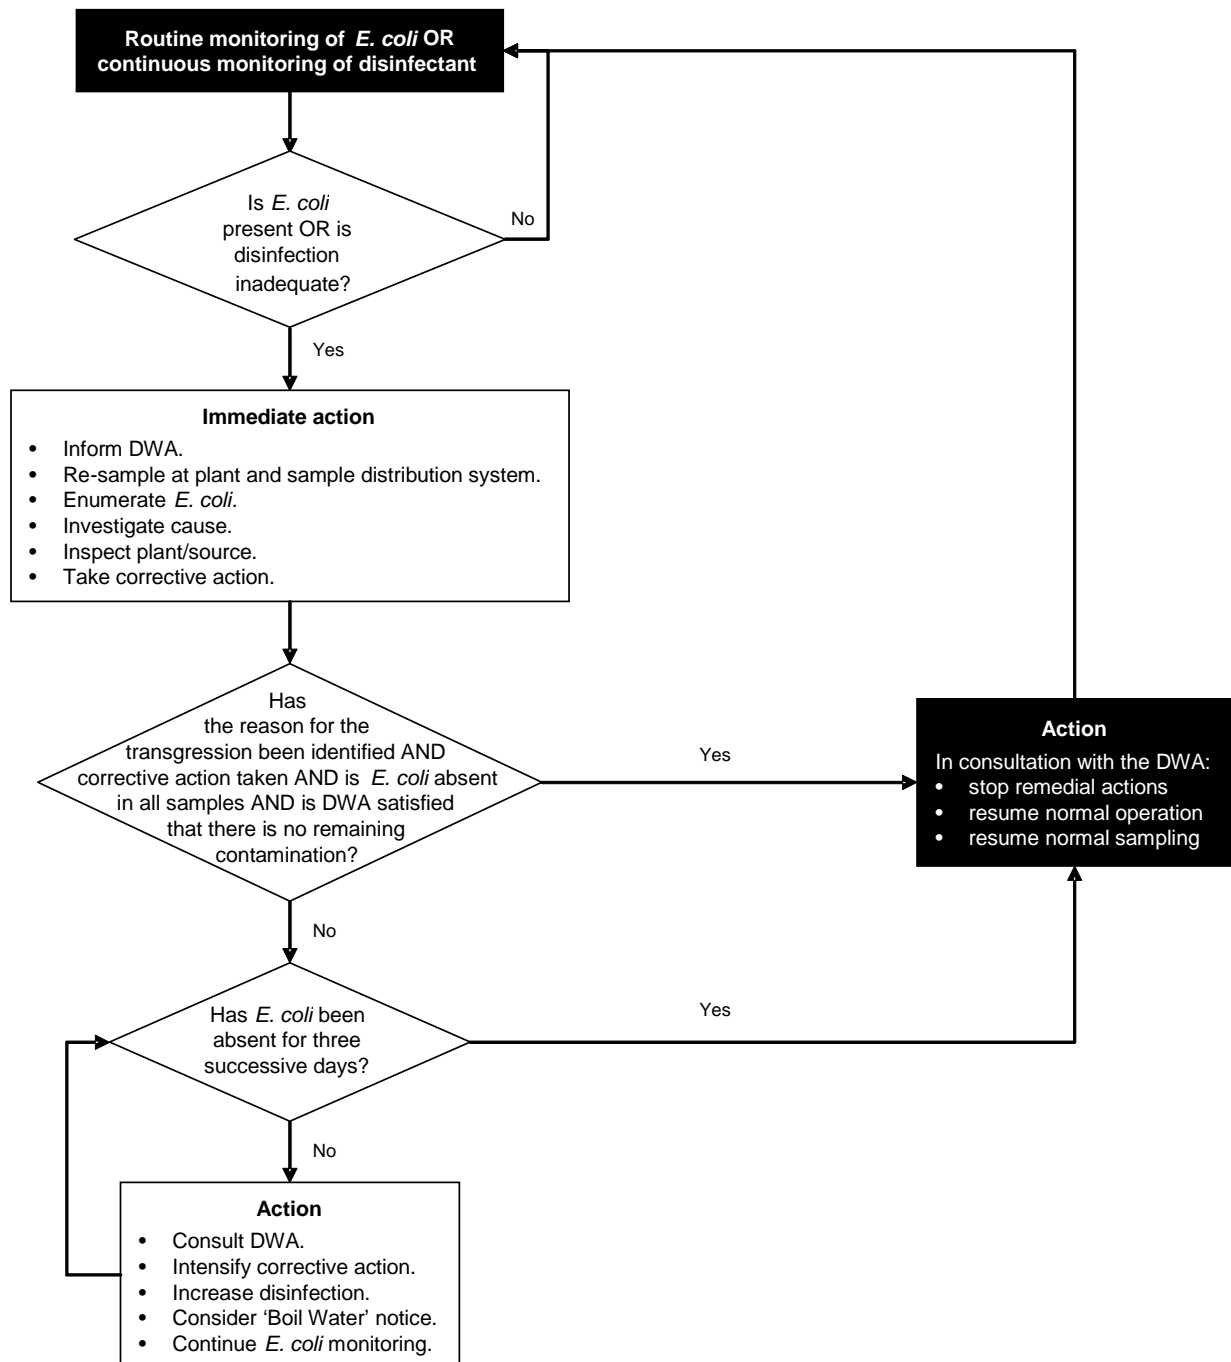
Figure 4.1: Response to *E. coli* contamination of drinking-water leaving treatment plant

A flow chart has been developed for each of the above scenarios showing the procedural steps and the personnel responsible. The flow charts show the general procedures only and give guidance to Operators who should be aware of the operational requirements of the water supply system. Additional guidance can be found in the operational manuals for each water supply. Furthermore, DWSNZ 2005/08 sets out response measures for performance transgressions which these procedures are based on. These are shown in Figure 4.1 and Figure 4.2.

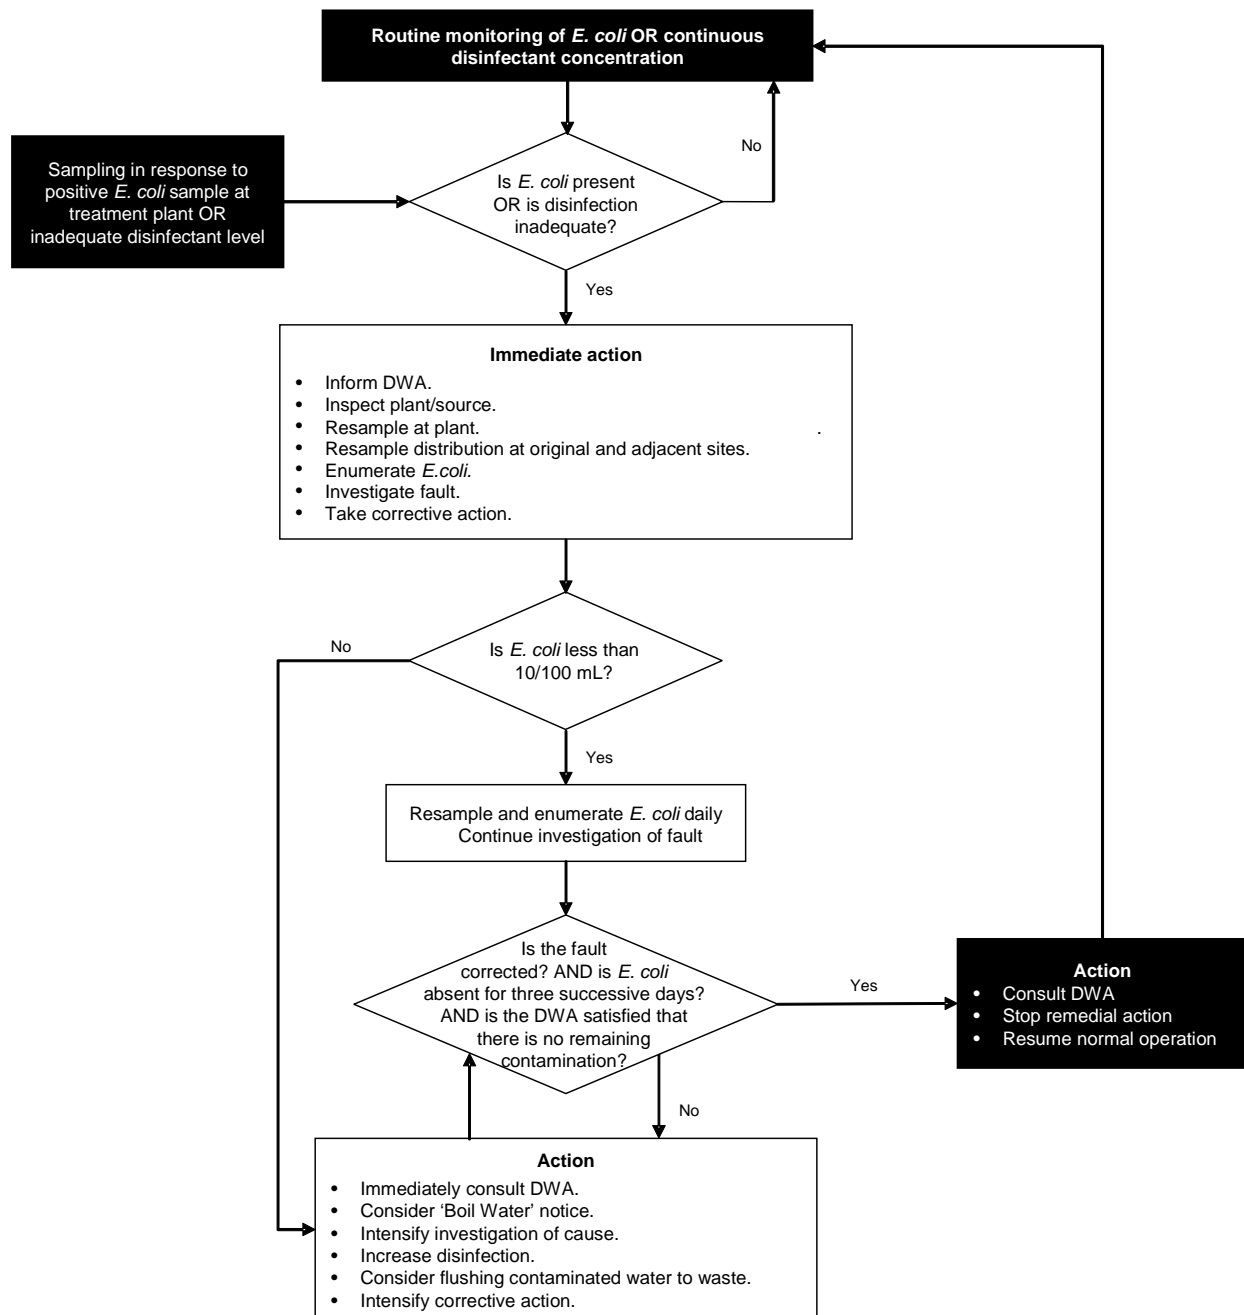
Figure 4.2: Response to *E. coli* contamination of a drinking-water supply distribution zone

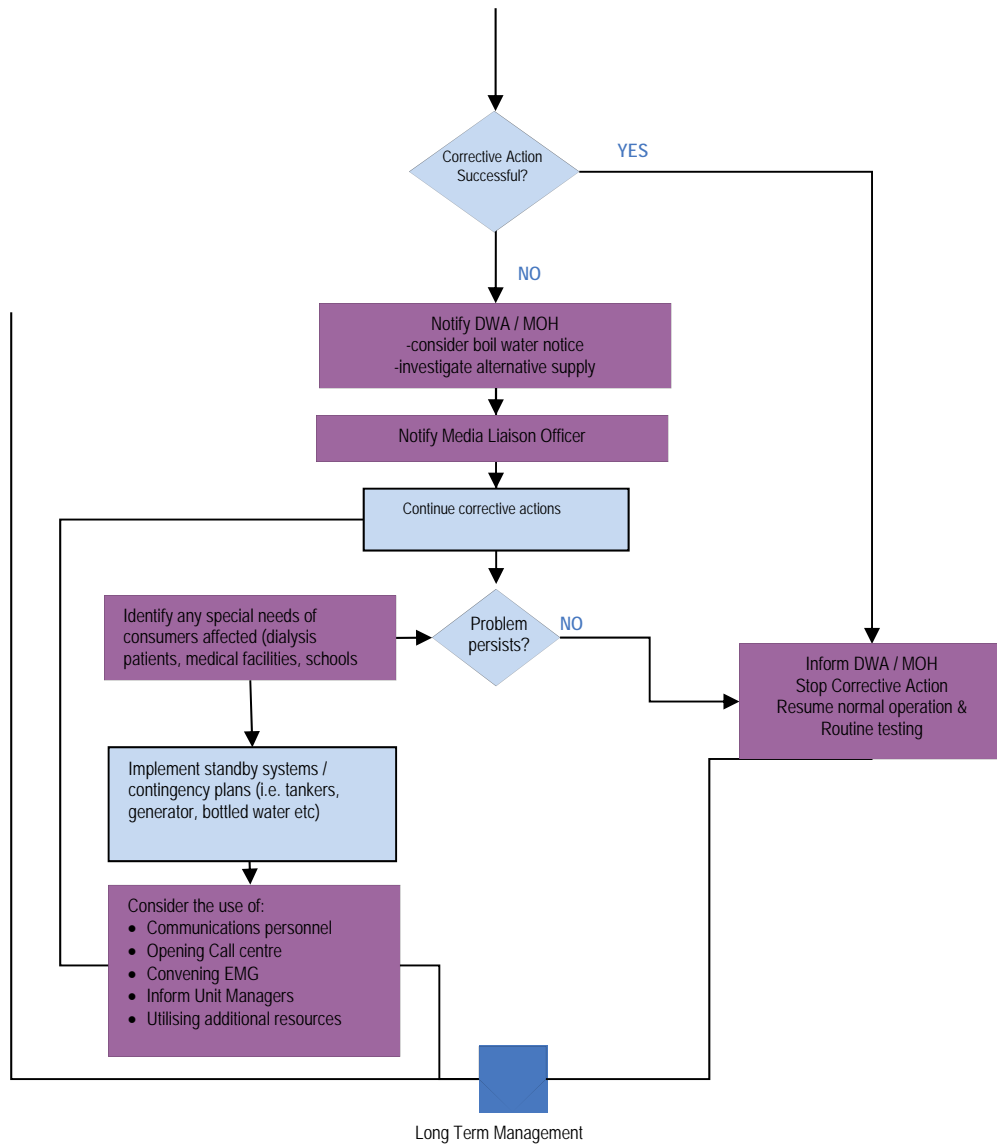
Continued from above

Contaminated Water Supply
