WAKATIPU INVESTMENTS LTD

LITTLES ROAD SUBDIVISION
DALEFIELD

GEOTECHNICAL ASSESSMENT FOR PROPOSED RURAL SUBDIVISION

REF: R5119-2A
DATE: 31 AUGUST 2019

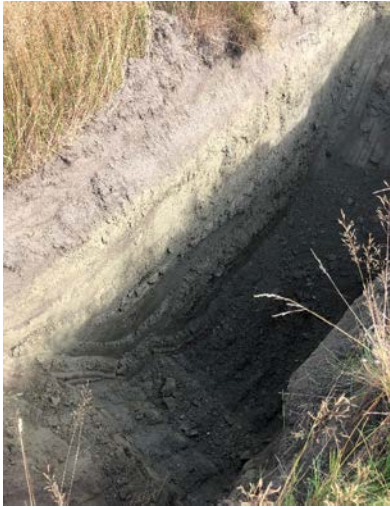
Project:	Proposed 24 Lot Subdivision	Project Number:	QV021
Site Location:	Little's Road, Queenstown	Client:	Wakatipu Investments Ltd
Tets Pit Number: Test pit #1 - Fine, sunny, no wind.			Sheet 1 of 10

TOPSOIL - turf, dark brown, dry	Topsoil	
0.5

Sandy SILT, LOESS - Light brown, moist	Loess	0.5
1.0						1.0
1.5						1.5
2.0

Silty, sandy GRAVEL - sub-rounded, light brown, AP20, schist based - Glacial Till	Glacial Till	2.0
2.5

2.2m bottom of pit, no water ingress.		2.5
3.0						3.0
3.5						3.5

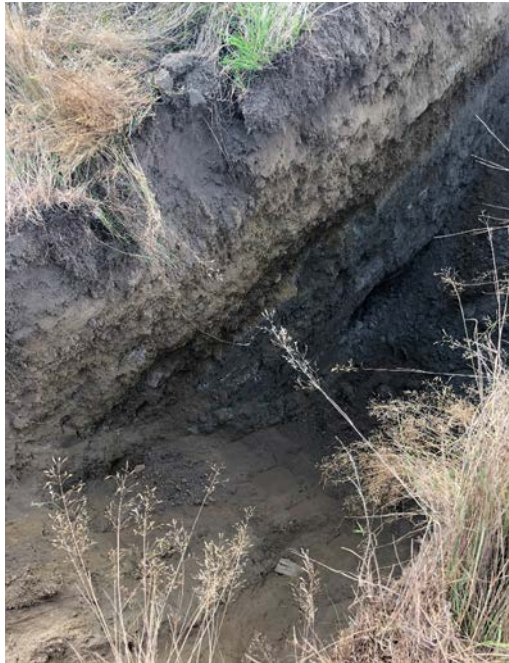
Project:	Proposed 24 Lot Subdivision	Project Number:	QV021			
Site Location:	Littles Road, Queenstown	Client:	Wakatipu Investments Ltd			
Tets Pit Number:	Test pit #2 - Fine, sunny, no wind.		Sheet 2 of 10			
Depth (m)	Water Level	Graphic Log	Moisture	Soil Rock Description	Geological Unit	Depth
				TOPSOIL - turf, dark brown, dry	Topsoil	
				Sandy SILT, LOESS - Light brown, dry	Loess	
0.5				Sandy GRAVEL, rounded, light brown, AP20, dry	Gravel	0.5
1.0				Silty, sandy GRAVEL - sub-rounded, light brown, AP20, schist based - Glacial Till	Glacial Till	1.0
1.5						1.5
				SAND - gray, moist, clean	Sand	
2.0				1.8m bottom of pit, no water ingress.		2.0

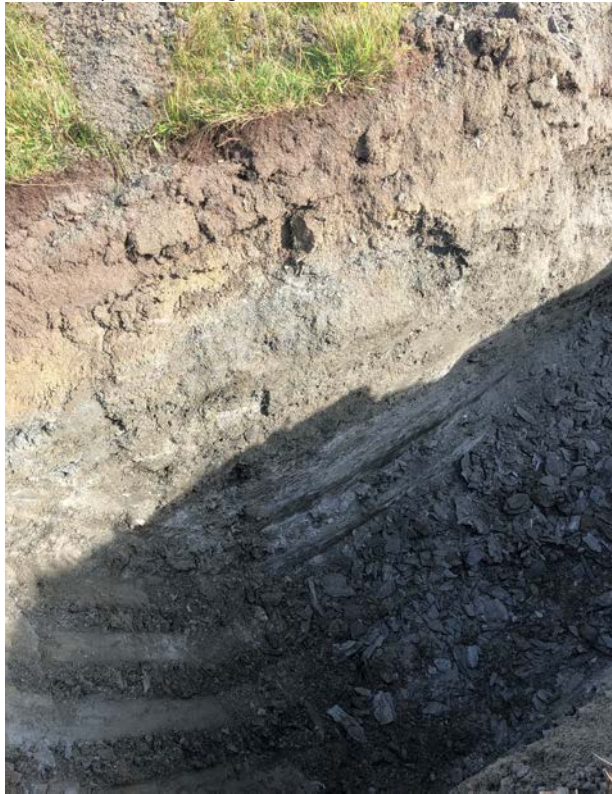
Schist BEDROCK - easily rippable at interface, more solid with depth	Bedrock	1.5
2.0				1.5m bottom of pit, no water ingress.

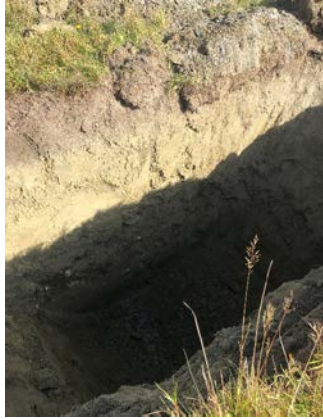
Project:	Proposed 24 Lot Subdivision	Project Number:	QV021
Site Location:	Little's Road, Queenstown	Client:	Wakatipu Investments Ltd
Tets Pit Number:			Test pit #4 - Fine, sunny, no wind.
			Sheet 4 of 10

Depth (m)	Water Level	Graphic Log	Moisture	Soil Rock Description	Geological Unit	Depth
				TOPSOIL - turf, dark brown, dry	Topsoil	
0.5				Sandy SILT, LOESS - Light brown, dry	Loess	0.5
1.0						1.0
1.5				Silty, sandy GRAVEL - sub-rounded, light brown, AP20, schist based - Glacial Till	Glacial Till	1.5
2.0						2.0
2.5				Schist BEDROCK - easily rippable at interface, more solid with depth	Bedrock	2.5
3.0				2.4m bottom of pit, no water ingress.		3.0
3.5

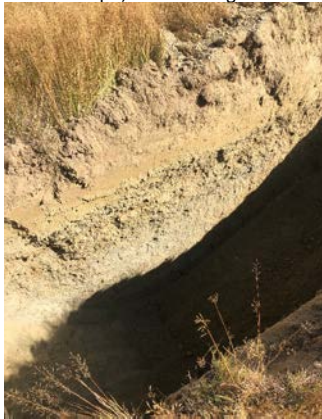
Sandy GRAVEL, some silt, cleaner with depth, light brown/gray, subrounded	Gravel	1.5
2.0						2.0
2.5				2.4m bottom of pit, no water ingress.		2.5
3.0

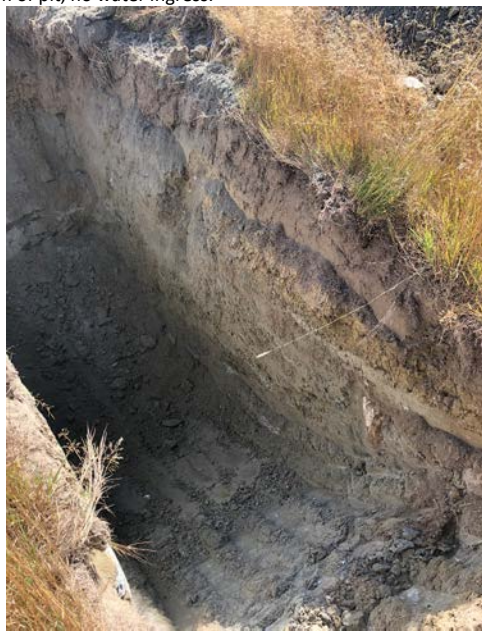
Project:		Proposed 24 Lot Subdivision			Project Number:		QV021						
Site Location:		Littles Road, Queenstown			Client:		Wakatipu Investments Ltd						
Tets Pit Number:		Test pit #6 - Fine, sunny, no wind.						Sheet 6 of 10					
Depth (m)		Water Level		Graphic Log		Moisture		Soil Rock Description		Geological Unit		Depth	
0.5

Schist BEDROCK - solid		Bedrock		2.0	
2.5								1.9m bottom of pit, no water ingress.				2.5	
3.0

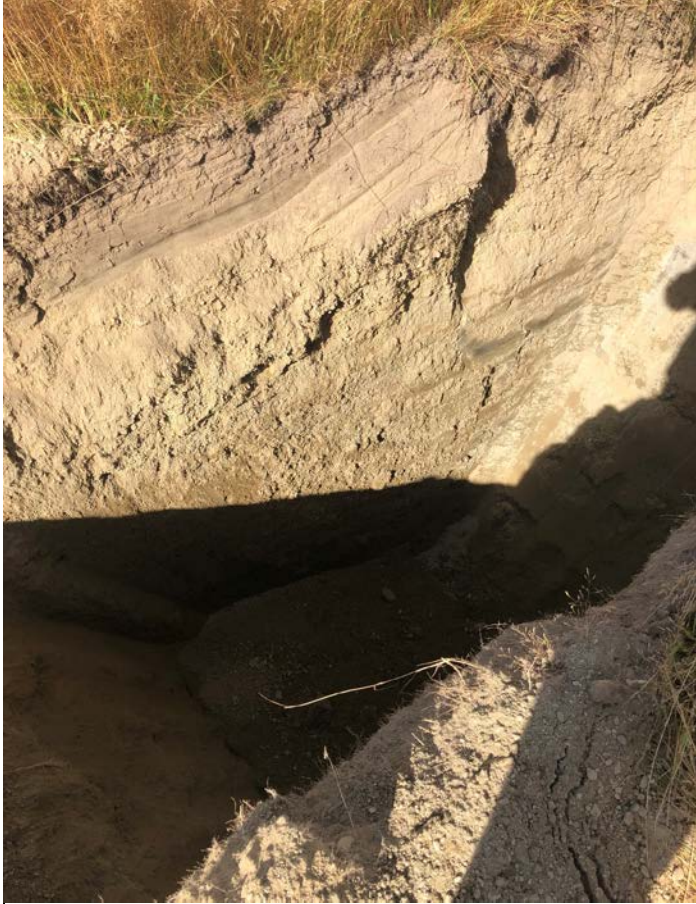
Project:	Proposed 24 Lot Subdivision	Project Number:	QV021
Site Location:	Little's Road, Queenstown	Client:	Wakatipu Investments Ltd
Tets Pit Number:			Test pit #7 - Fine, sunny, no wind.
			Sheet 7 of 10

Depth (m)	Water Level	Graphic Log	Moisture	Soil Rock Description	Geological Unit	Depth
				TOPSOIL - turf, dark brown, dry	Topsoil	
0.5				Sandy GRAVEL, some silt, cleaner with depth, light brown/gray, rounded	Gravel	0.5
1.0

1.0
1.5			1.5			
2.0			2.0			
2.5			2.5			
3.0				2.5m bottom of pit, no water ingress.		3.0
3.5

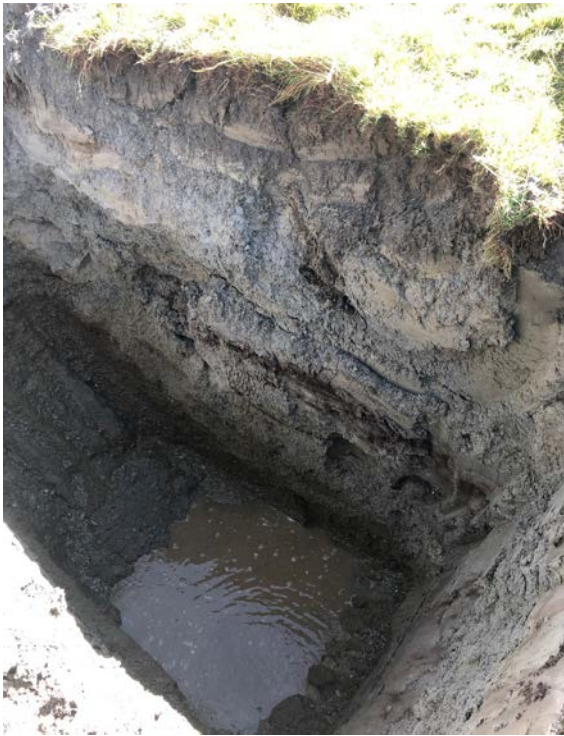
Project:	Proposed 24 Lot Subdivision	Project Number:	QV021
Site Location:	Littles Road, Queenstown	Client:	Wakatipu Investments Ltd
Tets Pit Number:			Test pit #8 - Fine, sunny, no wind.
			Sheet 8 of 10

Depth (m)	Water Level	Graphic Log	Moisture	Soil Rock Description	Geological Unit	Depth
				TOPSOIL - turf, dark brown, moist	Topsoil	
0.5				SILT layers - soft, damp, wetter with depth, organic	Silt	0.5
1.0						1.0
1.5						1.5
2.0				Sandy, silty GRAVEL, light brown/gray, subrounded, saturated, groundwater flows.	Gravel	2.0
2.5

2.5
3.0						3.0
3.5				3.6m bottom of pit, water ingress at >1.6m depth.		3.0

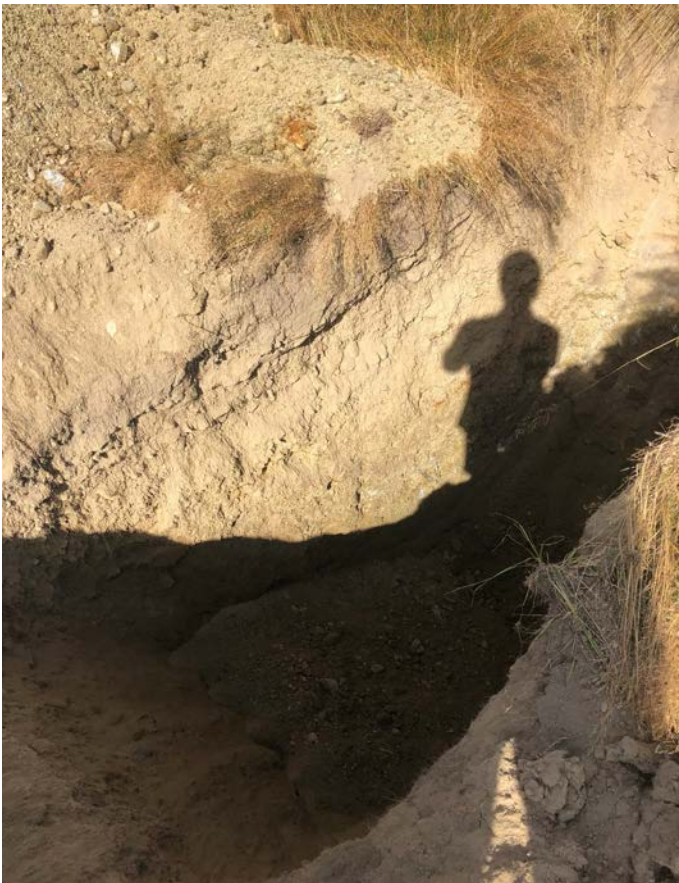
Project:	Proposed 24 Lot Subdivision	Project Number:	QV021
Site Location:	Littles Road, Queenstown	Client:	Wakatipu Investments Ltd
Tets Pit Number: Test pit #9 - Fine, sunny, no wind.			Sheet 9 of 10

Depth (m)	Water Level	Graphic Log	Moisture	Soil Rock Description	Geological Unit	Depth
				TOPSOIL - turf, dark brown, dry	Topsoil	
0.5				Sandy GRAVEL, some silt, cleaner with depth, light brown/gray, rounded, dry.	Gravel	0.5
1.0

1.0
1.5			1.5			
2.0			2.0			
2.5			2.5			
3.0				2.4m bottom of pit, no water ingress.		3.0
3.5

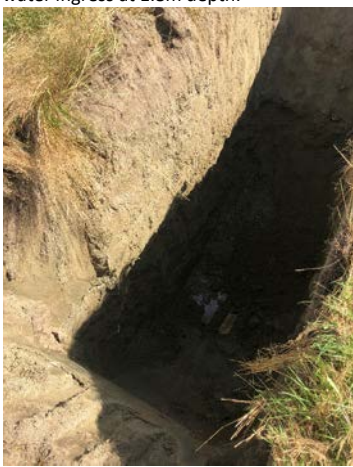
Sandy SILT, LOESS - Light brown, moist	Loess	1.0
1.5

Sandy GRAVEL, some silt, cleaner with depth, light brown/gray, subrounded, wet	Gravel	1.5
2.0						2.0
2.5				2.3m bottom of pit, water ingress at 1.8m depth.		2.5
3.0
